City of Midwest City ADA Self-Evaluation and Transition Plan

Project: ADA Self-Evaluation and Transition Plan

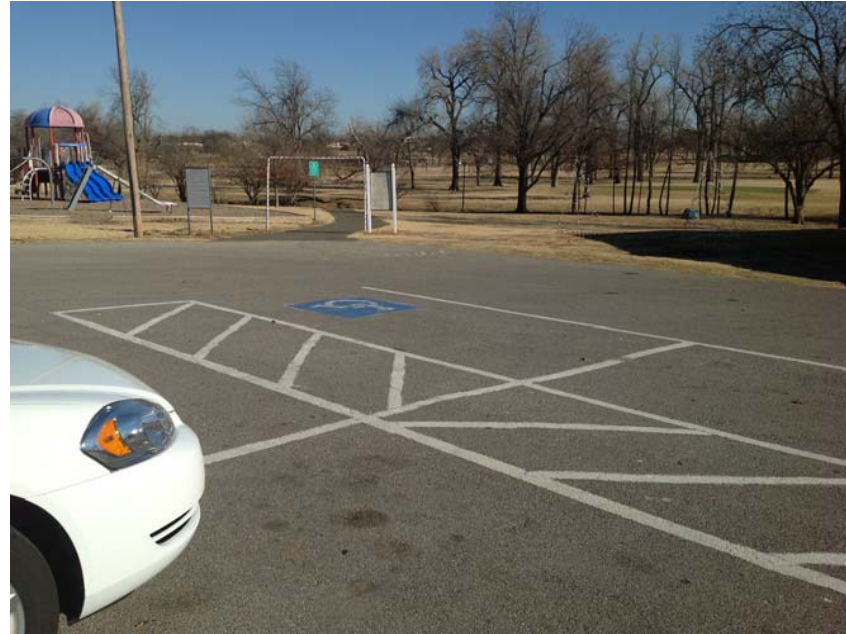
This is another view of the parking spaces noted above to show the slope issue.

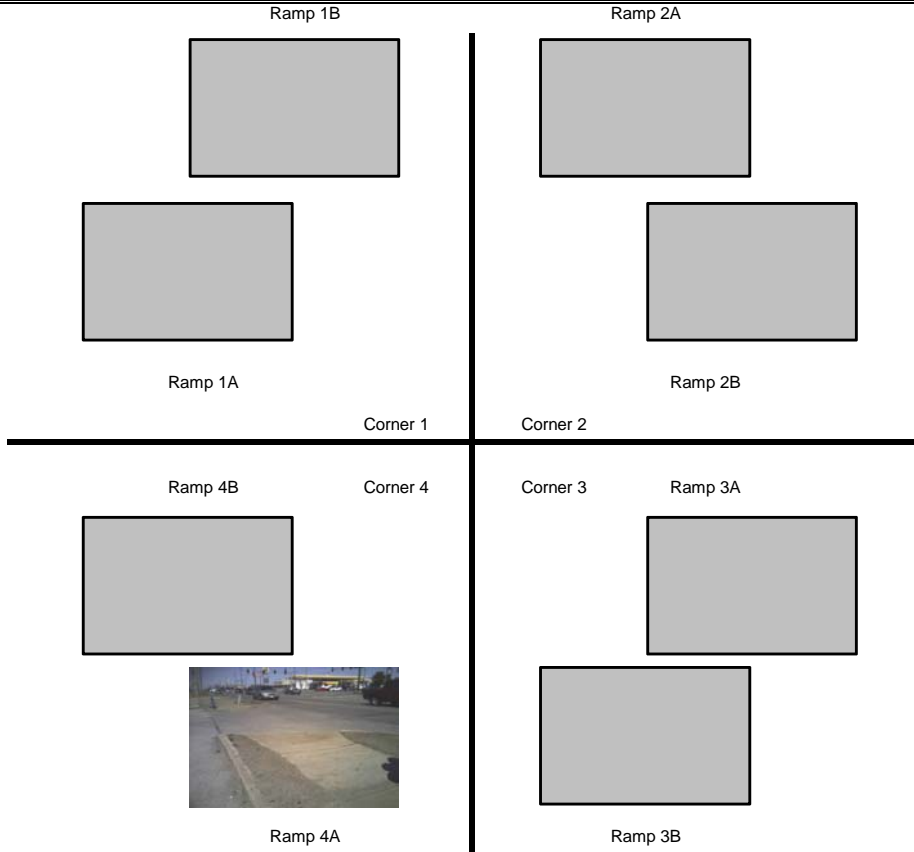
Clear floor space for pedestrian pushbutton is less than 30" x 48", has a cross slope greater than 2% or does not exist									
Ramp transition onto roadway is greater than 0.25"								X	Fix ramp transition
Ponding occurs at base of ramp									
No existing curb in path of travel			X	X					Do not install ramp
Ramp Priority:	H		-	-				H	H

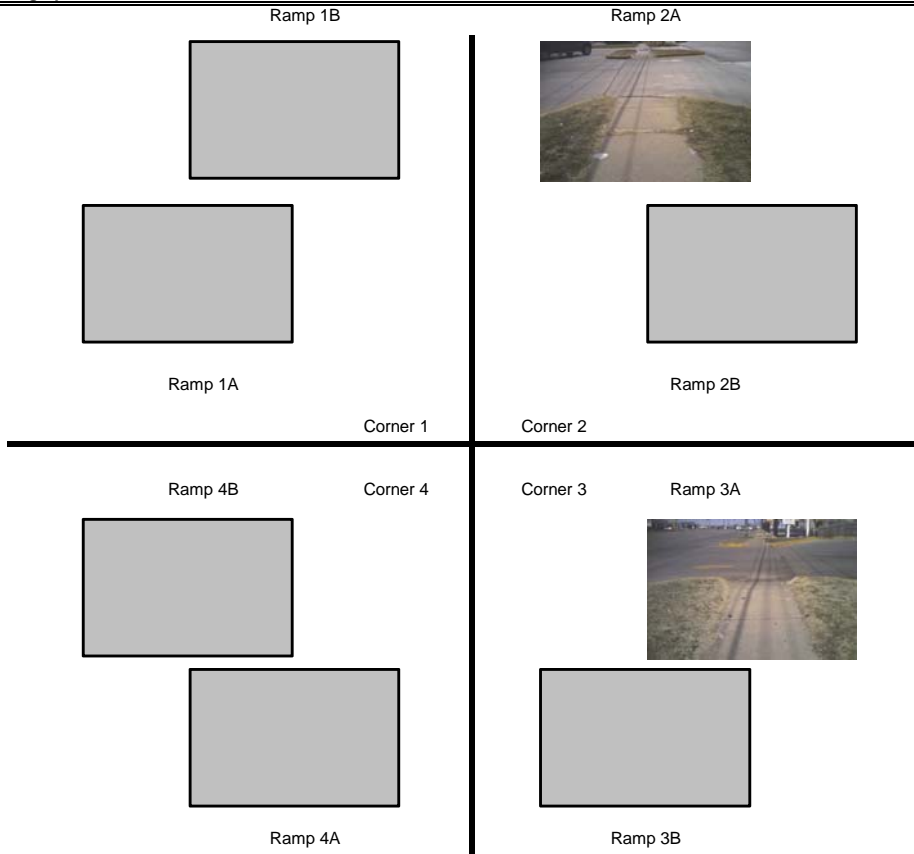
Clear floor space for pedestrian pushbutton is less than 30" x 48", has a cross slope greater than 2% or does not exist									
Ramp transition onto roadway is greater than 0.25"			X	X					Fix ramp transition
Ponding occurs at base of ramp			X	X					
No existing curb in path of travel	X						X		Do not install ramp
Ramp Priority:	-		H	H			-

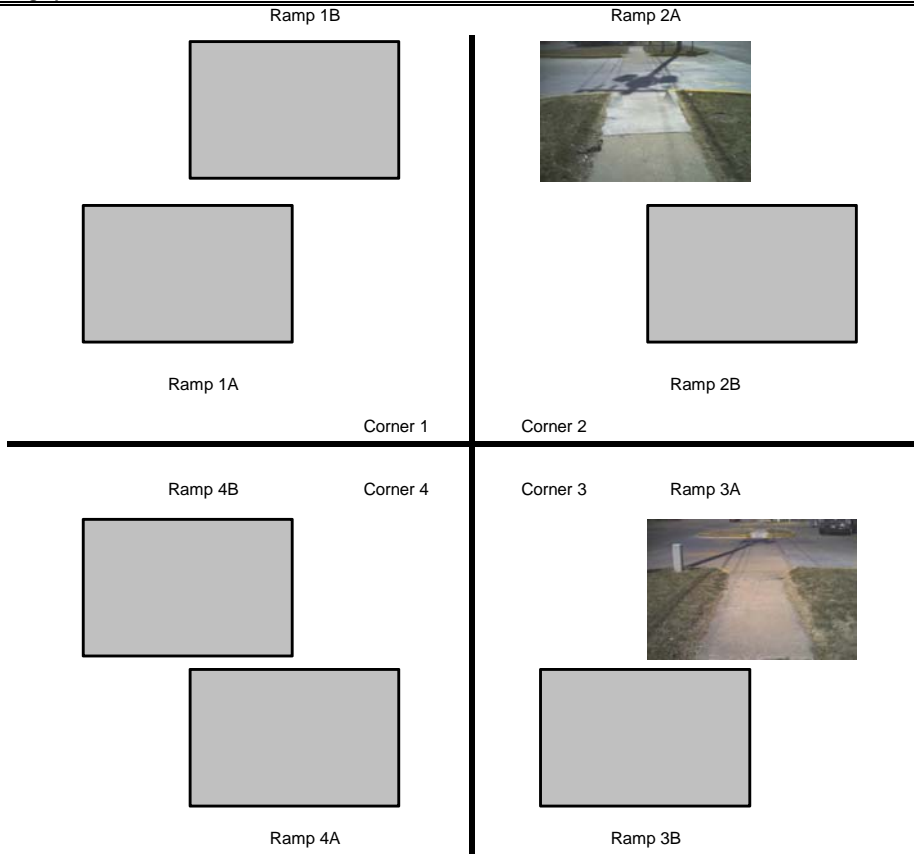
Clear floor space for pedestrian pushbutton is less than 30" x 48", has a cross slope greater than 2% or does not exist									
Ramp transition onto roadway is greater than 0.25"									
Ponding occurs at base of ramp									
No existing curb in path of travel	X						X		Do not install ramp
Ramp Priority:	-		H		H		-

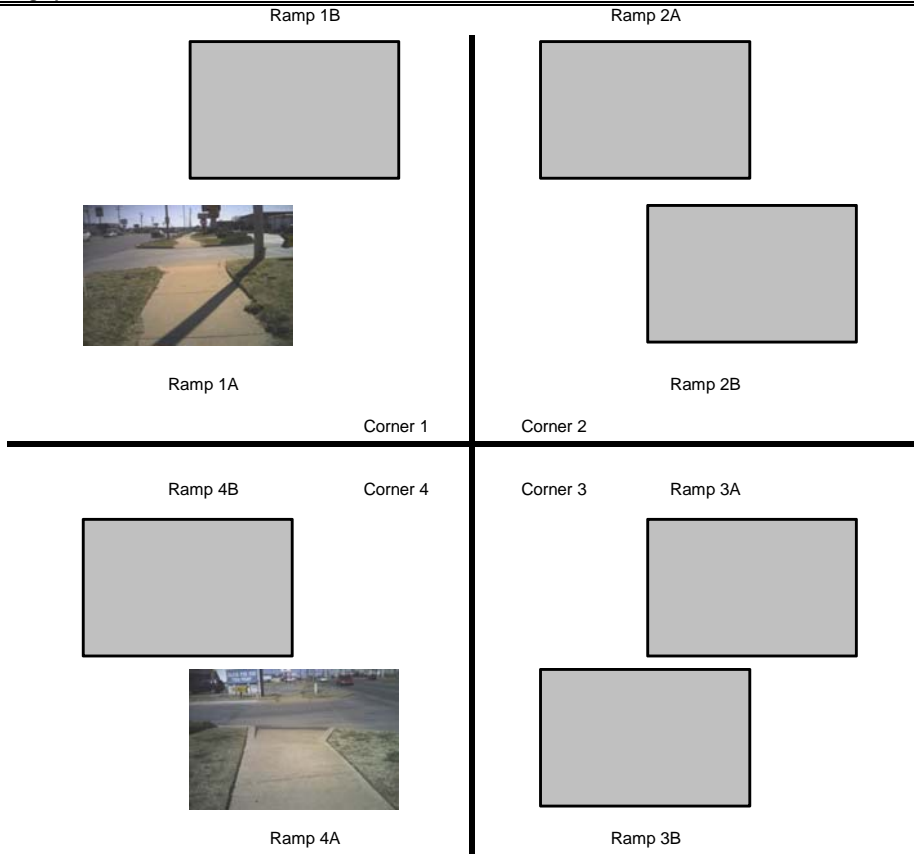
Clear floor space for pedestrian pushbutton is less than 30" x 48", has a cross slope greater than 2% or does not exist									
Ramp transition onto roadway is greater than 0.25"									
Ponding occurs at base of ramp									
No existing curb in path of travel			X		X				Do not install ramp
Ramp Priority:	H		-		-		H

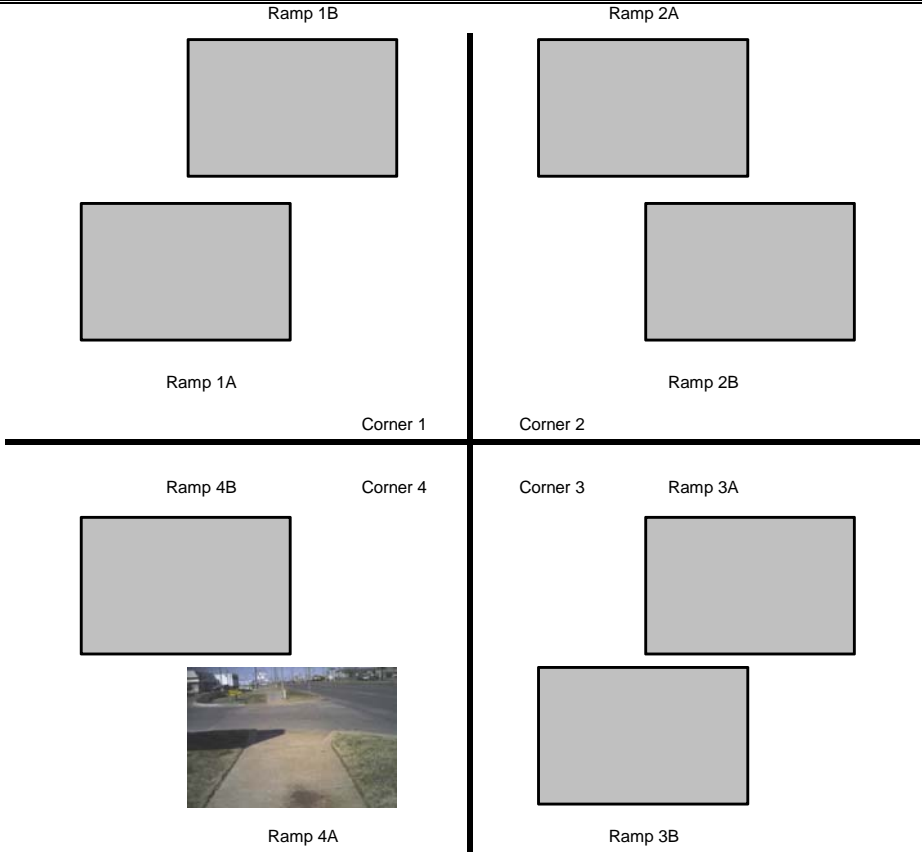
Clear floor space for pedestrian pushbutton is less than 30" x 48", has a cross slope greater than 2% or does not exist									
Ramp transition onto roadway is greater than 0.25"									
Ponding occurs at base of ramp									
No existing curb in path of travel	X		X		X				Do not install ramp
Ramp Priority:	-		-		-		H

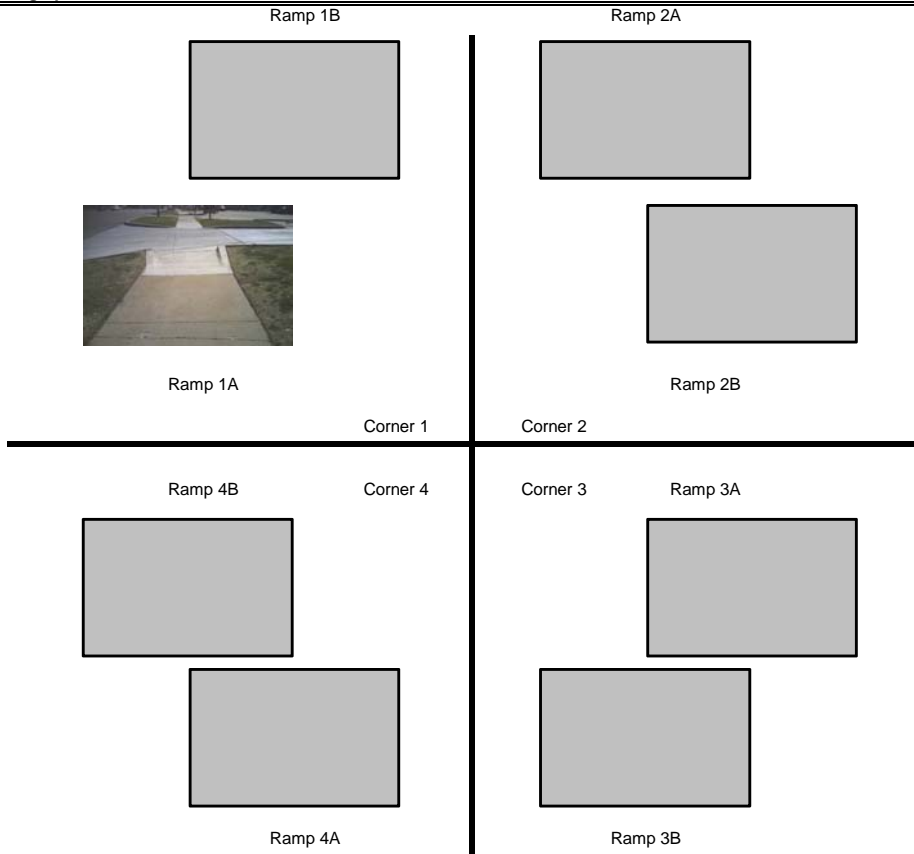
Clear floor space for pedestrian pushbutton is less than 30" x 48", has a cross slope greater than 2% or does not exist									
Ramp transition onto roadway is greater than 0.25"									
Ponding occurs at base of ramp									
No existing curb in path of travel							X		Do not install ramp
Ramp Priority:	H		H		H		-

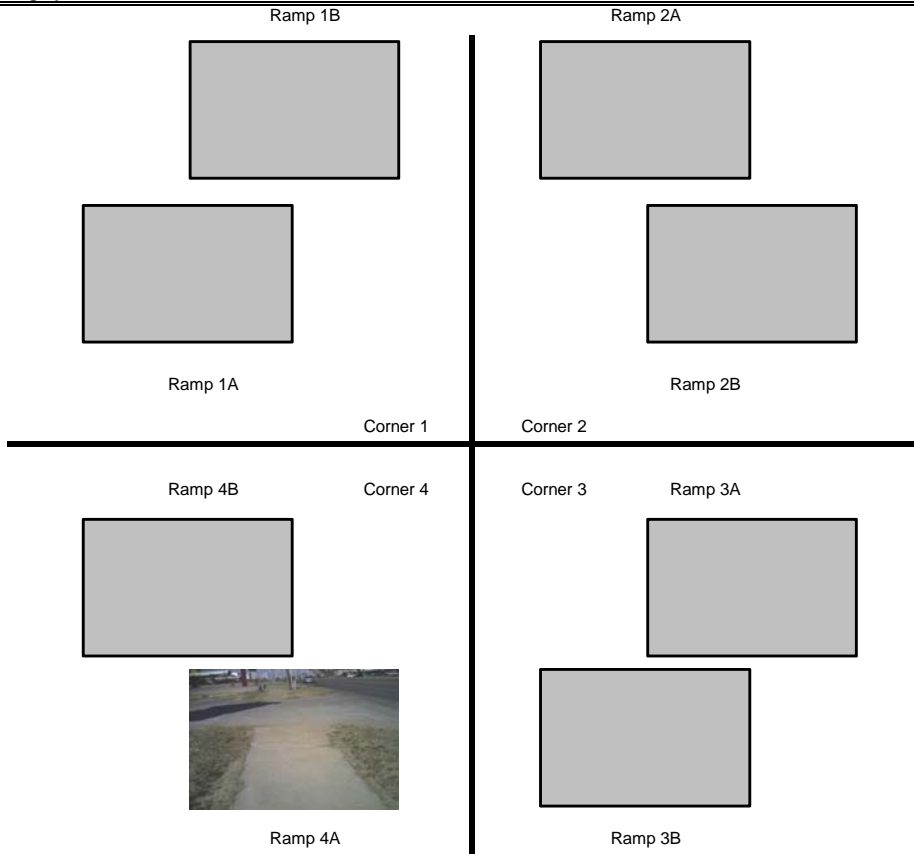
Ramp transition onto roadway is greater than 0.25"							X		Fix ramp transition
Ponding occurs at base of ramp							X		
No existing curb in path of travel	X		X		X				Do not install ramp
Ramp Priority:	-		-		-		H

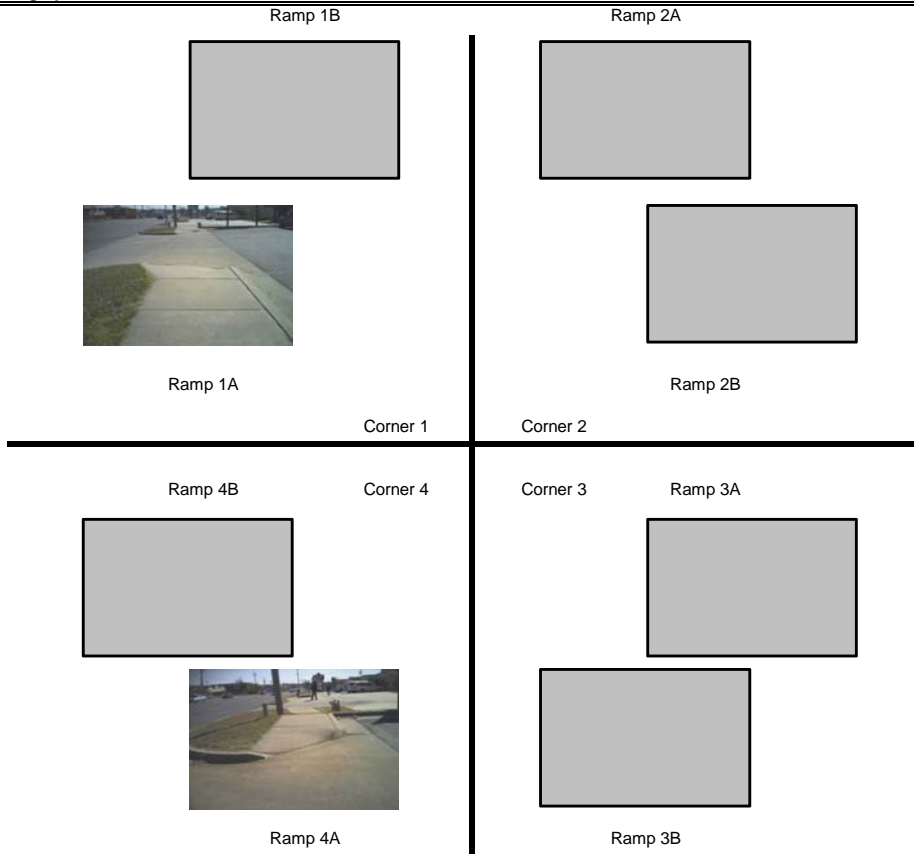
Clear floor space for pedestrian pushbutton is less than 30" x 48", has a cross slope greater than 2% or does not exist									
Ramp transition onto roadway is greater than 0.25"									
Ponding occurs at base of ramp									
No existing curb in path of travel			X		X				Do not install ramp
Ramp Priority:	H		-		-		H

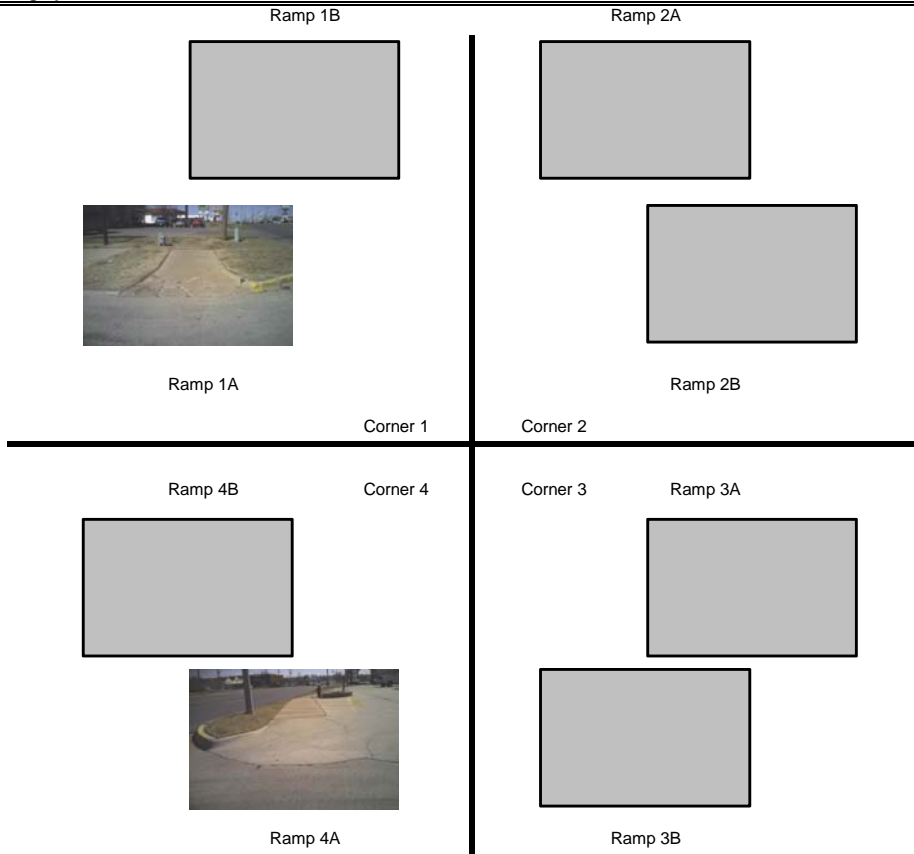
Clear floor space for pedestrian pushbutton is less than 30" x 48", has a cross slope greater than 2% or does not exist									
Ramp transition onto roadway is greater than 0.25"	X								Fix ramp transition
Ponding occurs at base of ramp									
No existing curb in path of travel			X		X				Do not install ramp
Ramp Priority:	H		-		-		H

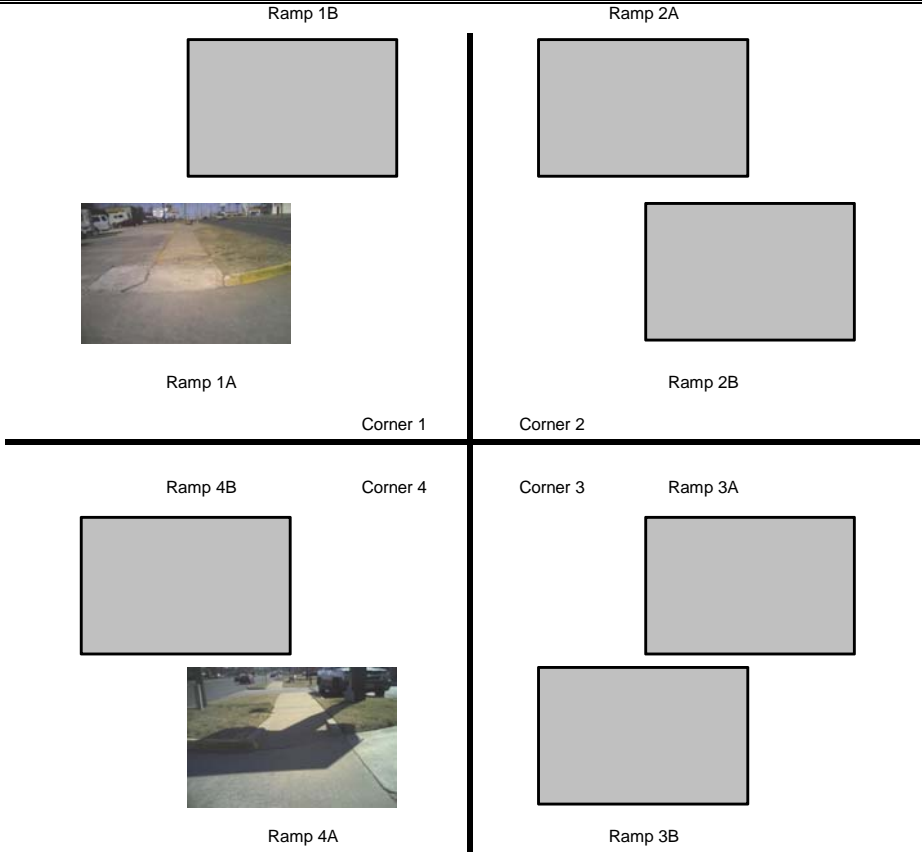
Clear floor space for pedestrian pushbutton is less than 30" x 48", has a cross slope greater than 2% or does not exist									
Ramp transition onto roadway is greater than 0.25"	X						X		Fix ramp transition
Ponding occurs at base of ramp									
No existing curb in path of travel			X		X				Do not install ramp
Ramp Priority:	H		-		-		H

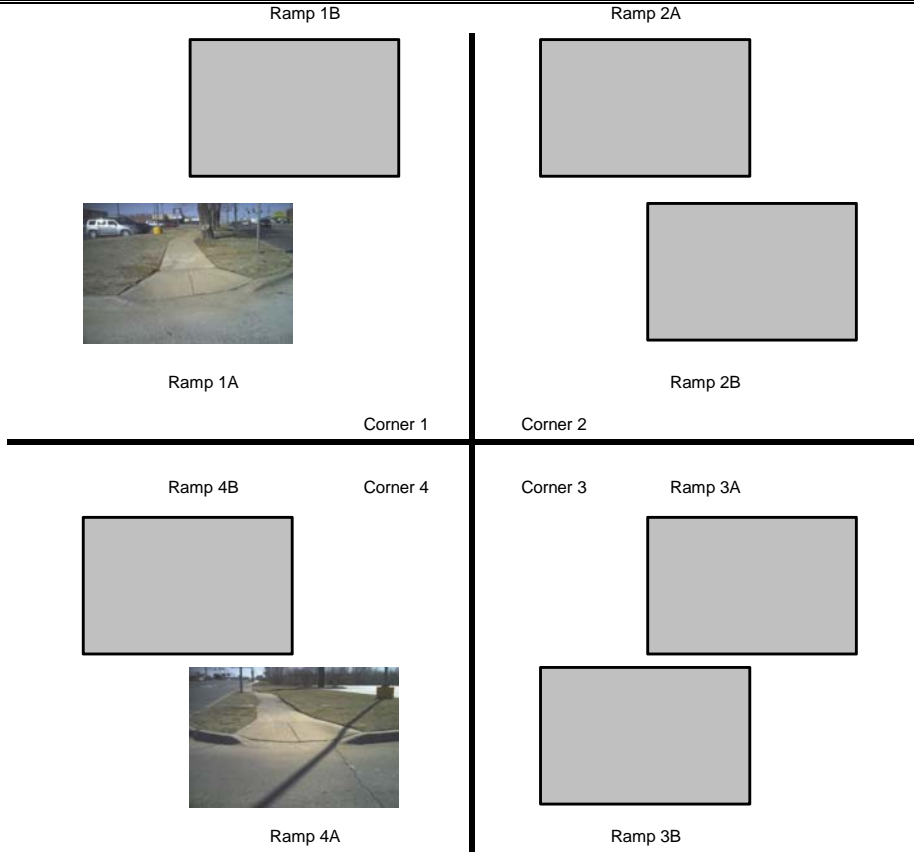
Clear floor space for pedestrian pushbutton is less than 30" x 48", has a cross slope greater than 2% or does not exist									
Ramp transition onto roadway is greater than 0.25"	X						X		Fix ramp transition
Ponding occurs at base of ramp									
No existing curb in path of travel									
Ramp Priority:	H		-		-		H

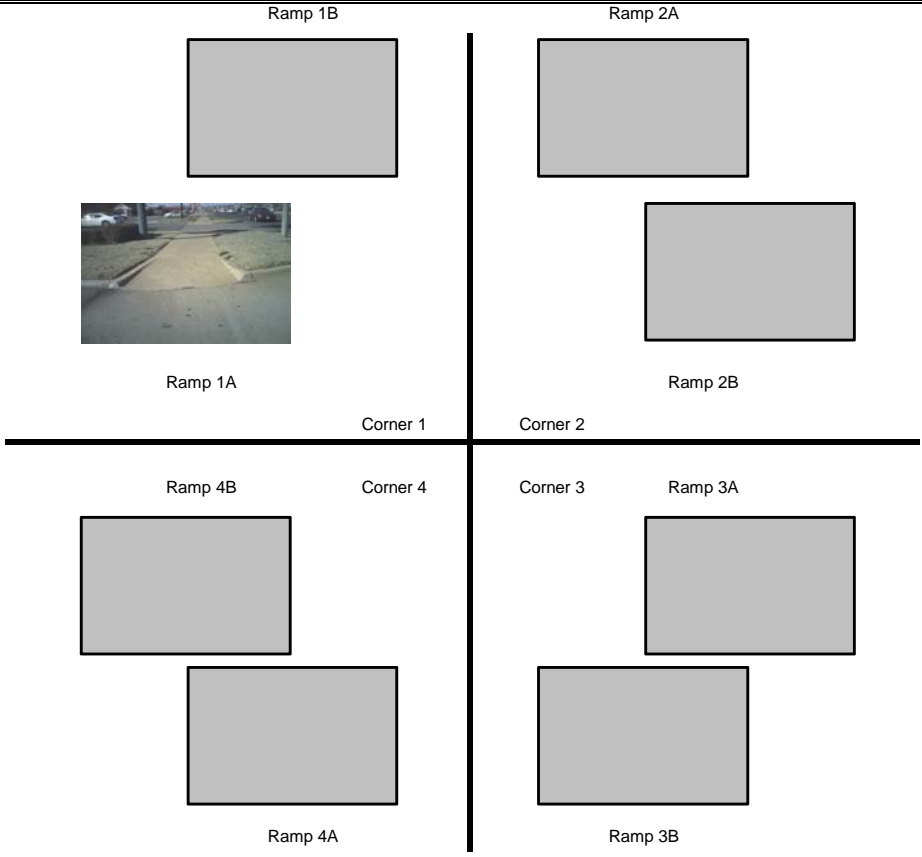
Ramp transition onto roadway is greater than 0.25"									
Ponding occurs at base of ramp									
No existing curb in path of travel			X	X	X				Do not install ramp
Ramp Priority:	H
