# Pre-Demolition Asbestos Inspection Report

2816 Parklawn Drive

Midwest City, Oklahoma

Terracon Project No. 03257090

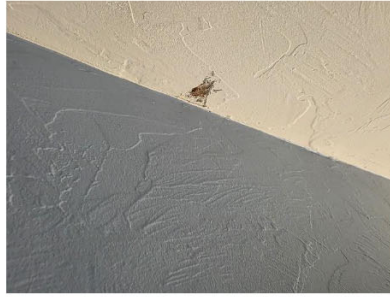
**Photo #2** White texture wallboard

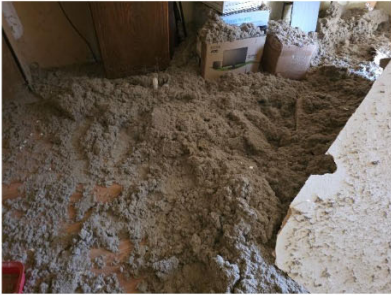
**Photo #3** Ceiling insulation

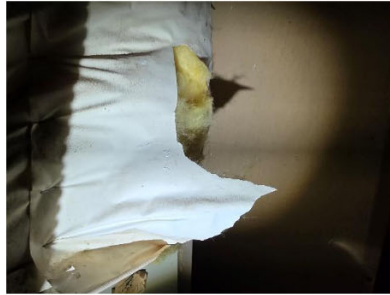
**Photo #4** Duct insulation

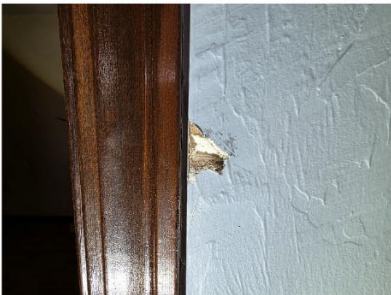
**Photo #5** Grey texture wallboard

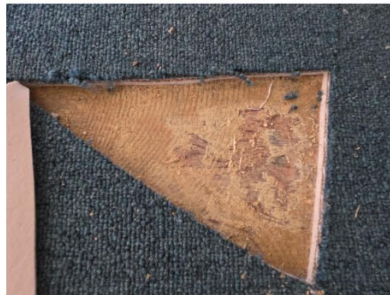
**Photo #6** Blue carpet mastic

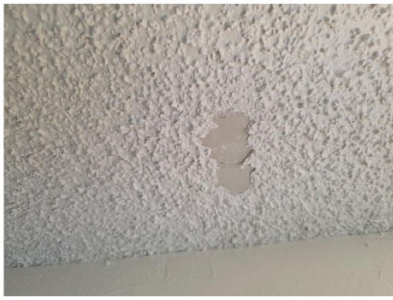
| HA | Material Description | Material Location | Percent/Type Asbestos | NESHAP Category | Condition | Estimated Quantity* |
|---|---|---|---|---|---|---|
| 6 | Pop Corn Ceiling | Suit 4 entrance NW side | 4% Chrysotile | RACM | Good | 4,000 sq ft. |

| Table A-1: Asbestos Inspection Sample Summary | | | | |
|---|---|---|---|---|
| | | 018 | Room 4 entrance NW side | Asbestos Present (Chrysotile 4%) |

**Photo #7** Pop corn ceiling

The above-mentioned RACM (ceiling texture/popcorn ceiling), was in good condition at the time of the inspection. In accordance with USEPA and ODOL guidelines and regulations, due to the likelihood of these materials being rendered friable during demolition activities, these materials must be removed and properly disposed of by an ODOL licensed asbestos abatement contractor prior to the commencement of demolition activities.

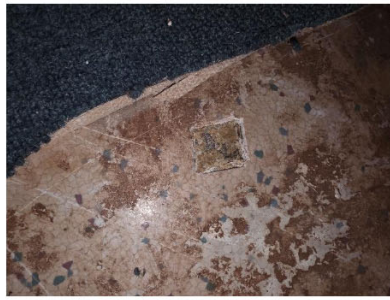
**Photo #8** White and blue speckled vinyl

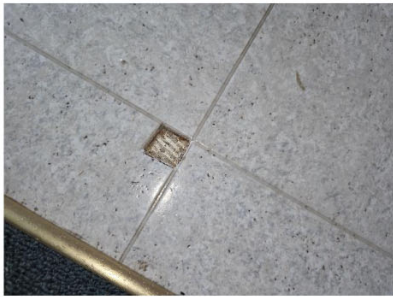
**Photo #9** 12x12 white speckled tile

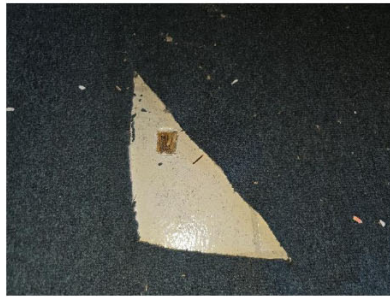
**Photo #10** Speckled vinyl found under blue carpet

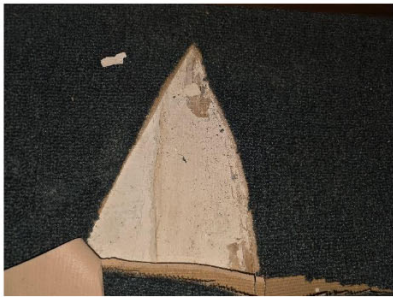
**Photo #12** White vinyl found under blue carpet

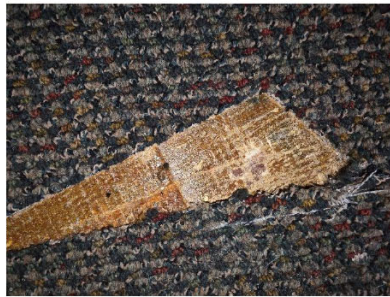
**Photo #13** Mastic under carpet

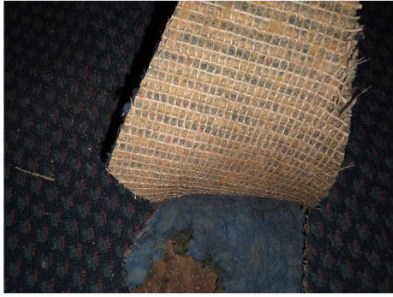
**Photo #14** Carpet mastic

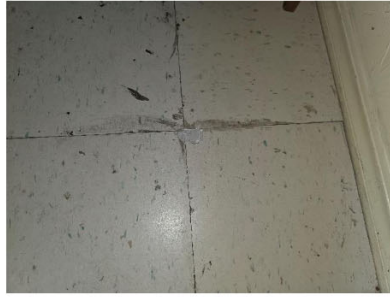
**Photo #15** 12x12 white tile

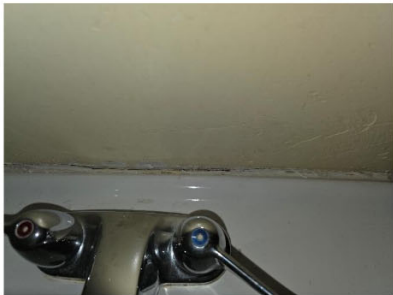
**Photo #16** Sink caulking

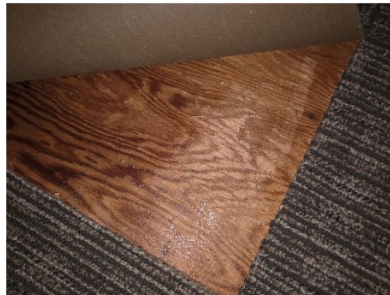
**Photo #17** Carpet mastic

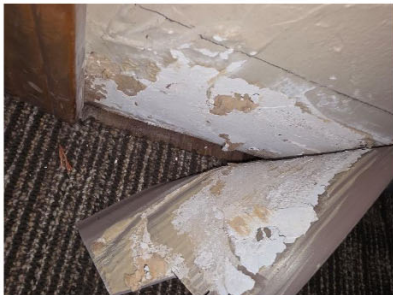
**Photo #18** Tan cove base

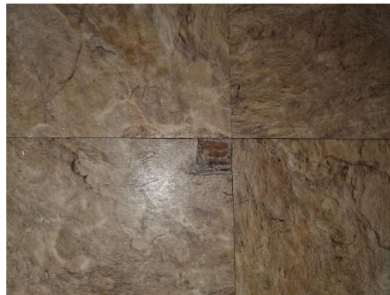
**Photo #19** Tan vinyl mastic

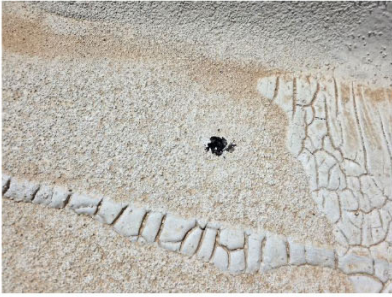
**Photo #20**     Roof tar

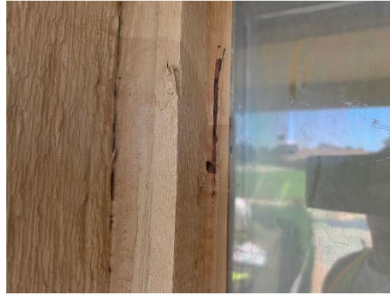
**Photo #21**     Outside window caulking

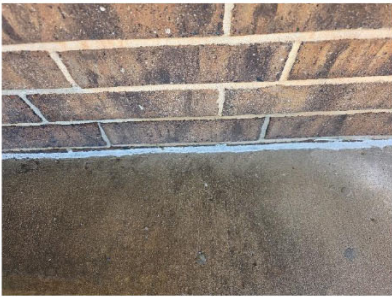
**Photo #22**     Outside wall caulking
