Wastewater Collection System Master Plan

August 12, 2025

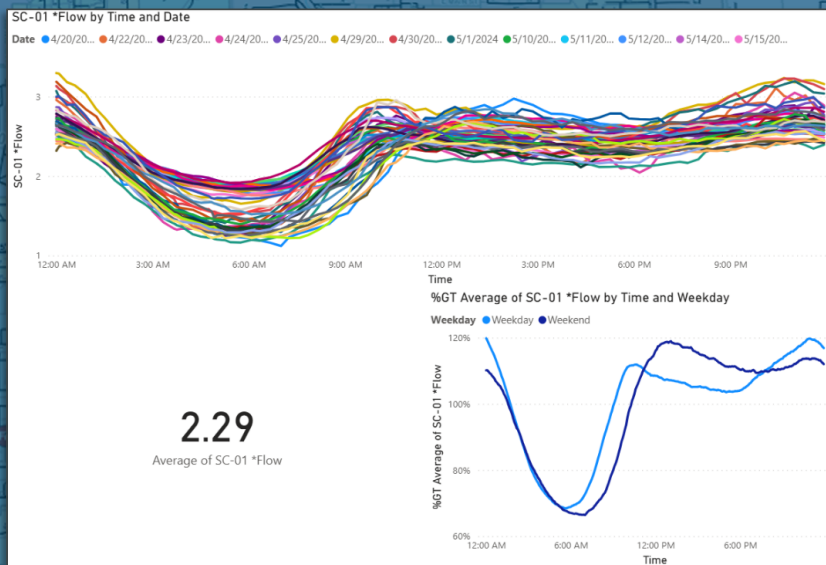
Flow Monitoring

- 18 Flow Meters and 4 Rain Gauges installed for 60 days in Spring 2024
- Identify Inflow and Infiltration (I/I)
- Calibrate the Hydraulic Wastewater Model

Freese & Nichols Midwest City Phase 2		Site Name CC-03
Project No. 30-0937-01	Site Code 1	
System Information		
Project Pipe Dia. (in) 36.0	Area Location Map	
Municipality Midwest City	Area View Picture	
Street RG-03	Top View Picture	
Assigned Rain Gauge RG-03	Investigation Photo	
Current Manhole or Gully Connecting MH I.D. 36in-72in	Installation Photo	
System Characteristics <input checked="" type="checkbox"/> Inflow <input checked="" type="checkbox"/> Infiltration <input checked="" type="checkbox"/> Combined <input checked="" type="checkbox"/> Hydraulic	Hydraulic Characteristics	
Location Information		
Site Address 8625 NE 50th St, Oklahoma City, Oklahoma	Site Information	
City Address 09 Ave	Pipe Height (ft) 33.00	
Longitude -87.4310200	Pipe Width (in) 36.25	
Latitude 35.47340000	Pipe Type Iron	
MH Type Precast Concrete	Pipe Slope 0.00	
Manhole Depth (ft) 12.00	CIP 100%	
Manhole Width (ft) 6.0	R25 0.0

Elevation (ft) 6.0	R25 0.0	
Height (ft) 6.0	R25 0.0	
Structural Integrity Safe	Hydraulic Information	
Flow Depth (ft) 2.87		
Instant Velocity (ft/s) 2.73		
Surge Height (ft) 0.00		
LSI Type None		
LSI Depth (ft) 0.00		
Needs Cleaning No		
Backwater No		
Pipe Path Straight		
Pipe Material No		
Hydraulic Rating Good		
Installation Notes		
Location in Pipe (ft) 2.0		
Location from Manhole Upstream		
Access Pressure, Velocity, and UTM		
Access Surface (Optional) Code: Structure Cover		
Signal Strength 75		
Post Installation Notes		
Meter Type A01		
Meter Model A01		
Installation Date 4/20/2024		
Approvals		
Recommended by F&N		
Client Approval

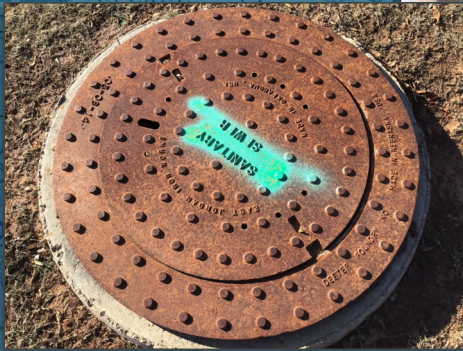
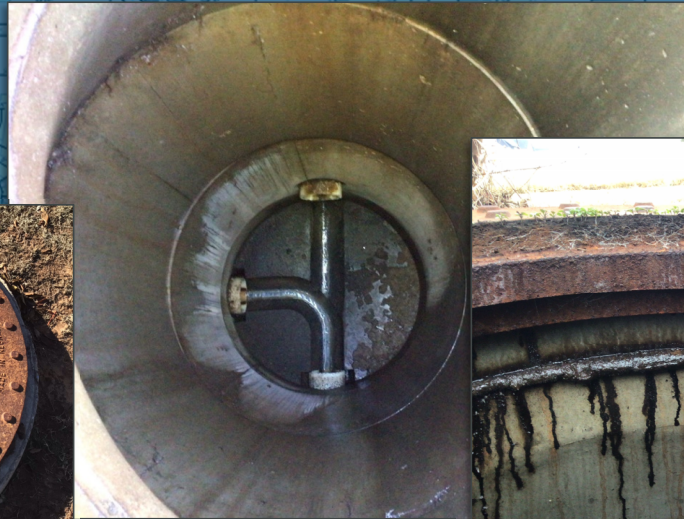
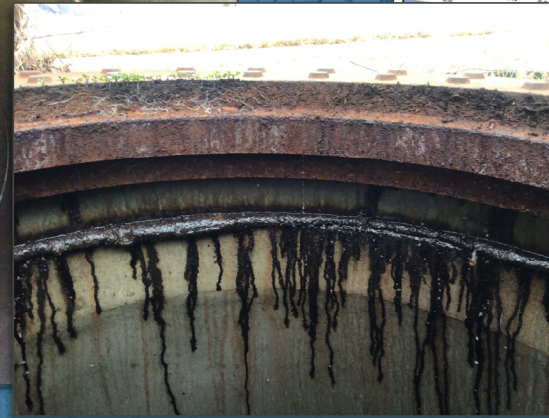
Manhole Inspections

- Inspected 300 Manholes
- Gathered data for model building
 - Depth
 - Connectivity
 - Condition

A screenshot of a digital inspection report form for Freese & Nichols. The form is titled "Midwest City WW Assessment Ph 1" and includes fields for "Inspected By", "Inspected Date/Time", "System Information", "Location Information", "Site Information", "Area Location Map", "Area View Picture", "Top View Picture", "Investigation Photo", "Installation Photo", "Install Plan Sketch", "Install Cross-Section Sketch", and "Approvals". The form is filled out with data for a specific manhole inspection.

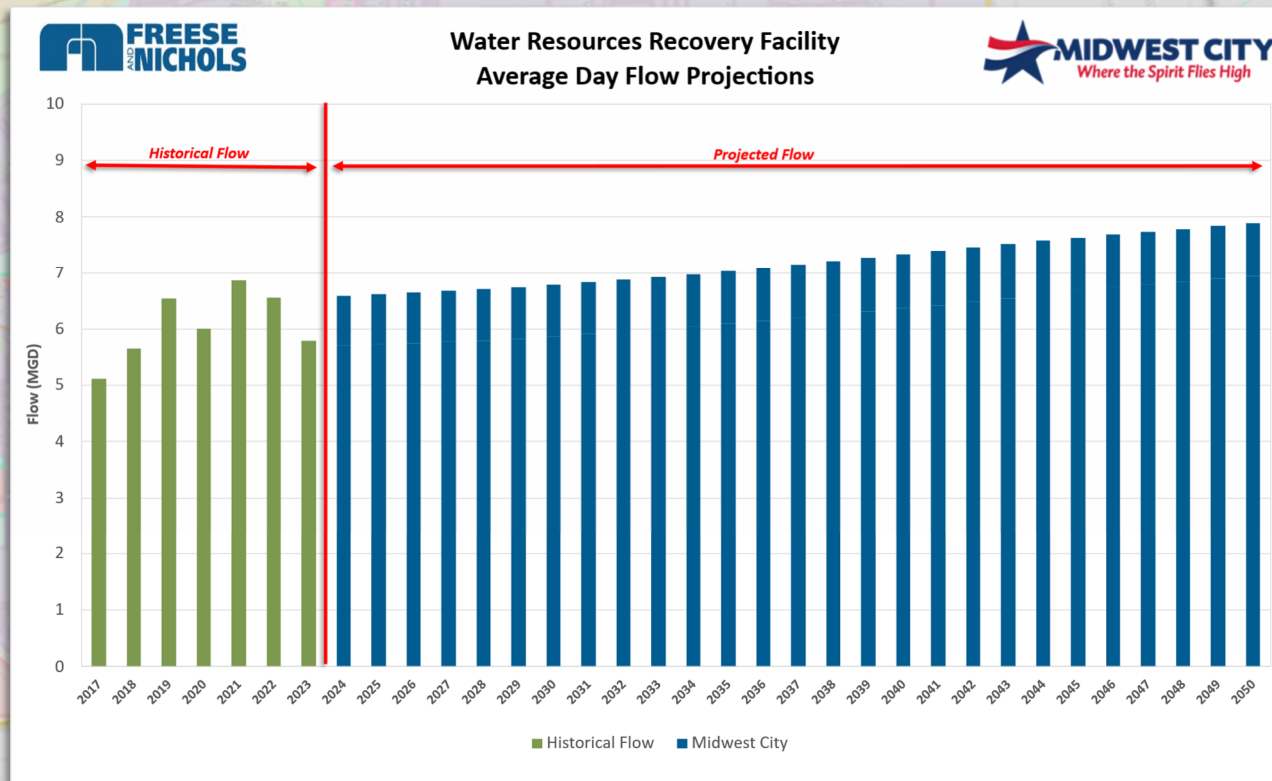
Wastewater Flow Projections

- Reviewed Historical WRRF Flows and Projected Future Flows

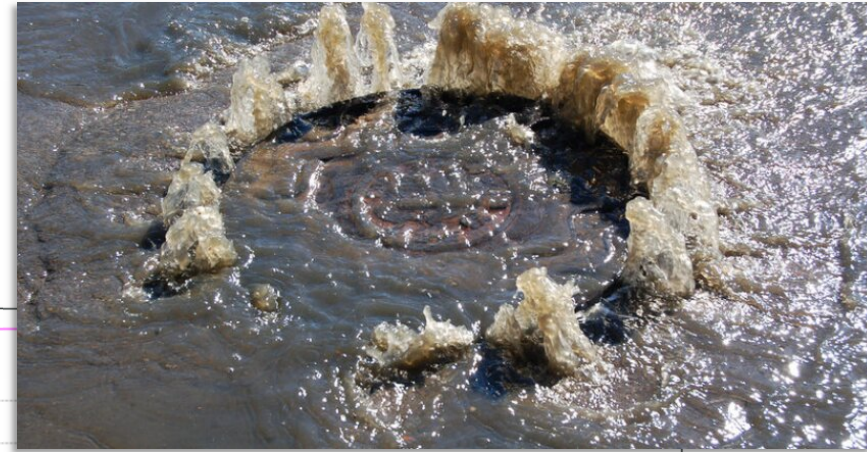
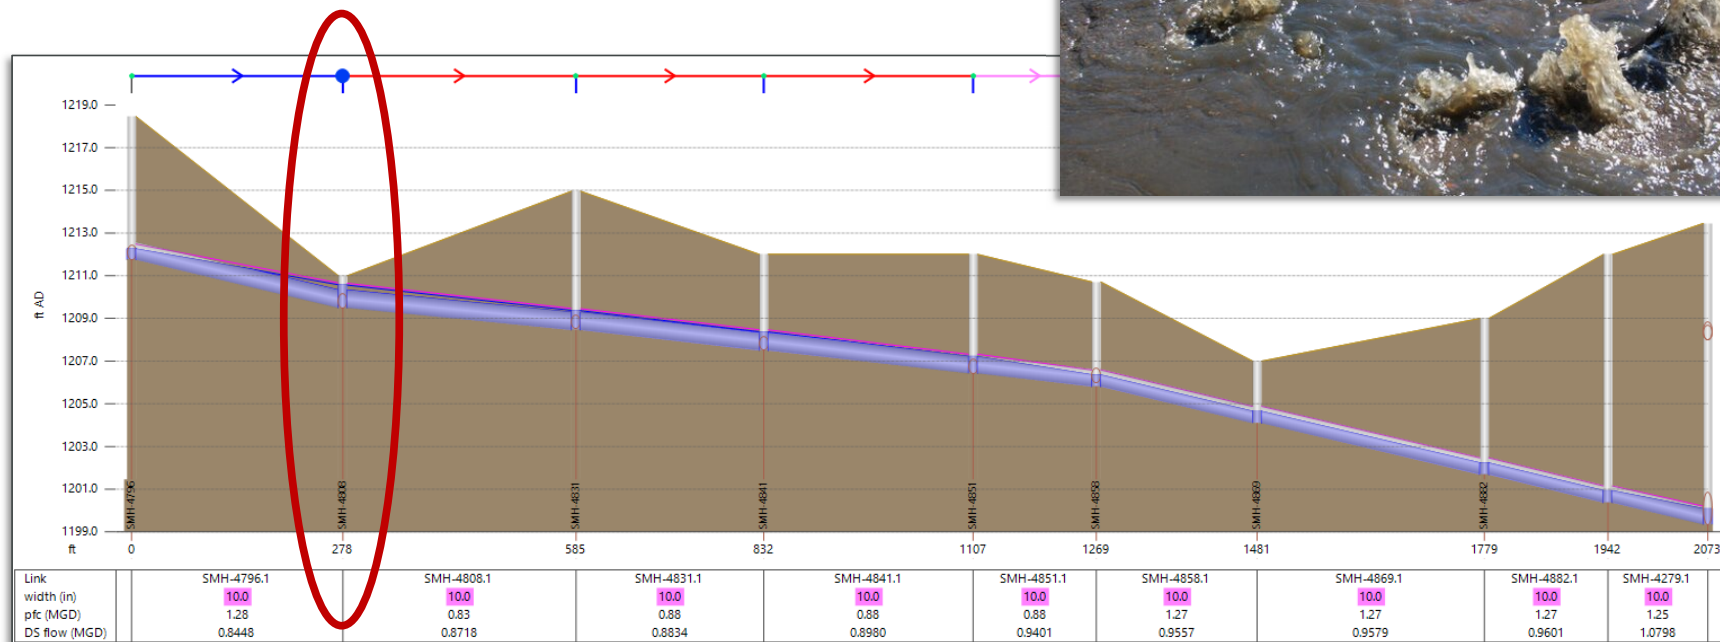
Collection System Analysis

- Identify excessive surcharging
- Model Predicted Overflows

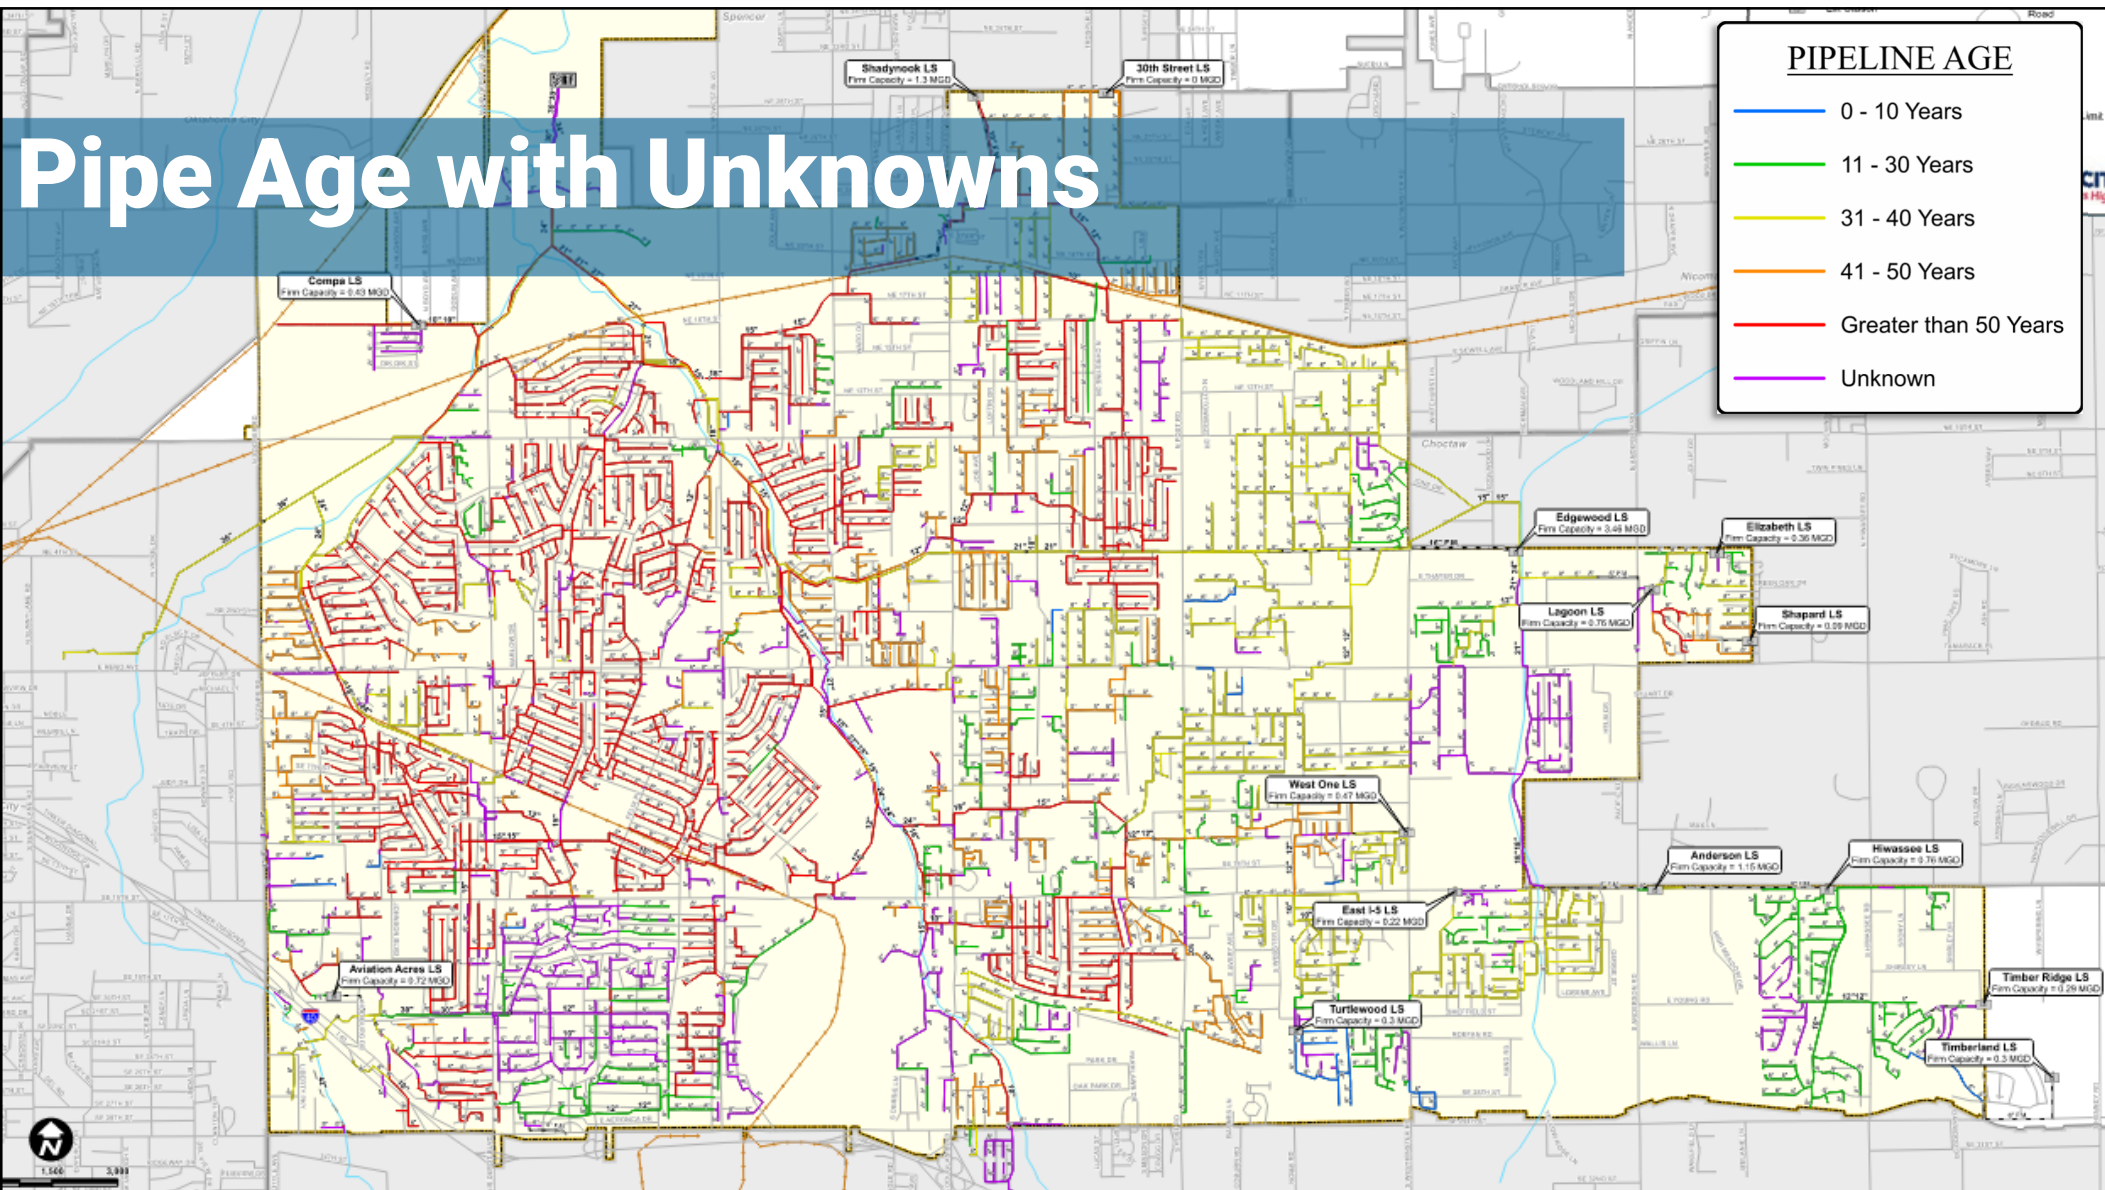
Pipe Age with Unknowns

PIPELINE AGE

- 0 - 10 Years
- 11 - 30 Years
- 31 - 40 Years
- 41 - 50 Years
- Greater than 50 Years
- Unknown

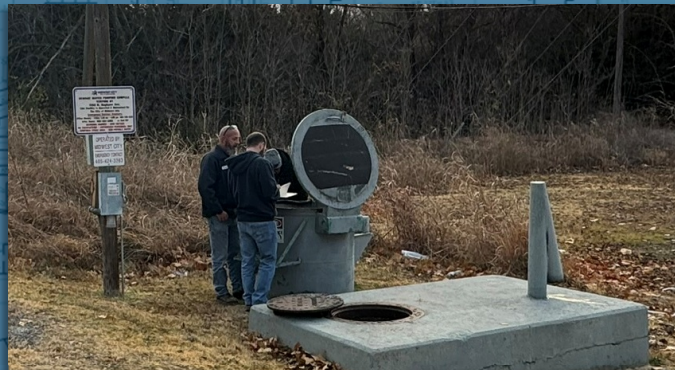
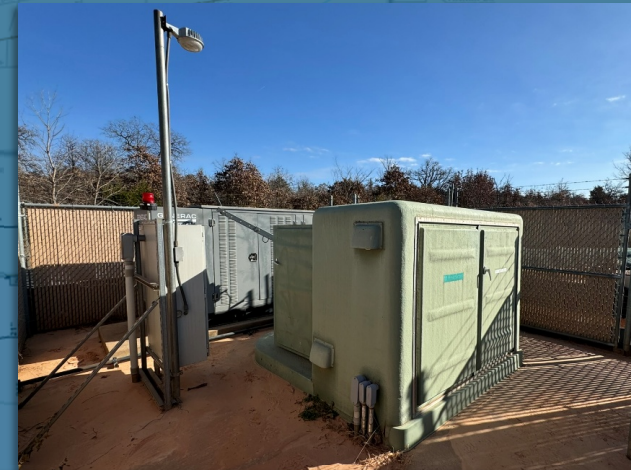
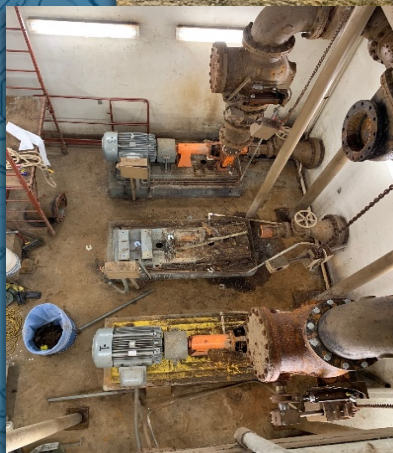
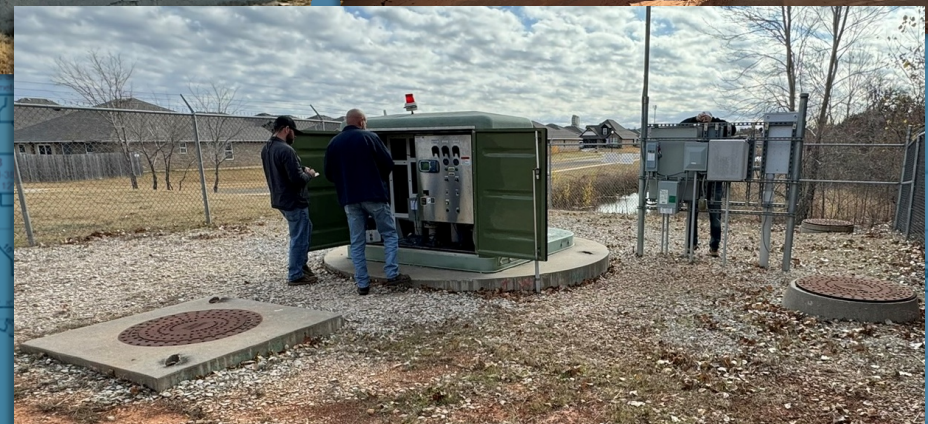
Lift Station Condition Assessments

- Inspected 15 Lift Stations
- Weighted condition scores for prioritization
- Identified general site recommendations

Install Year: 1976
 Number of Pumps: 2
 Pump Installation Date: 2010
 Pump Brand: Flygt NP30RS MT1
 Design Point (GPM): 60 GPM @ 52' TDH
 Horsepower: 7
 Calculated Capacity (GPM): 240 GPM @ 45' TDH
 Existing (2025) Peak Flows (GPM): 21
 Future (2044) Peak Flows (GPM): 21
 Effluent (in): 8
 Force Main Diameter (in): 4.0
 Construction Replacement Cost: \$ 157,500.00
 Generator: N/A

Component Group	Component Condition	Weight Factor	Weighted Component Rating	Comments
Pumps and Motors	1	20%	0.20	Factories were good no signs of corrosion, very mild corrosion on piping in wet well. Pumps appear to be in good condition at time of site visit.
Electrical - MCC, Back-up Power, Cables	2	20%	0.40	Electrical was updated during the rehab in 2010. Electrical is in good condition. The alarm system, including wet well and power failure alarms, remain unchanged.
Instrumentation - SCADA, Alarms, Controls	2	15%	0.30	No flow meters or pressure gauges.
Structure - Hatches, Corrosion, Cracks, Leaking	2	25%	0.50	New wet well in 2010. Pump rails and fasteners in good condition. Pump chains are in not installed.
Piping and Valves	2	10%	0.20	There is no discharge isolation. Gate and Check valves are in good condition.
Manhole/Vault - Access	2	10%	0.20	No HVAC in the enclosed structure.

Condition Rating	-	100%	1.70	-
Additional Inspection Notes:				
The 2010 rehabilitation included a new wet well, electrical systems, valves, and other components.				
Debris Notes:				
No fog or debris issues.				
General Recommendations:				
Add Force Main Isolation Valve, Bypass Piping, Pressure Gauge, Flowmeter and Flowmeter Vault.

- Assessed Condition of:
 - Pumps and Motors
 - Electrical
 - Instrumentation
 - Structure
 - Piping and Valves
 - Mechanical
 - Site
