City of Midwest City ADA Self-Evaluation and Transition Plan

Project: ADA Self-Evaluation and Transition Plan

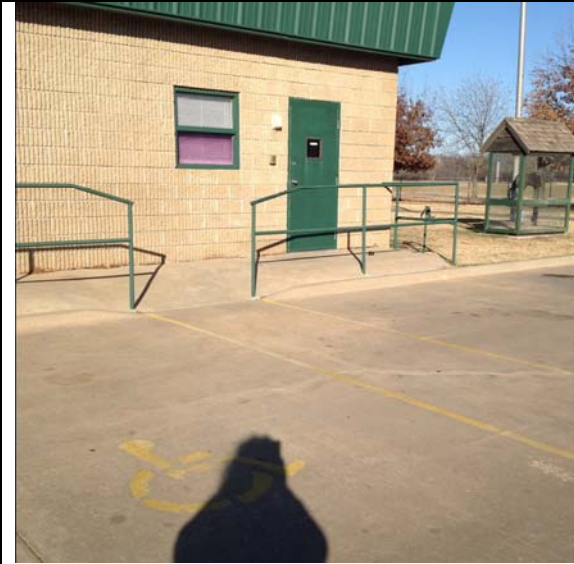
1. Accessible parking space for Animal Shelter

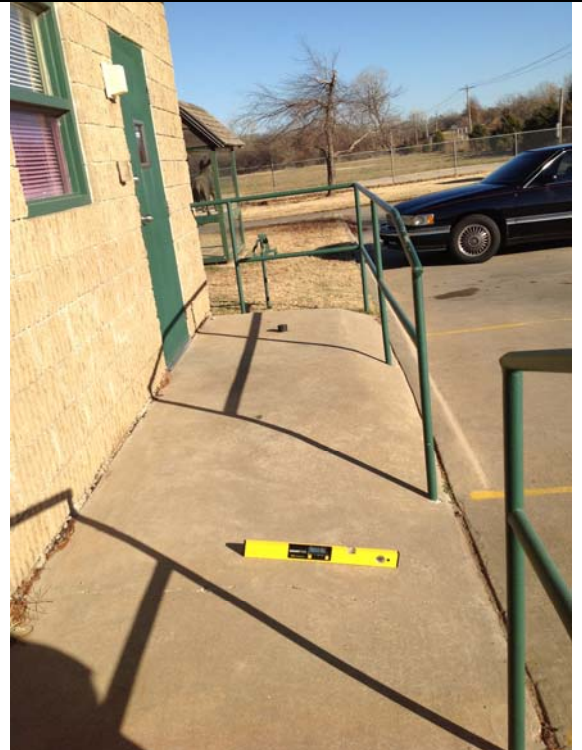
2. Severe slope to entry

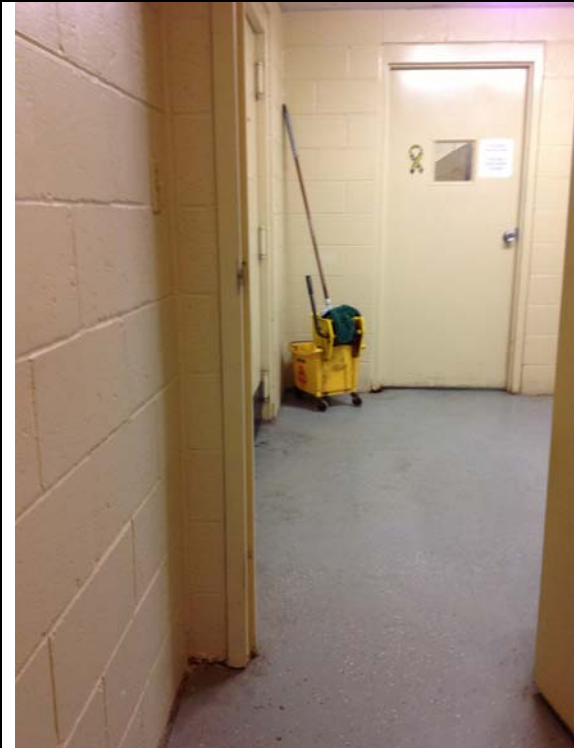
Violation #1: Several doors in the building do not have the required maneuvering clearances.

3. Hallway door, no 18" on pull side

Recommendation: Move doors to provide the required maneuvering clearance or install power assisted doors.

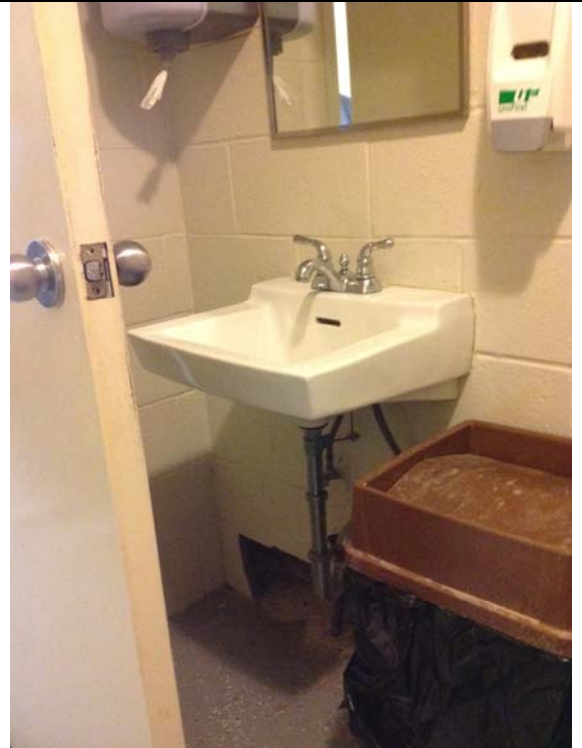
Violation #1: Neither restroom has any accessible features, however both could be more compliant.

4. Men's restroom, door swings into clear floor space requirements

Recommendation: The men's room would have more maneuvering clearance if the door swing was changed. The women's room would have more maneuvering clearance if the stall partitions were removed.

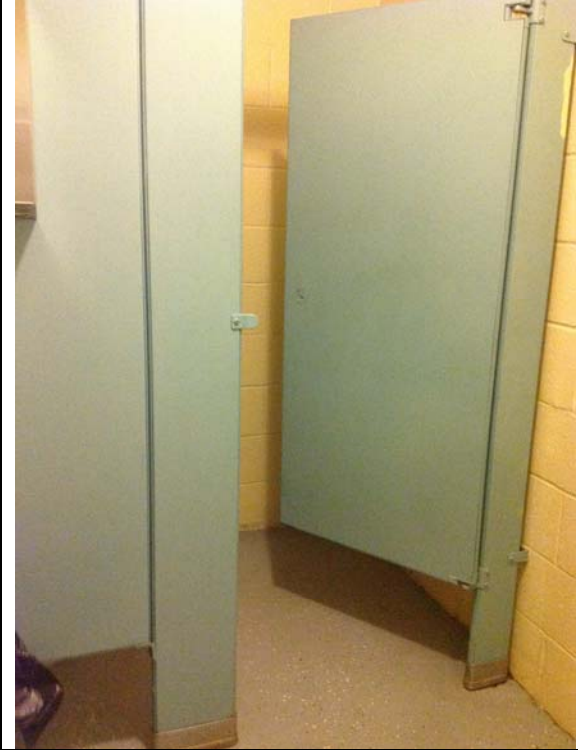
5. Women's restroom partitions can be removed

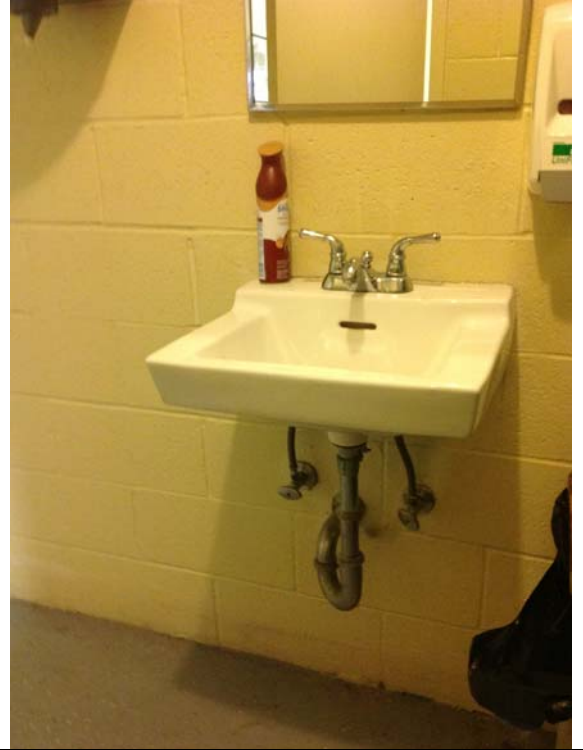
Violation #3: Neither restroom has a compliant water closet or lavatory and the mirrors are mounted too high.

6. Both lavatories pipes need to be wrapped and mirrors lowered

Replaced both restrooms with compliant water closets. The lavatories will need the pipes under neath them to be wrapped and the mirrors must be lowered so that the bottom of the reflecting surface measures no more than 40"

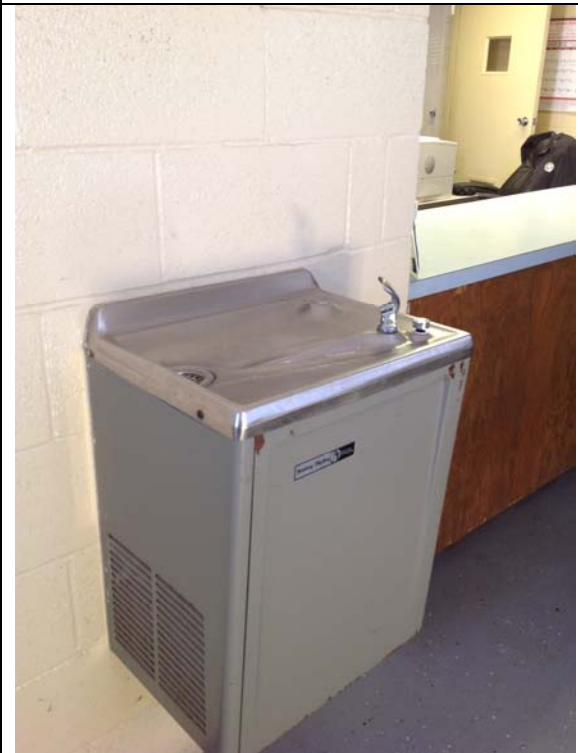
Violation #1: Only one drinking fountain is provide and it's at standard height. When one is provided at standard heights one is also required at accessible heights. There is no drinking fountain for people who use wheelchairs or people of short stature.

7. Drinking Fountain.

Recommendation: Install at least one accessible height drinking fountain with the spout not to exceed 36".

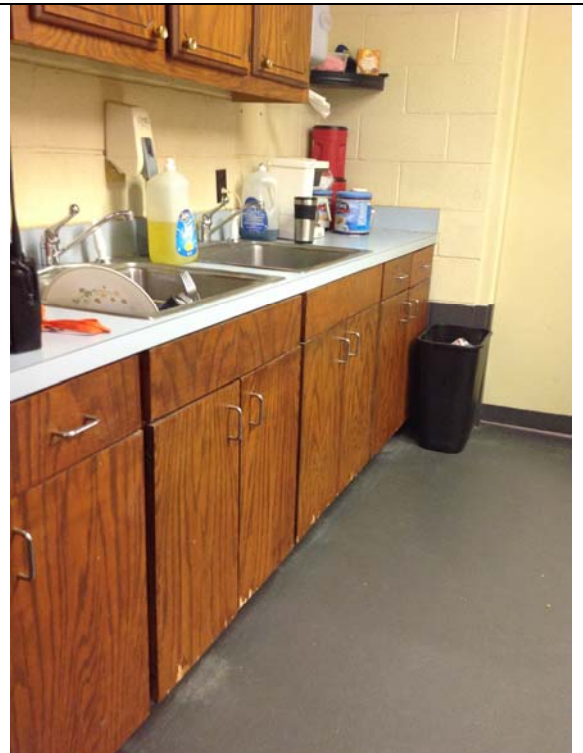
Violation #1: The counter is mounted at 36" aff with no knee clearance below the sink.

8. Break room sink

Recommendation: The sink and counter top need to be altered so that they are no higher than 34" from the finished floor. The sink is also required to have appropriate knee clearance to allow a frontal approach for someone in a wheelchair.

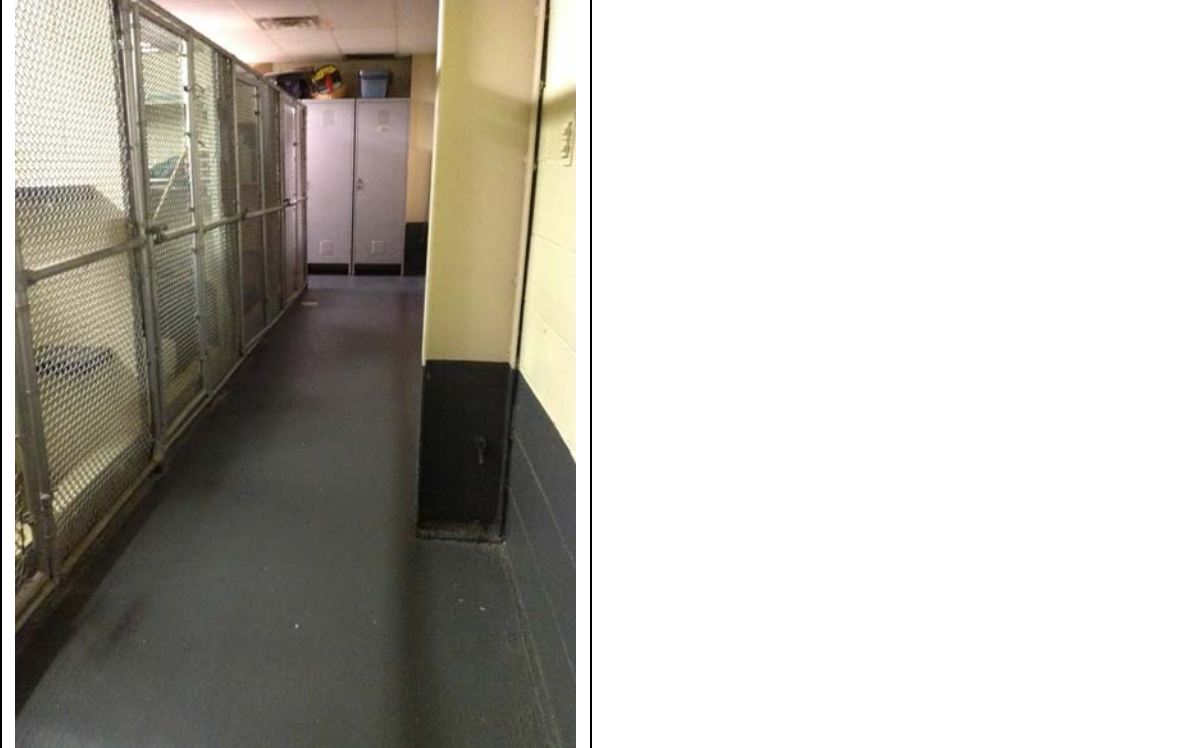
9. Interior path of travel at runs

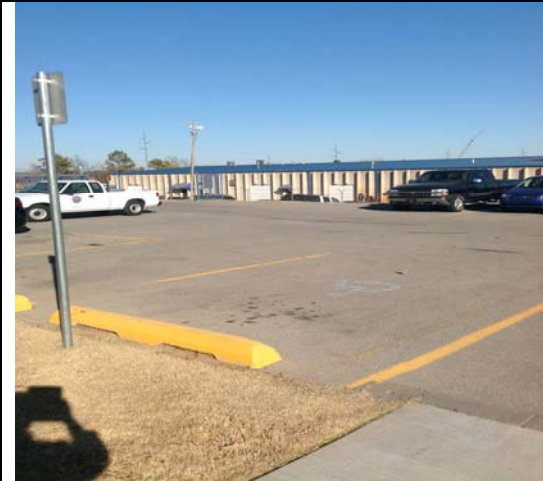
1. Parking.

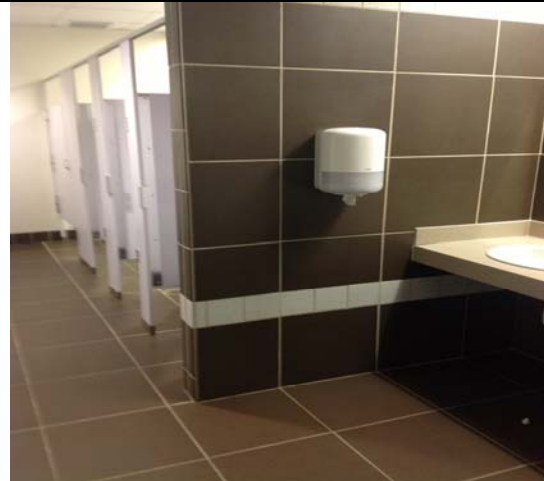
Violation #1: The paper towel dispenser is located along the accessible route and protrudes more than 4" into the path of travel.

2. Paper towel Dispenser.

Recommendation: Move the paper towel dispenser so it is located outside the accessible route, is over an obstruction or replace with a smaller type of dispenser.

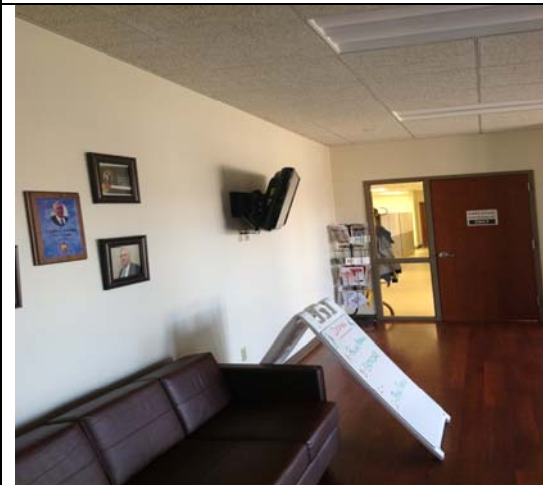
Violation #1: The television mounted on the wall in the lobby is mounted between 27" and 80" and protrudes more than 4" into a circulation path.

3. Television.

Recommendation: Raise the TV so the leading edge is above 80" or install a cabinet or permanent fixture underneath it.

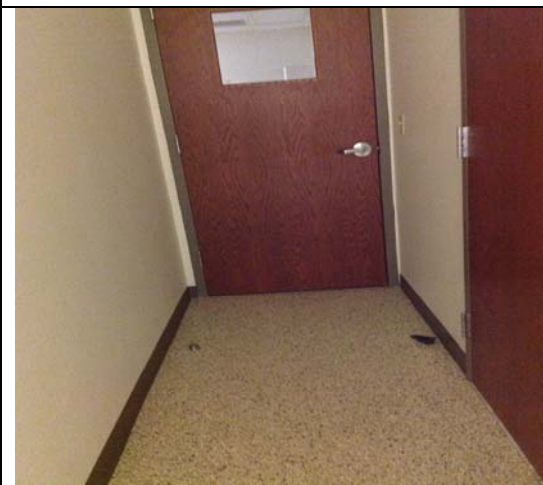
5. Kitchen exit number two.

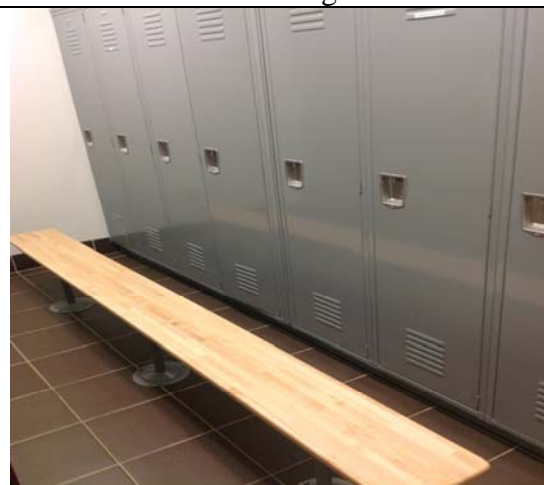
Violation #2: The bench in the locker room is not accessible.

6. Locker room bench.

Recommendation: Install an accessible bench in the dressing rooms that measures 20" - 24" by 42" and has clear floor spaces along the short axis.

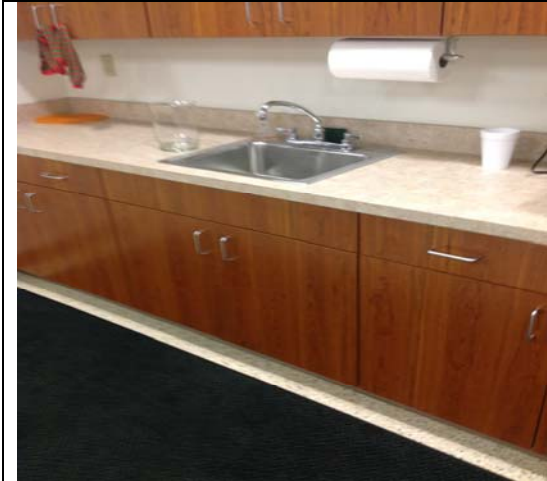
Violation #1: The counter top in the breakroom and the conference room measures 36" above finished floor.

7. Breakroom.

Recommendation: The breakroom sink and counter top needs to be altered so that it is no higher than 34" high from the finished floor as does the counter in the conference room.

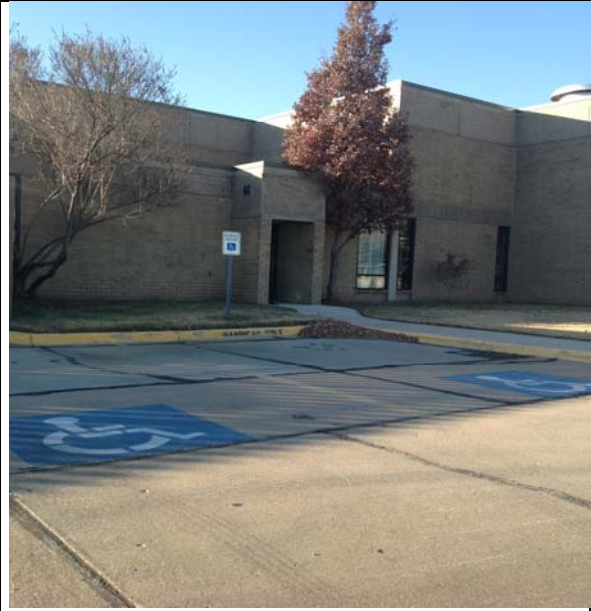
Violation #1: North parking lot has no access aisle or compliant path of travel to the building entrance. There are also no van spaces provided.

1. North parking lot accessible parking space for City Hall

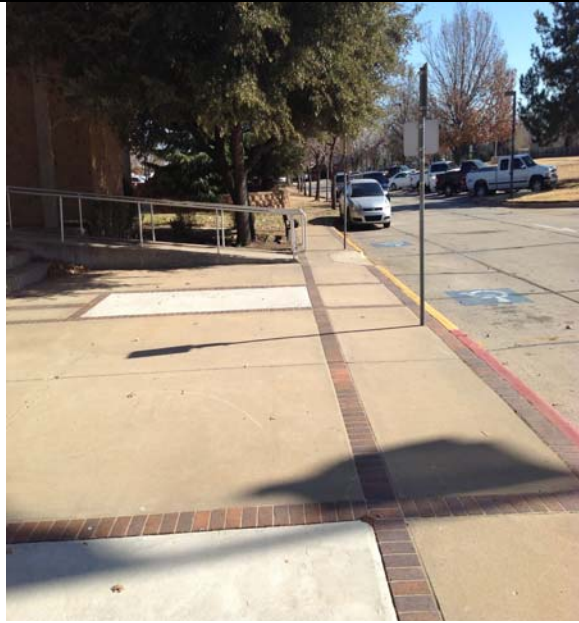
2. South parking lot accessible parking space for City Hall

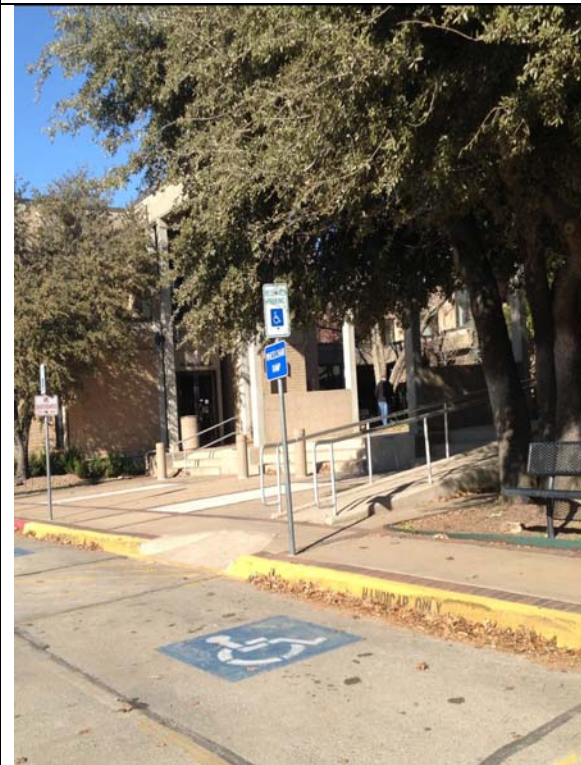
Violation #1: The south side has a ramp that provides access into all three buildings in the City Hall Complex. The route is not compliant.

3. Ramp on south side of City Hall

Recommendation: The south ramp needs to be revised for compliance or an alternate accessible entry established. The severity of the slopes in front of this building are a liability.

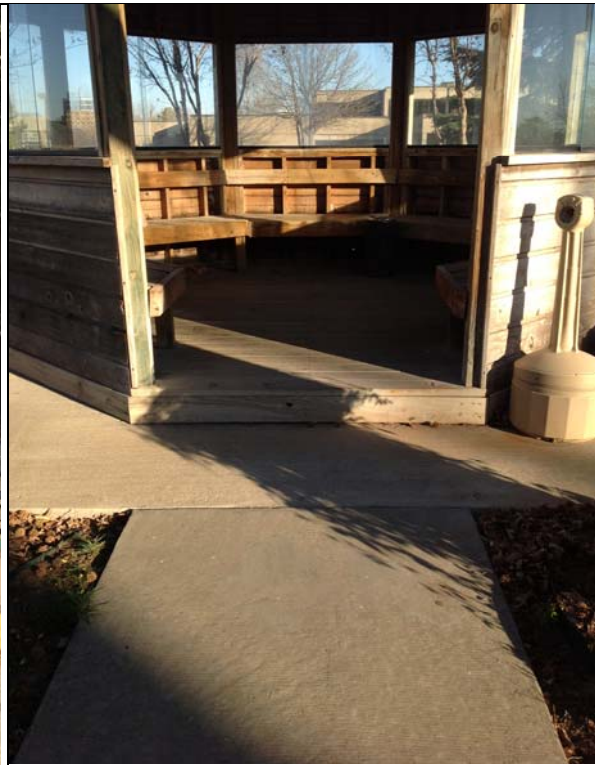
Violation #2: There is a level change to into the employee smoking gazebo.

4. Employee gazebo north side of City Hall

Recommendation: The smokers gazebo needs to be altered for compliance.

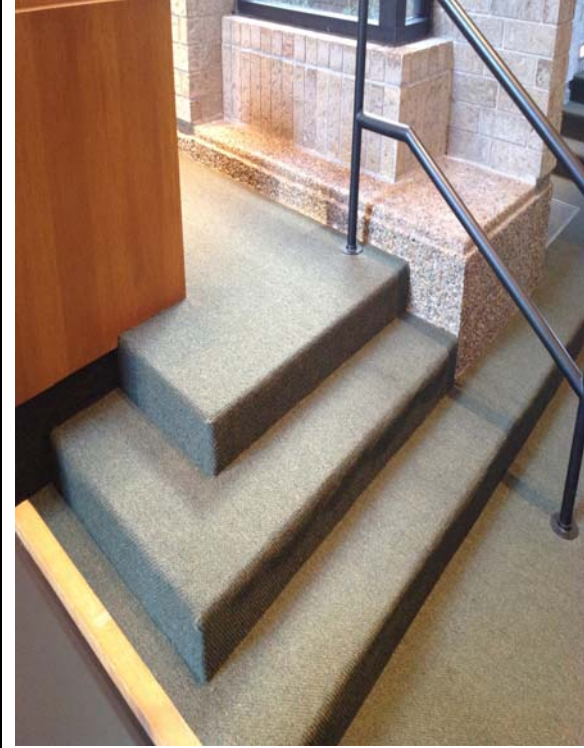
5. Counsel Chambers

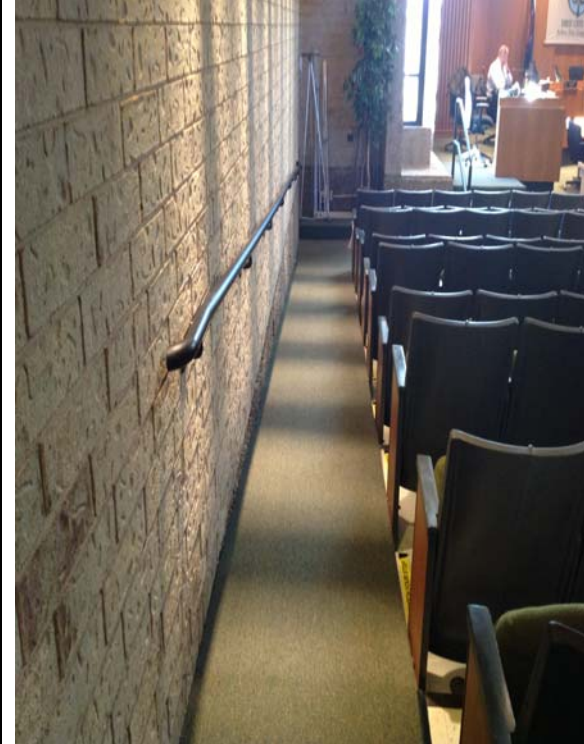
6. Path of travel to counsel recess room

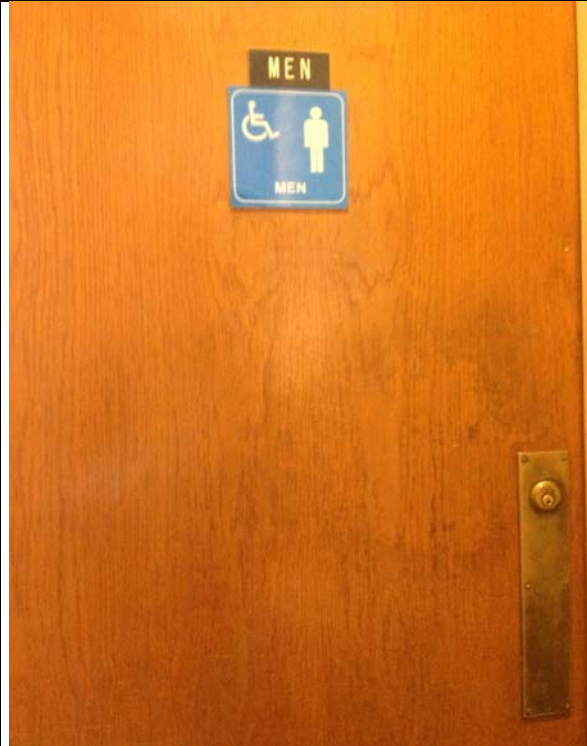
9. Door maneuvering clearance

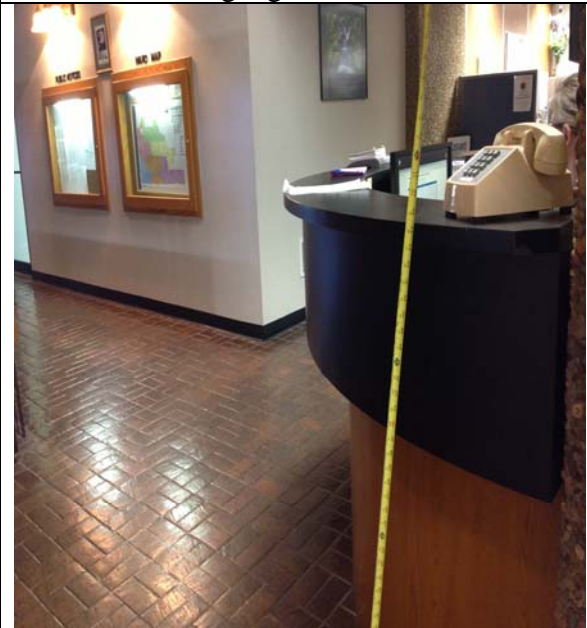
11. Cashier counter

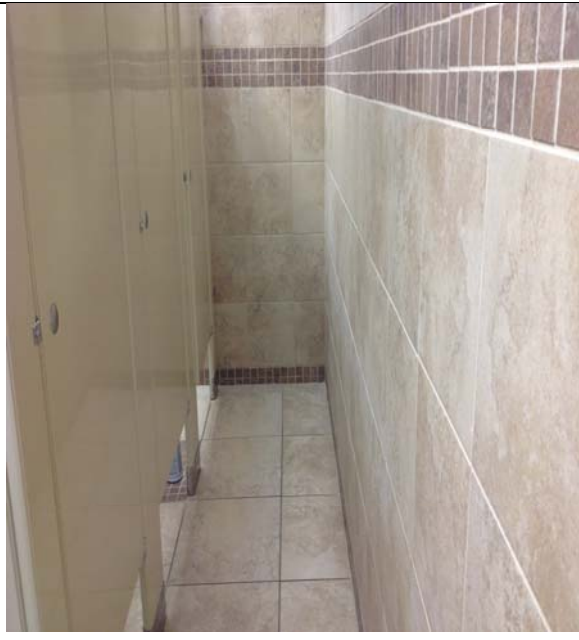
15. Water closets not compliant

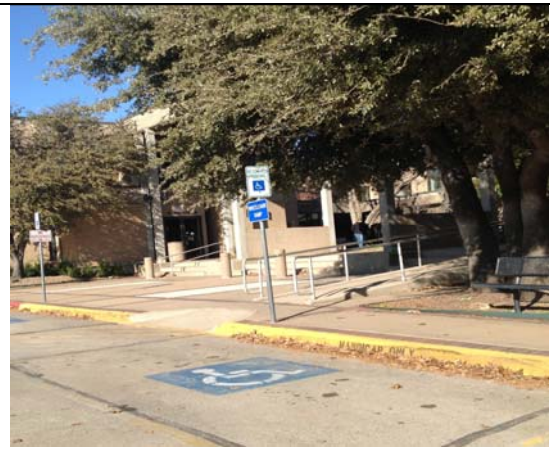
4. Comment: Violation AR_I1

Violation #1: The ramp that leads to the main entry does not comply. The slope is up to 10.6%. The maximum allowable slope is 8.3%.

Recommendation: Replace the ramp with a compliant ramp with a slope that does not exceed 8.3%.

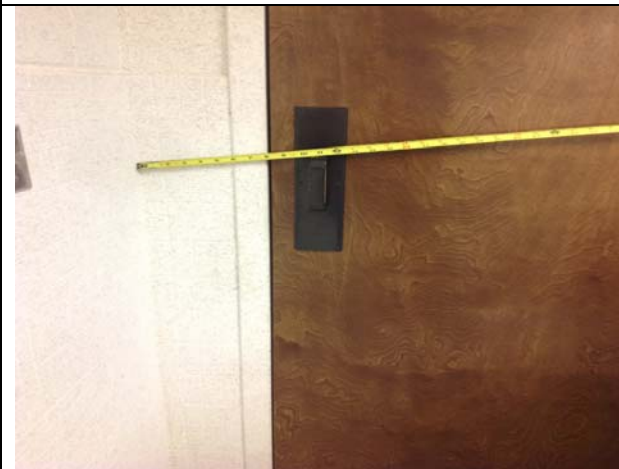
5. Comments: Violation AR_I2

Violation #2: Several doors have a maneuvering clearance that is less than 18" on the pull side, including the restroom doors and doors into the main hallway.

Recommendation: Move the door to provide the required 18" minimum clearance or install powered door.

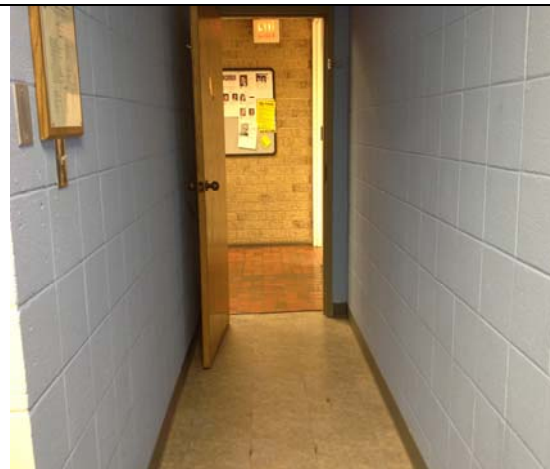
6. Comments: Violation AR_I3

Violation #3: The path throughout the building has round knobs instead of lever hardware through doors.

Recommendation: Cylindrical hardware needs to be replaced with lever hardware that does not require tight grasping or twisting to operate.

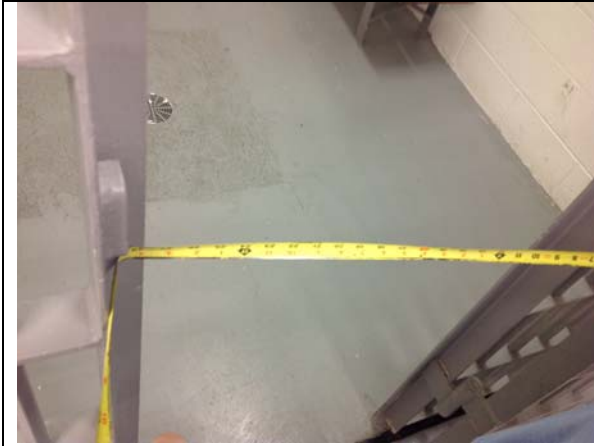
7. Comment: Violation AR_I4

Violation #4: Doors into the jail cells do not have the required 32" clear width.

Recommendation: Ensure at least one of each type of cell is accessible for people with varying disabilities. This may mean widening doors, installing alarms and/or visual strobes or building new accessible cells, all must connect to an accessible route.

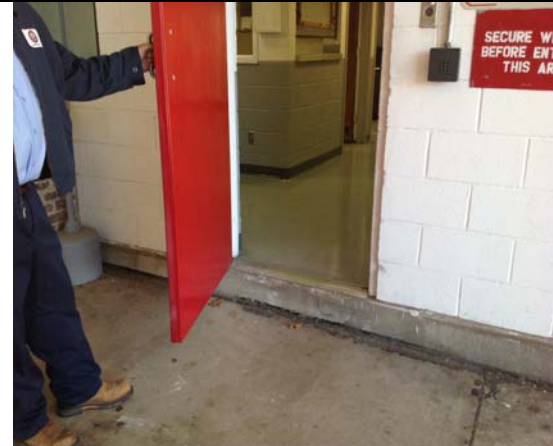
8. Comment: Violation EN_I1

Violation #1: There are no accessible entrances for prisoners. The Sallyport is not accessible.

Recommendation: Install a ramp at the prisoner entrance to ensure prisoners with mobility aides are able to enter.

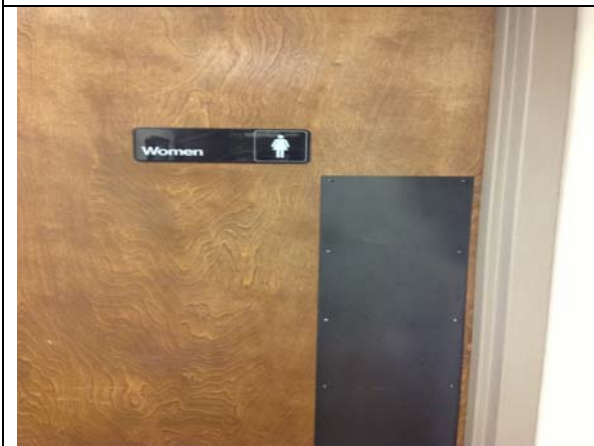
9. Comment: Violation HW_I1

Violation #1: The signage throughout the building does not comply. All signs designating permanent spaces are required to have grade 2 Braille and raised characters.

Recommendation: Locate signage on the wall adjacent to the latch side of the door. Mounting height shall be 48" to 60" AFF to the centerline of the sign and ensure it has grade 2 Braille and raised characters.

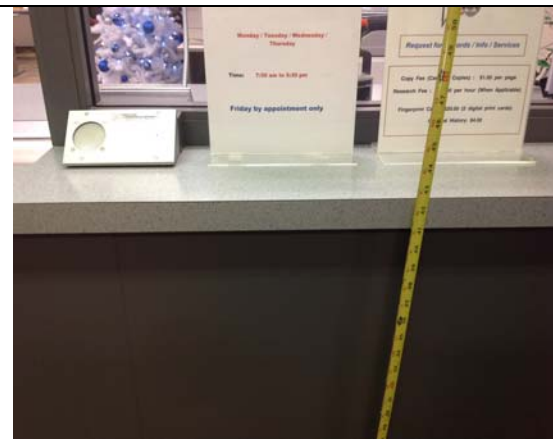
10. Comment: Violation HW_I2

Violation #2: The transaction counter measures at 42.5"

Recommendation: Lower at least one of each type of transaction counter so that a section of the counter at least 36" wide is no higher than 36" AFF.

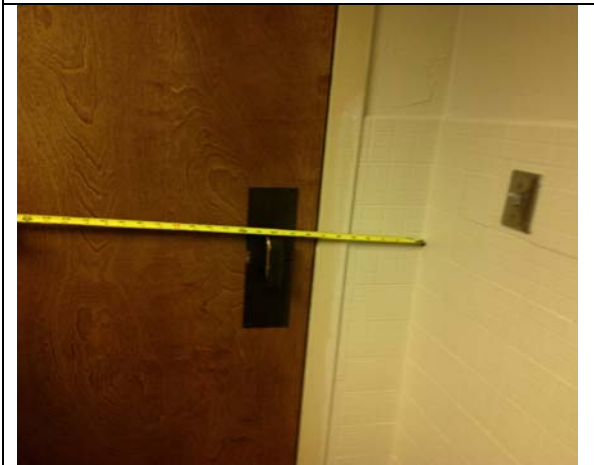
11. Comment: Violation RR_I1

Violation #1: The restroom doors do not have 18" on the pullside of door.

Recommendation: The doors were addressed and costs associated under "accessible route"

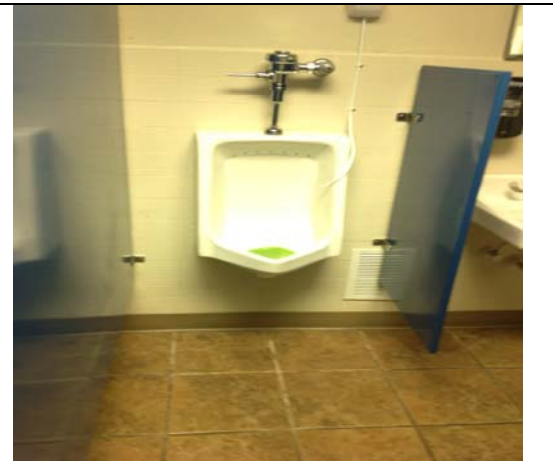
12. Comment: Violation RR_I2

Violation #2: No accessible urinal provided in any of the restrooms.

Recommendation: The urinal will need to be lowered so the rim is at or below 17" aff.

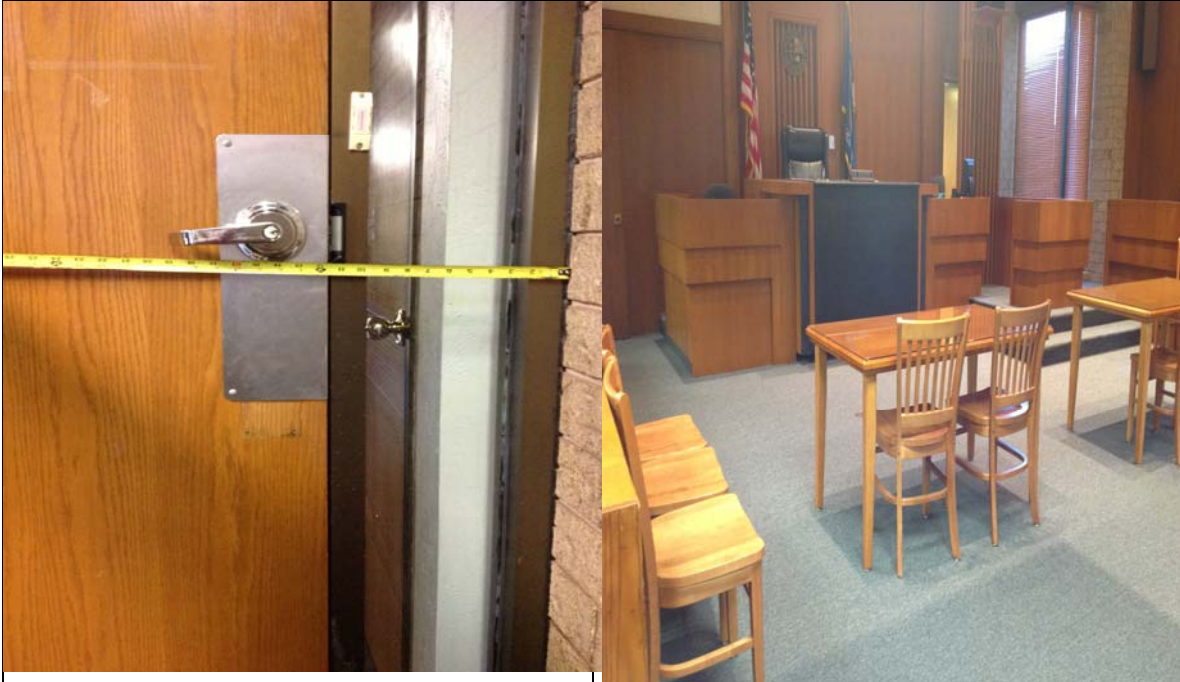
1. No door maneuvering clearance

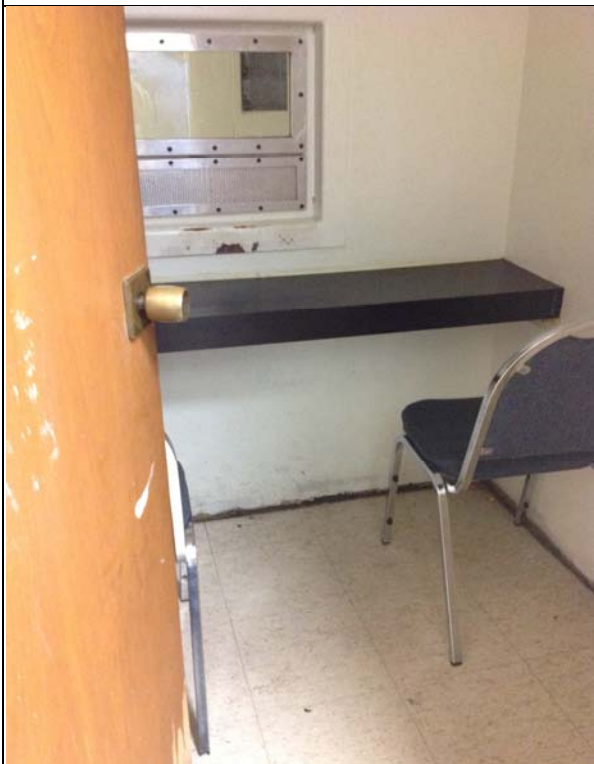
3. Cylindrical hardware needs to be replaced

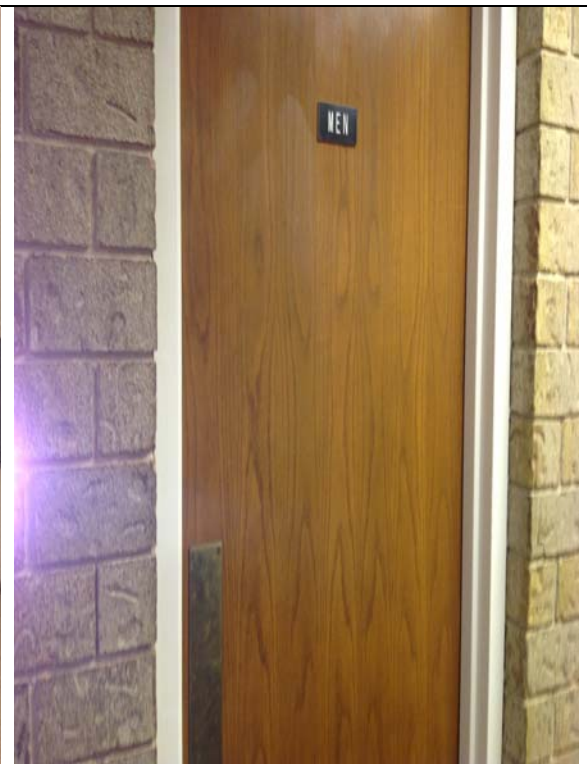
4. Non-compliant signage

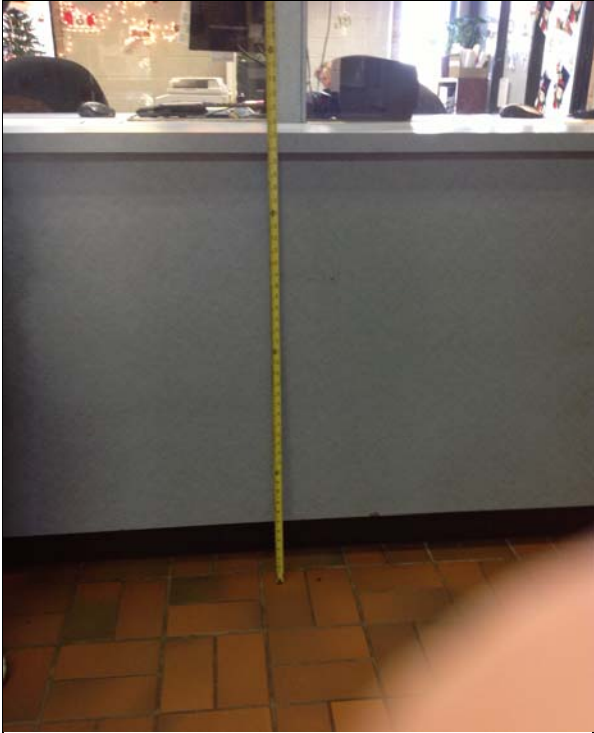
5. Cashier counter height above standards

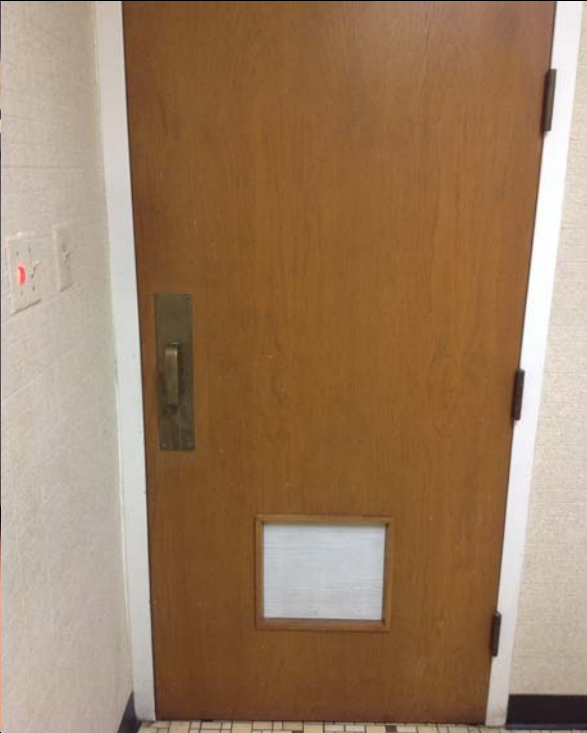
6. Restroom door maneuvering clearance.

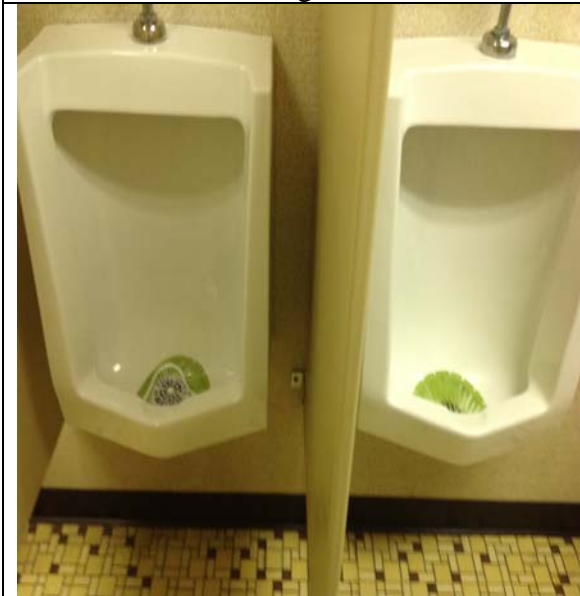
7. No accessible urinals

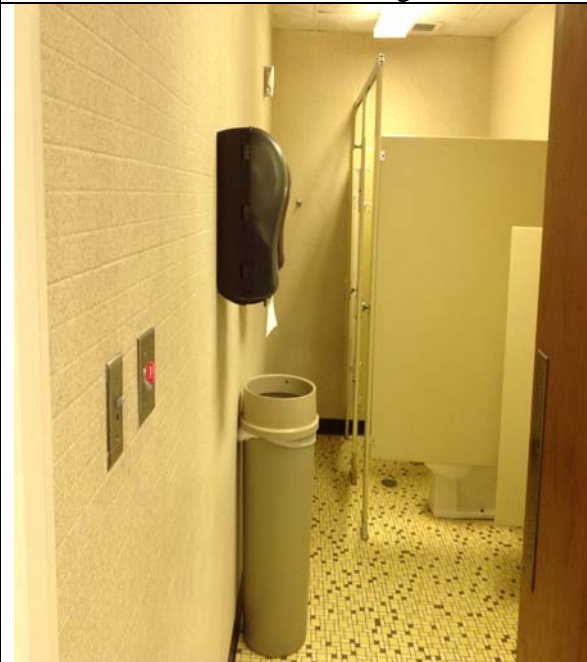
8. No accessible water closets.

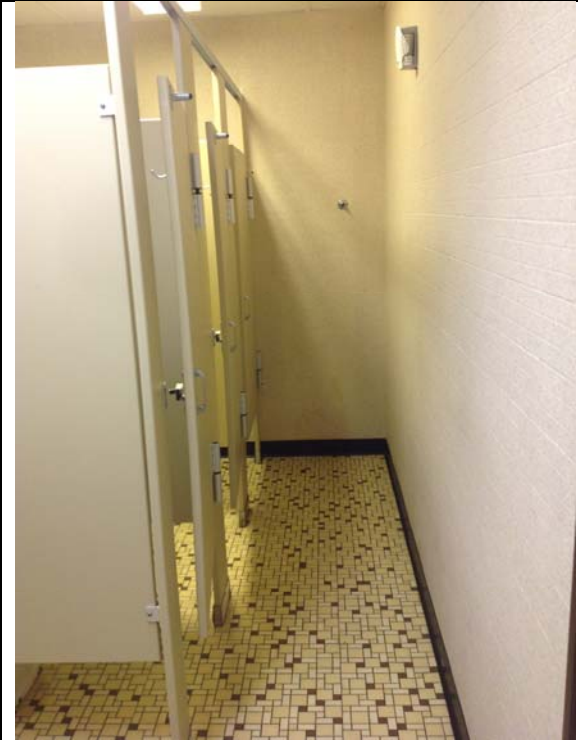
9. No accessible path of travel

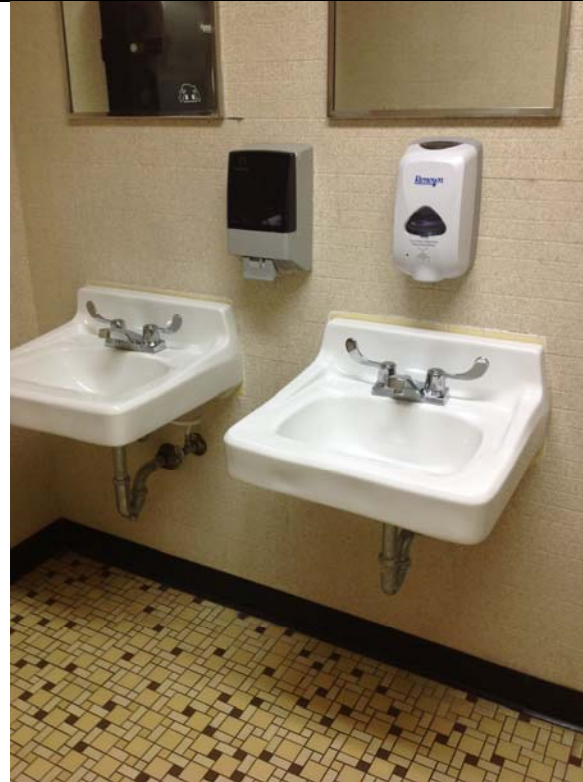
10. Water pipes are not wrapped or covered

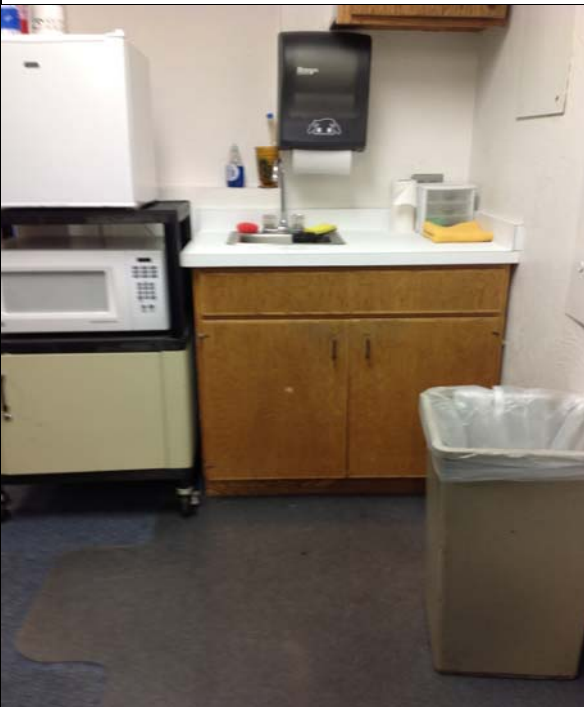
11. Break room sink has no knee clearance and counter measures at 36 in.

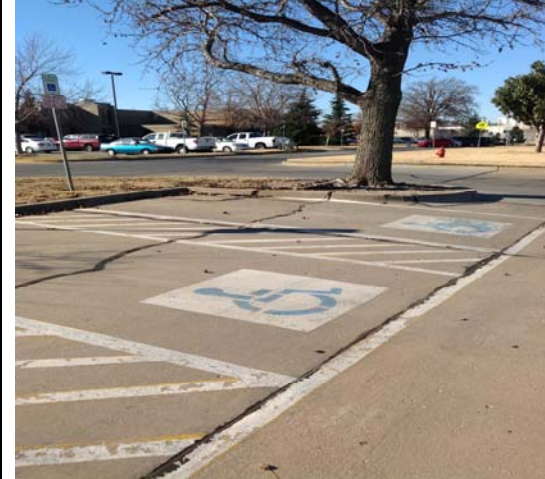
1. Parking lot on east parking.

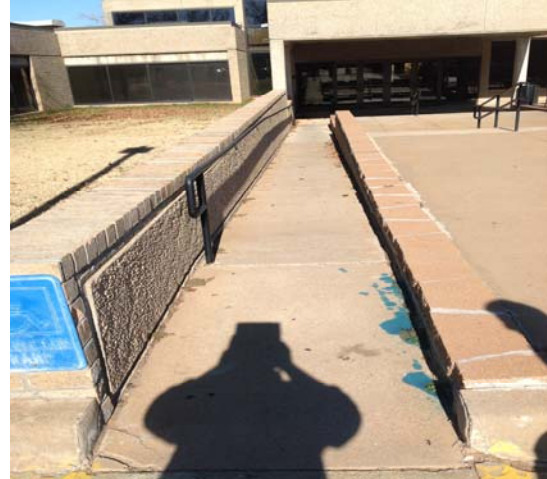
Violation #1: A ramp is provided in the front and only has hand rails on one side.

2. Entry ramp with one handrail.

Recommendation: Install compliant handrails on both sides of exterior ramp.

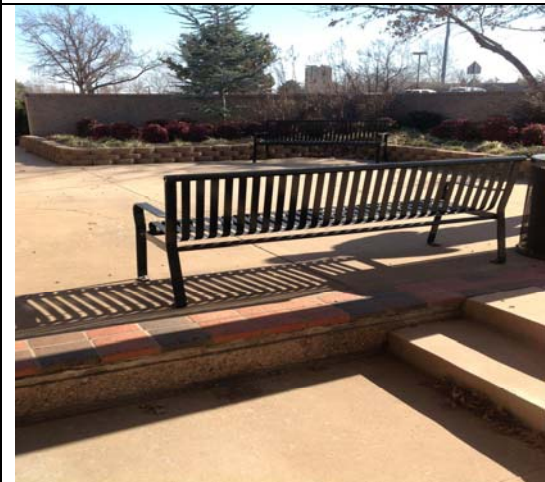
Violation #2: There is no accessible route into the outdoor seating area in the front.

3. Outdoor seating area at front entrance.

Recommendation: Add accessible route into the seating area.

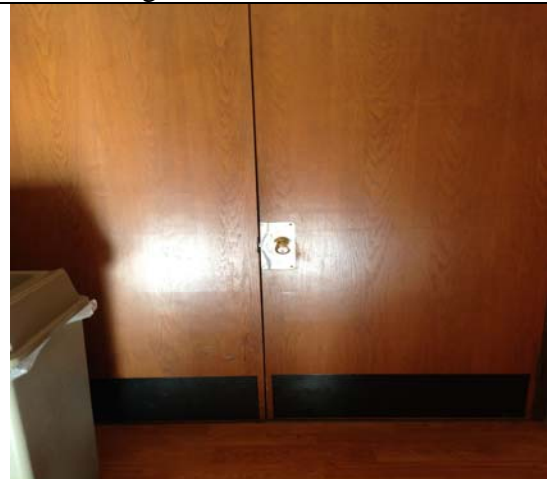
Violation #1: The majority of the doors have knobs that require tight grasping or twisting to operate.

6. Door hardware.

Recommendation: Install lever hardware on all interior doors.

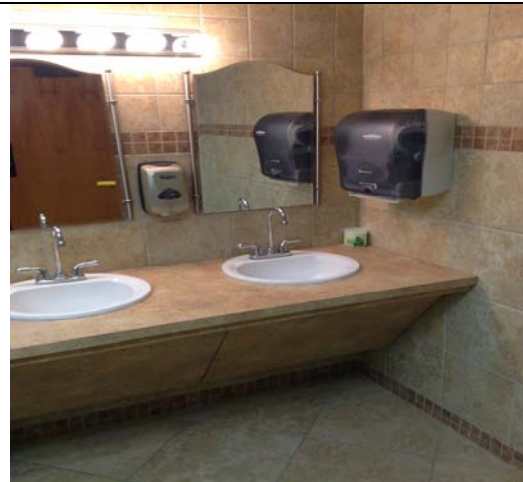
Violation #4: The mirrors are mounted at 44" to the bottom of the reflecting surface, at least one must not be higher than 40" aff.

10. Mirrors

Recommendation: Lower at least one mirror so the bottom of the reflecting surface is mounted at 40" maximum height.

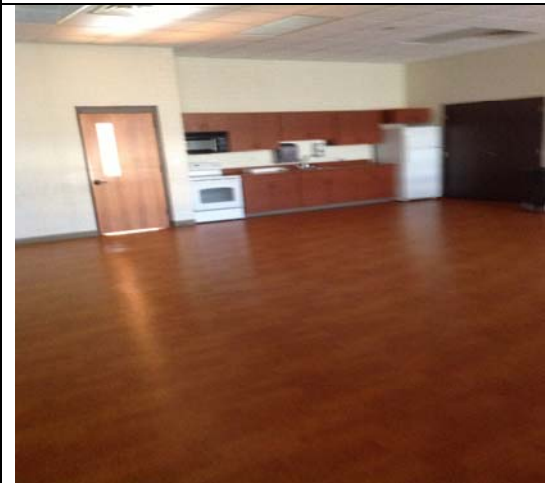
Violation #1: The Counter is at 36" and has no knee clearance under the sink.

11. Breakroom.

Recommendation: Lower the counter to 34" aff and provide the required knee clearance for a frontal approach to the sink.

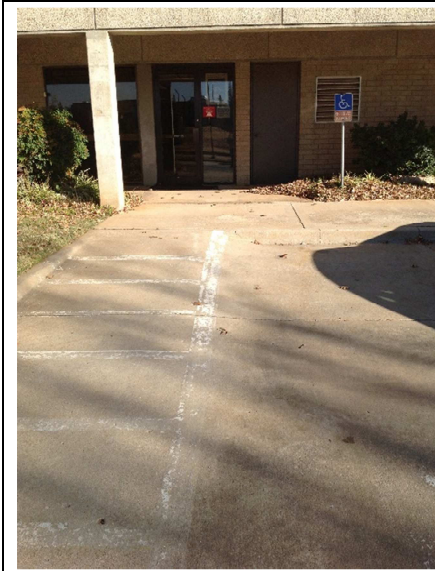
1. There is only one accessible space (two required) and the access aisle has a slope in it, The signage is mounted too low and this space only serves the training room, when it's occupied there is no accessible route to the main entry point.

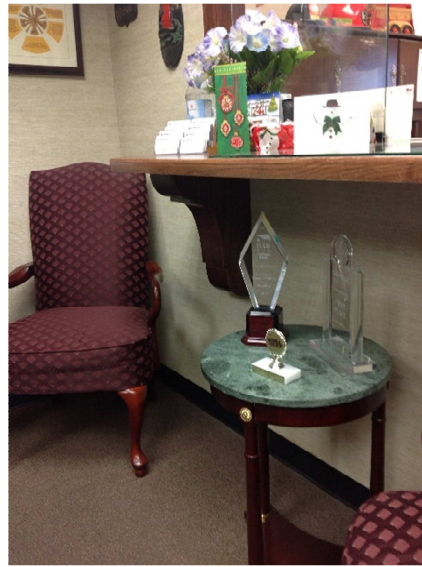
2. The main entry counter is mounted at 42" without a lowered section.

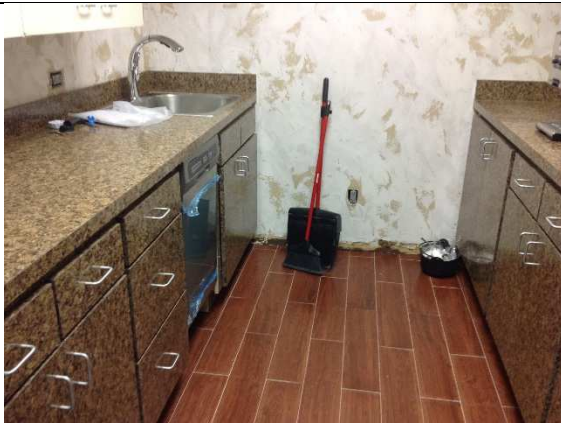
3. This break room was being installed at the time of the inspection. Because it's new it's required to be fully compliant and it's not. The counters are too high and the door does not have the required maneuvering clearances.

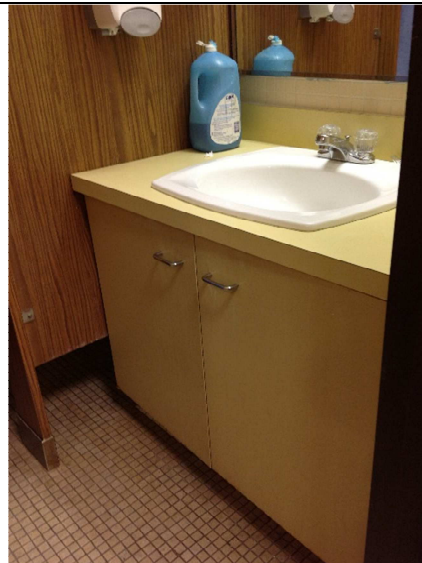
4. This restroom would be the one the "public" would use and has no compliant features. This lavatory does not have the required knee clearance, the mirror is too high and the faucets require grasping and twisting to operate.

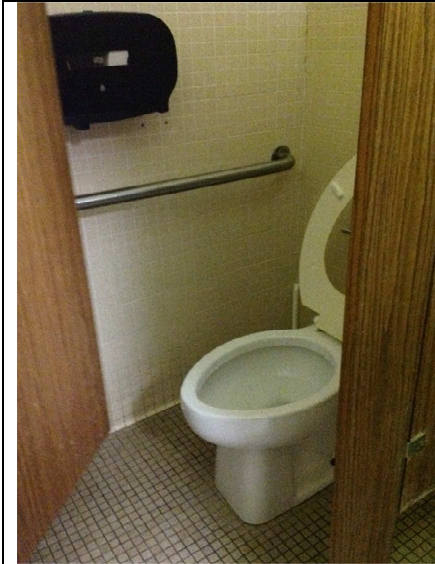
5. This is the water closet in the restroom noted above. Without partitions, this might be able to be a compliant single user toilet room.

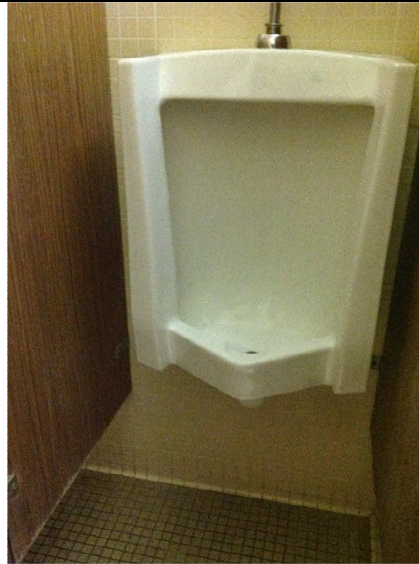
6. The urinal needs to be lowered and the path to it widened. The rim may not exceed 17" aff and the path leading to it must be a minimum of 36" wide.

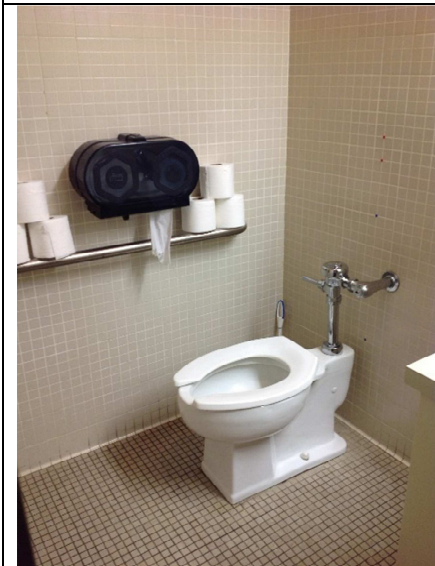
7. This is the most accessible toilet room in the facility. The flush control is on the wrong side, there is no back grab bar, the toilet paper dispenser is in the wrong location and the lavatory does not have the required knee clearance.

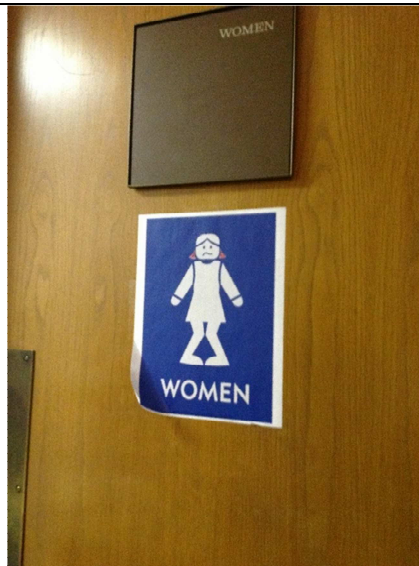
8. All signage indicating permanent spaces is required to have both raised characters and Braille. Signage will need to be replaced in this facility.

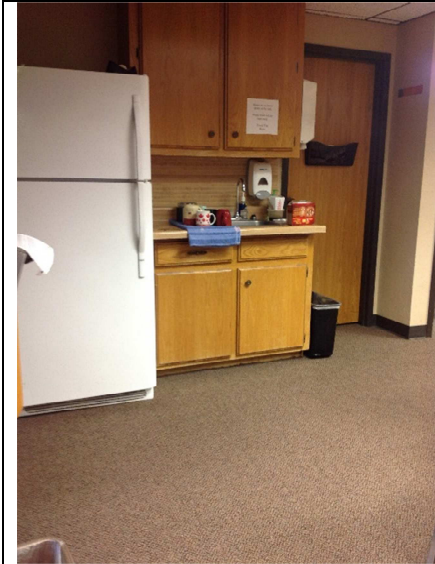
9. There are no compliant break rooms in the building. The counter heights are required to be 34" and the sink is required to have knee clearance.

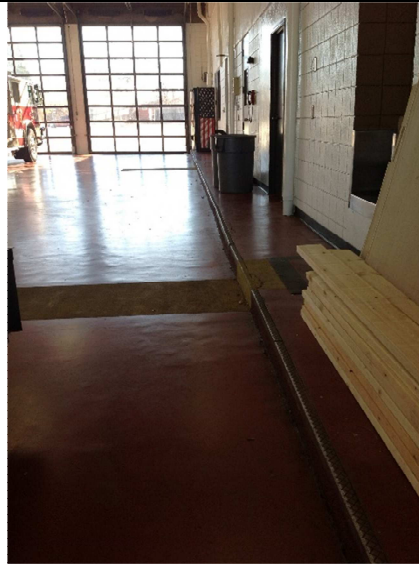
10. There is no access into the truck bay. The chutes the fire fighters use have no access to them and the bay itself has a level change along the only path of travel.
