City of Midwest City ADA Self-Evaluation and Transition Plan

Project: ADA Self-Evaluation and Transition Plan

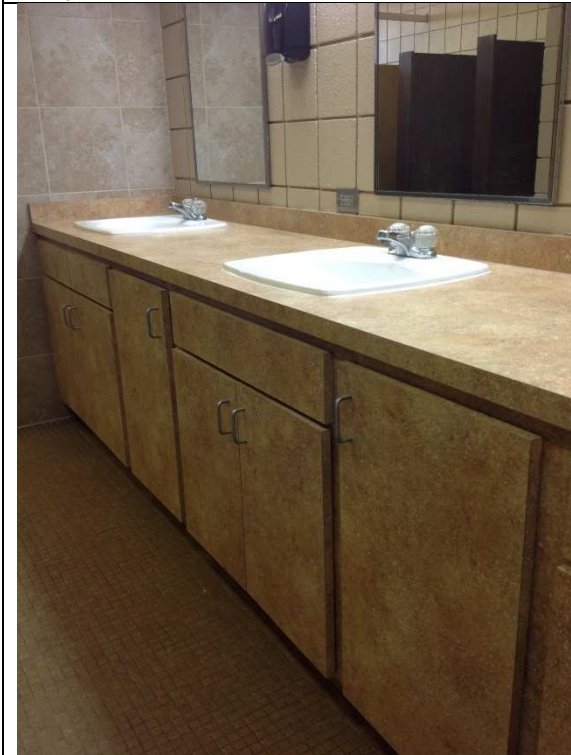
11. Even the largest restroom does not have compliant features. This lavatory does not have the required knee clearance or faucets.

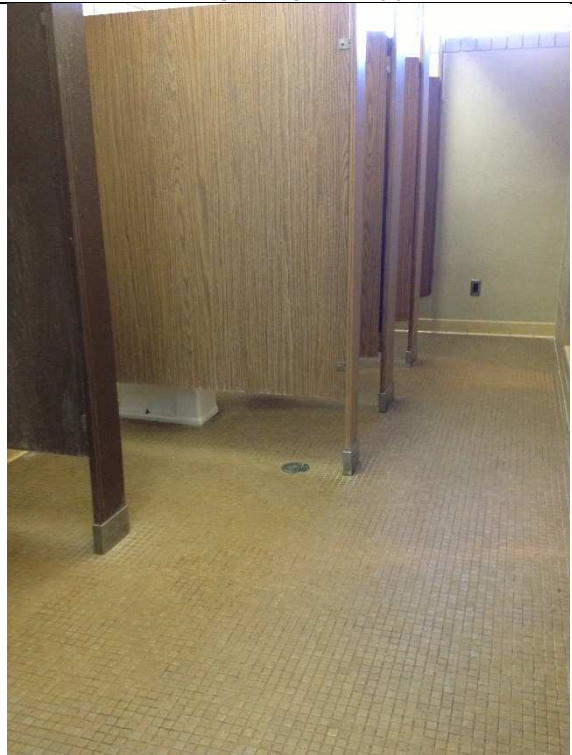
12. There are no compliant stalls or urinals in the restroom. A compliant urinal is 17" above the floor to the top of the rim.

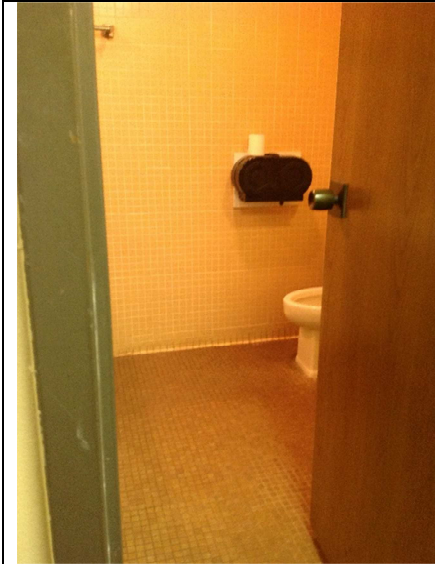
13. This men's room has no accessible features at all. If the door were to swing out, this one might be able to achieve compliance.

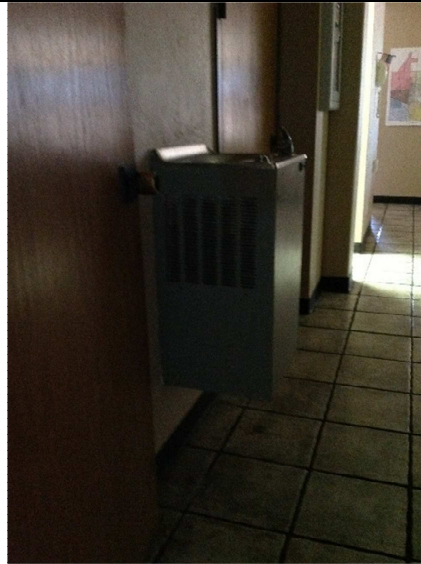
14. There are standard height drinking fountains but none at compliant heights,

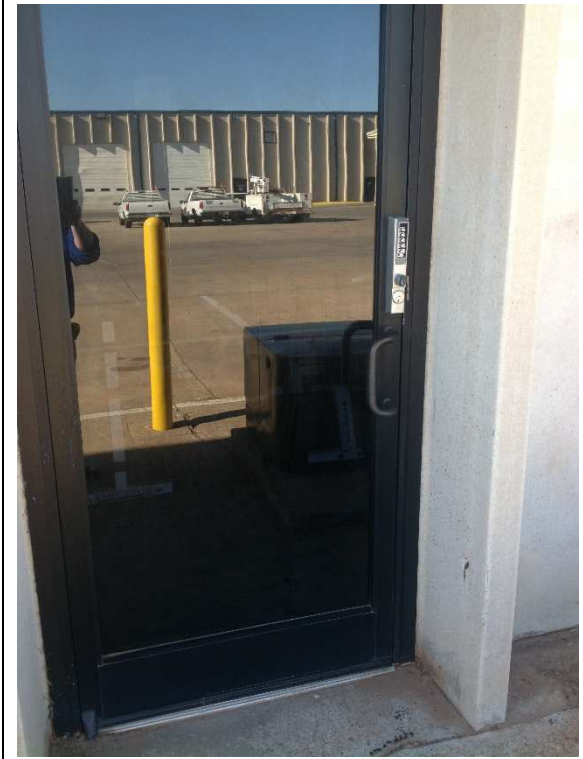
1. The entry doors are inset without proper maneuvering clearances.

Recommendation: Install compliant entry doors to each building that is occupiable.

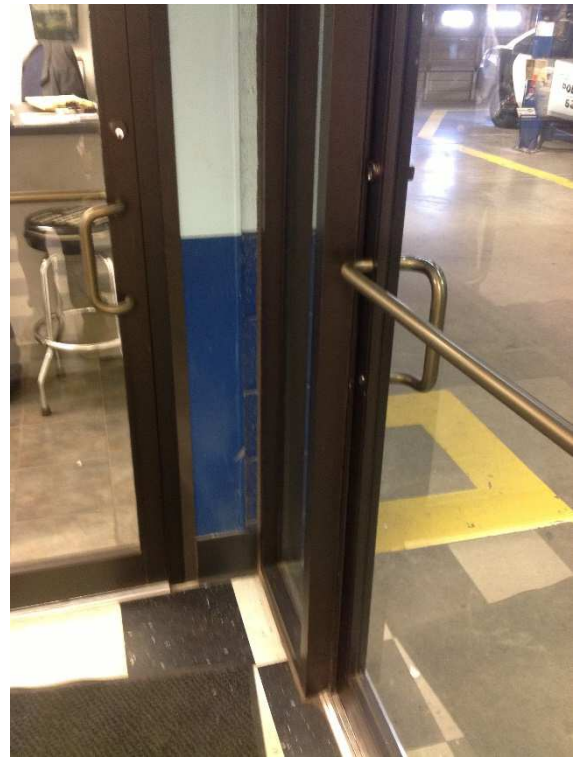
Violation #2: Several doors have a maneuvering clearance that is less than 18" on the pull side, including restroom doors and doors into the main hallway.

2. Doors in main work areas also do not have the required maneuvering clearances.

Recommendation: Move the doors along the accessible routes to provide the required 18" minimum clearance or install power assisted doors.

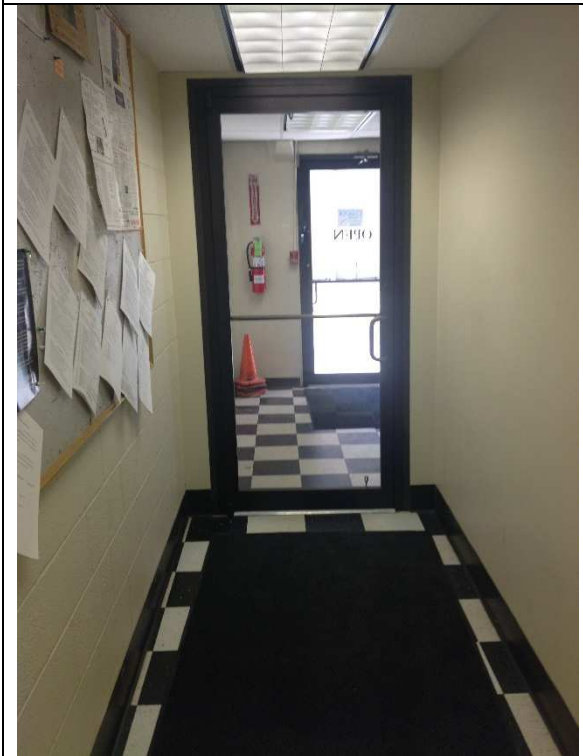
3. This door does not have the required maneuvering clearances.

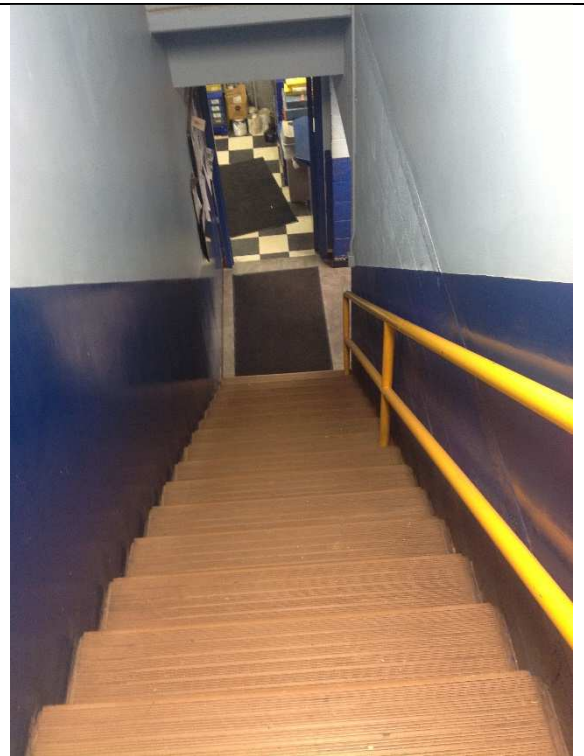
4. There is no elevator or vertical access provided.

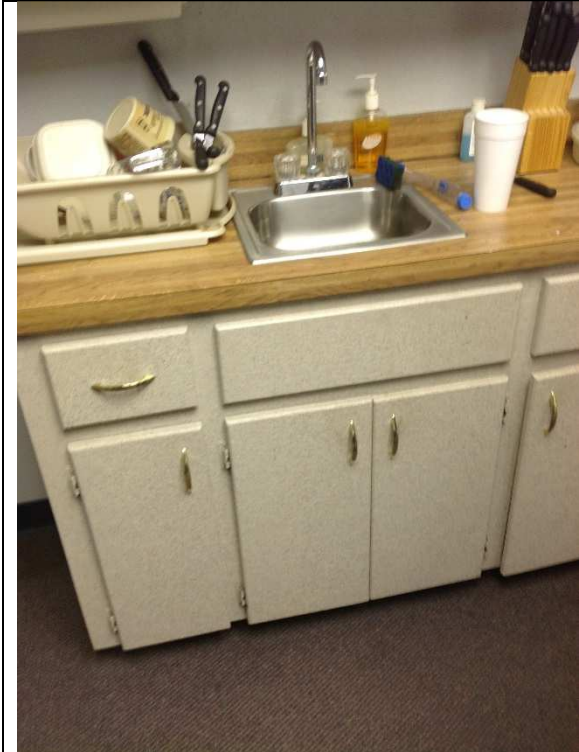
5. This break room is required to have counters at 34" and knee clearance under the sink.

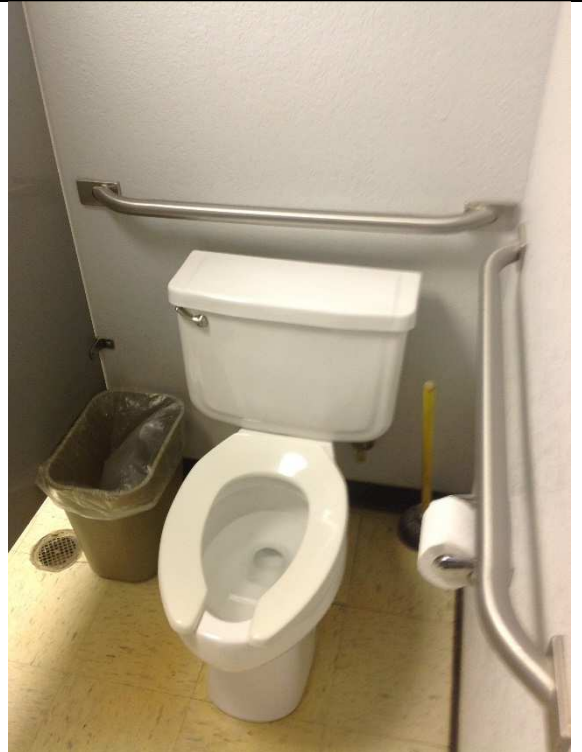
6. Although some access is attempted, the stall is not a compliant size and meets no standard.

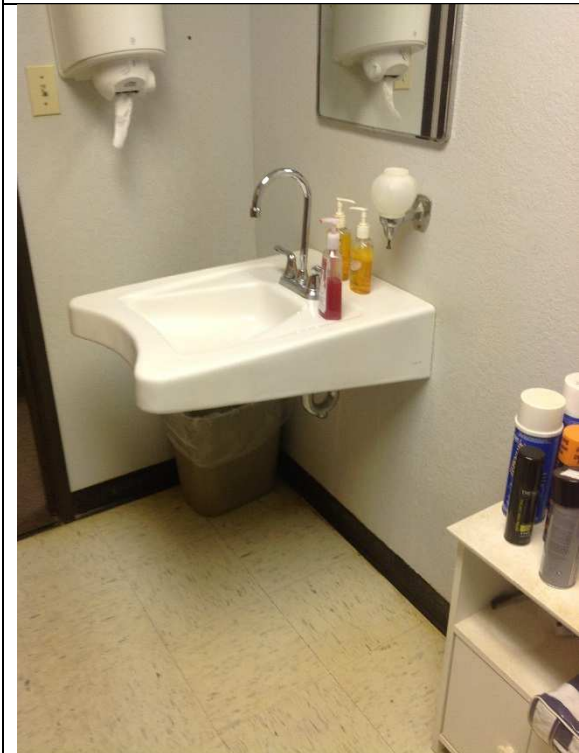
7. Although this is a compliant lavatory, the pipes underneath it are not wrapped or protected and the mirror is mounted way too high for compliance.

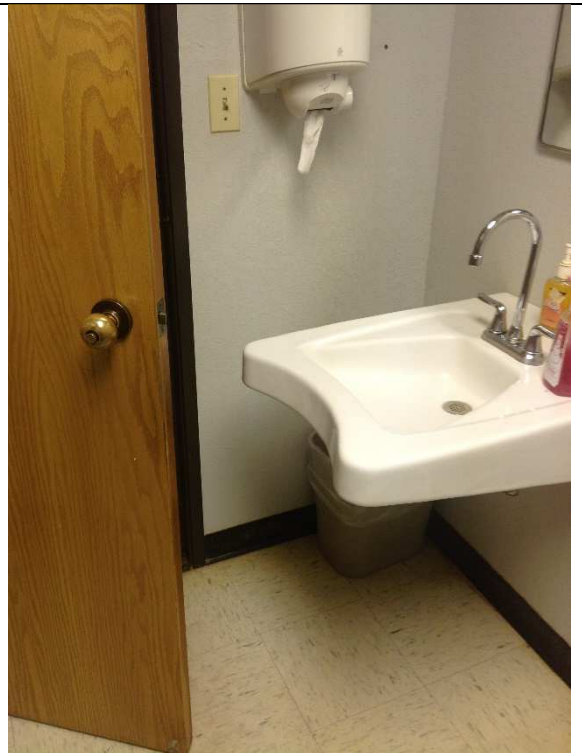
8. This appears to be the restroom that they have attempted to make accessible. However, with the door swinging in, we do not have the required maneuvering clearances for either the door or the room.

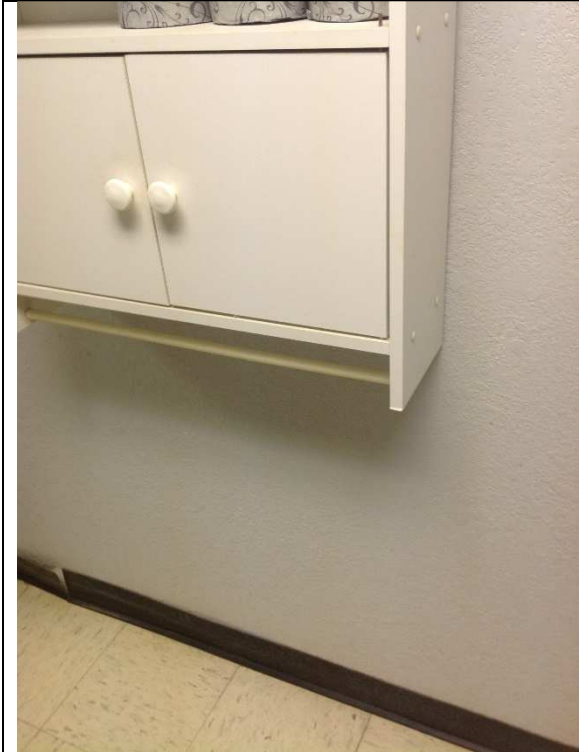
9. This is mounted in the “accessible” toilet room and is a protruding object along the path of travel.

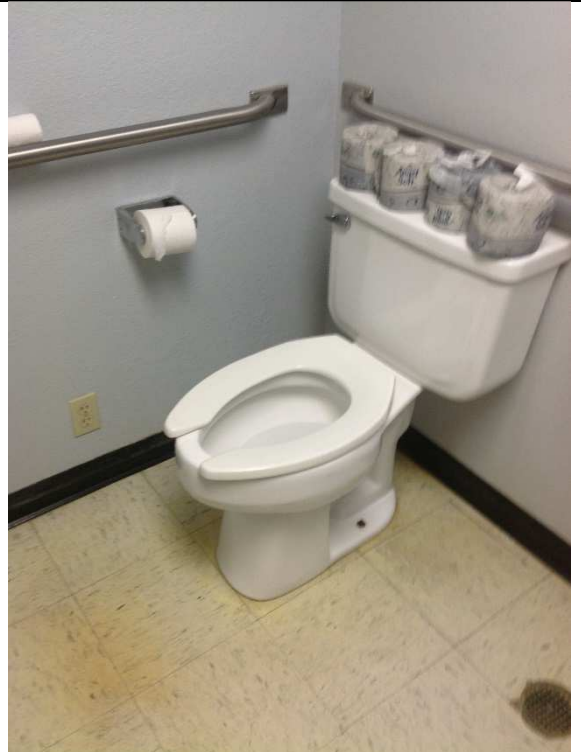
10. Even the toilet room planned for compliance has non-compliant features such as the flush control on the wrong side.

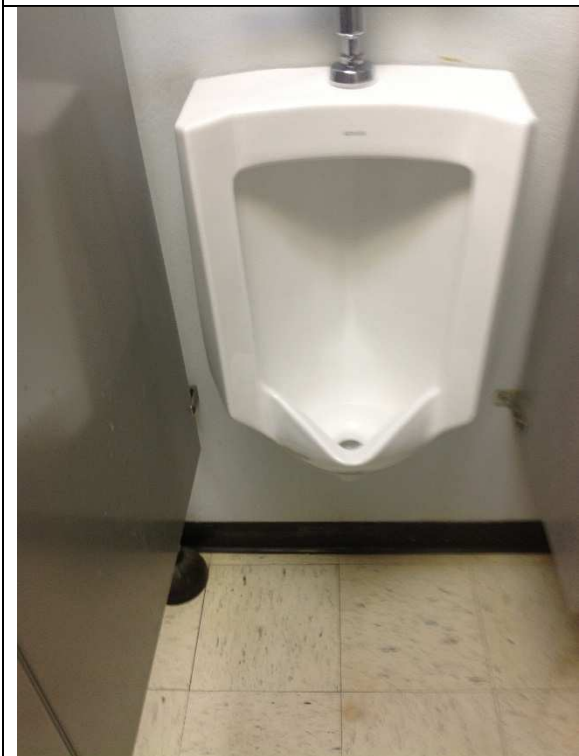
11. None of the urinals, in any of the restrooms, are compliant.

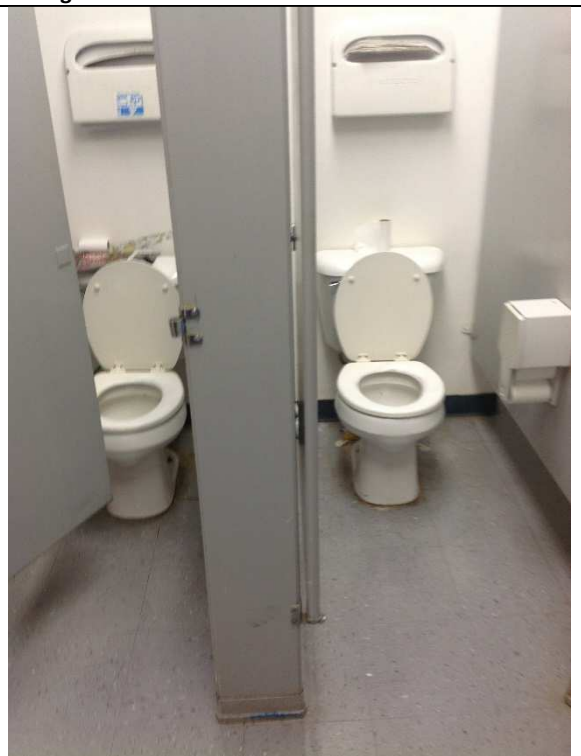
12. There are no compliant stalls or urinals in the larger restrooms.

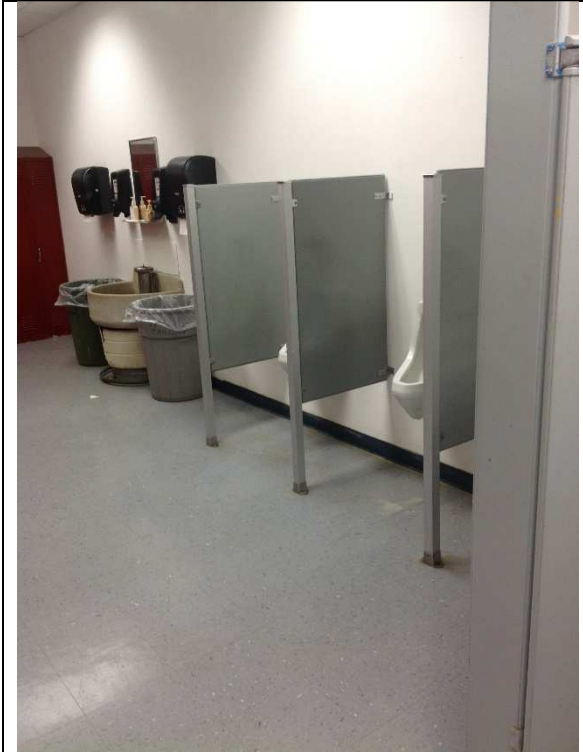
13. This men's room has no accessible features at all. A compliant urinal is 17" above the floor to the top of the rim.

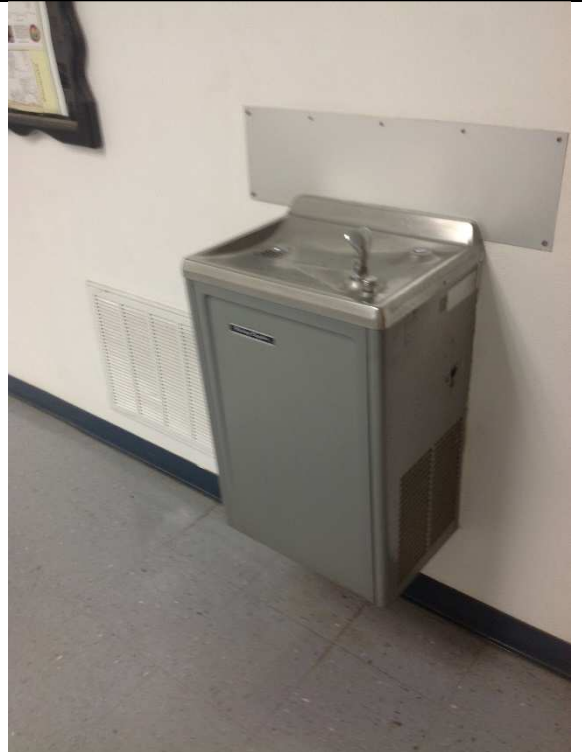
14. There are standard height drinking fountains but none at compliant heights,

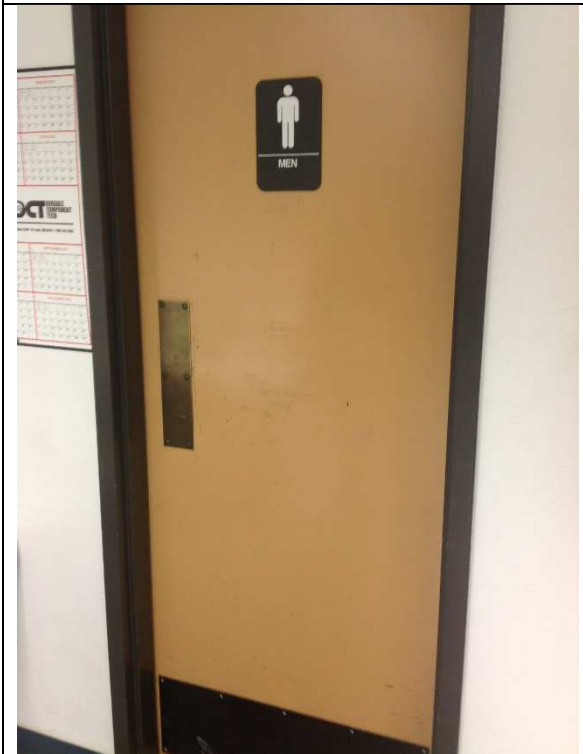
Violation #1: The signage throughout the building does not comply. All signs designating permanent spaces are required to have grade 2 Braille and raised characters.

15. The signage is required to be mounted on the latch side of the door with both raised characters and Braille.

Recommendation: Signage designating permanent spaces needs to be located on the wall adjacent to the latch side of the door. Mounting height shall be 48" to 60" AFF to the centerline of the sign and ensure it has grade 2 Braille and raised characters.

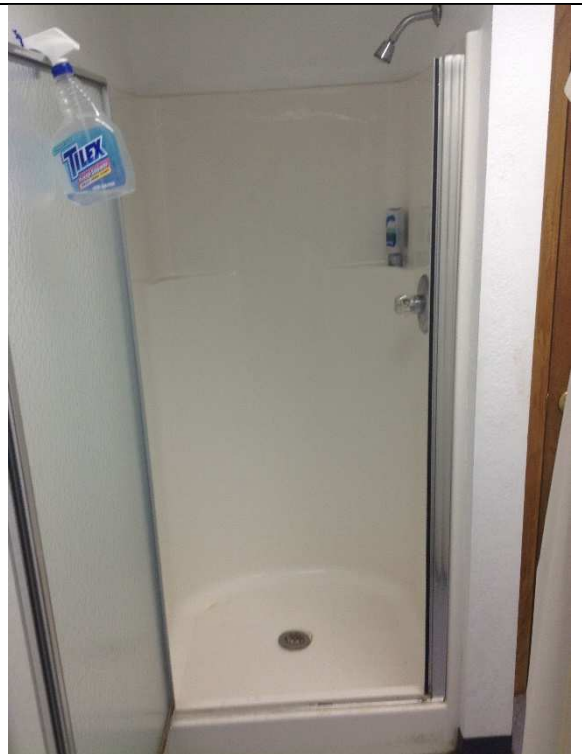
16. There are no compliant showers in the complex.

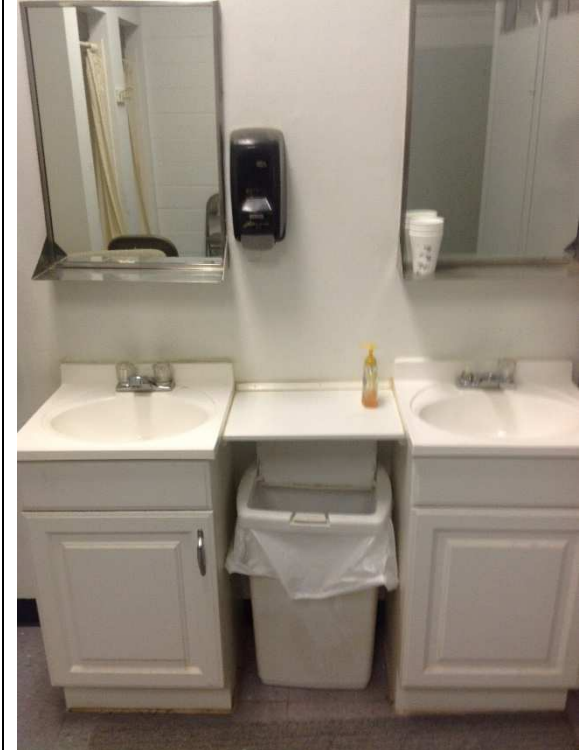
17. This restroom has no compliant features at all.

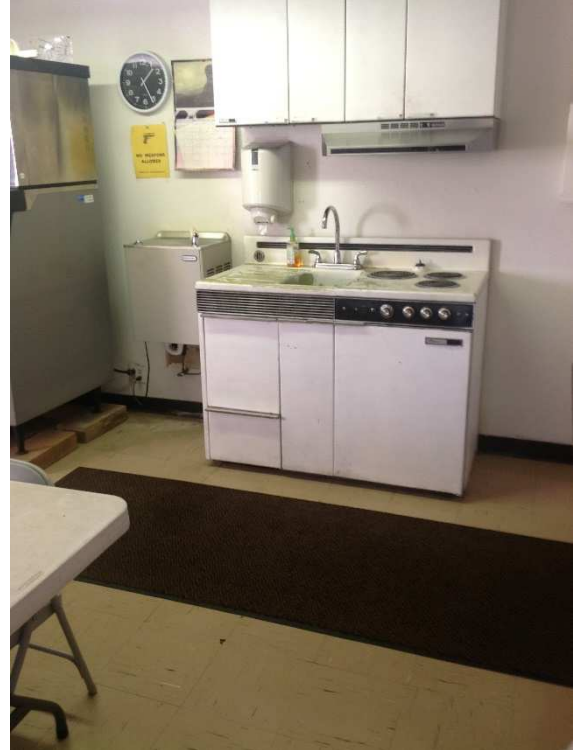
18. None of the break rooms in the complex comply.

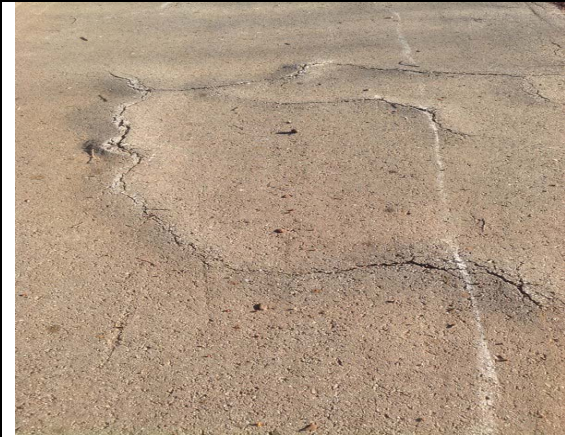
1. Comment: Violation AR_I1

Violation #1: There is no accessible route to get into the park. The path from the street does not have a curb cut to provide access. One should be installed and connected to the path provided.

Recommendation: Install a curb cut to access and connect to the path provided.

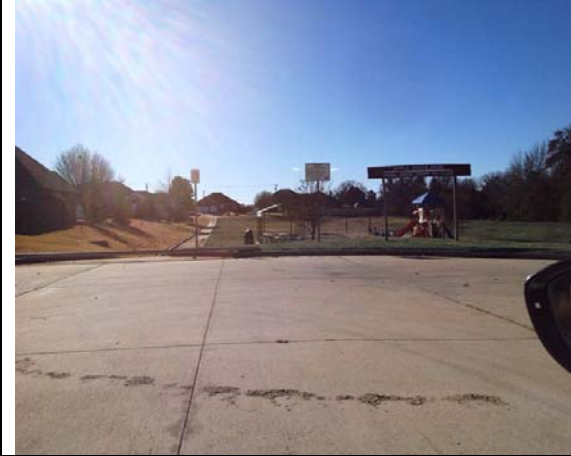
1. Comment: Violation AR_I1

Violation #1: No accessible route is provided onto the playground from the street.

Recommendation: Provide an accessible route from street to playground

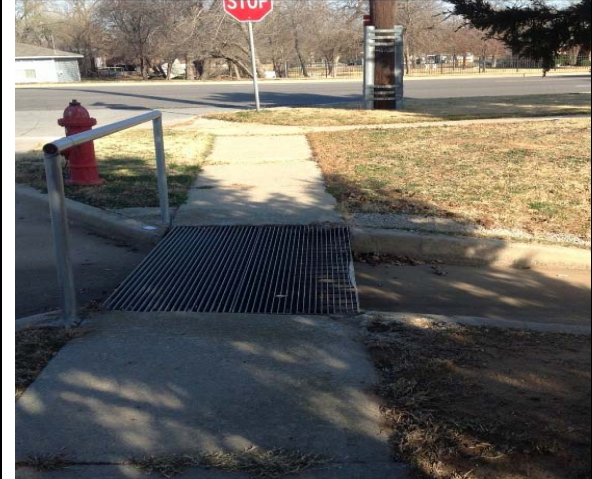
1. Comment: Violation AR_I1

Violation #1: A solid curb prevents access to the park unless someone in a wheelchair uses a private driveway.

Recommendation: Install a curb cut for access to park.

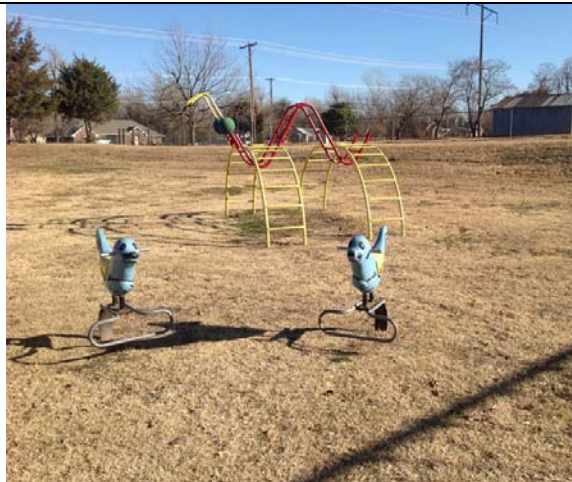
4. Comment: Violation Amn_I1

Violation #1: The playground equipment does not have accessible features.

Recommendation: Install Compliant playground equipment - Cost will depend on equipment purchased

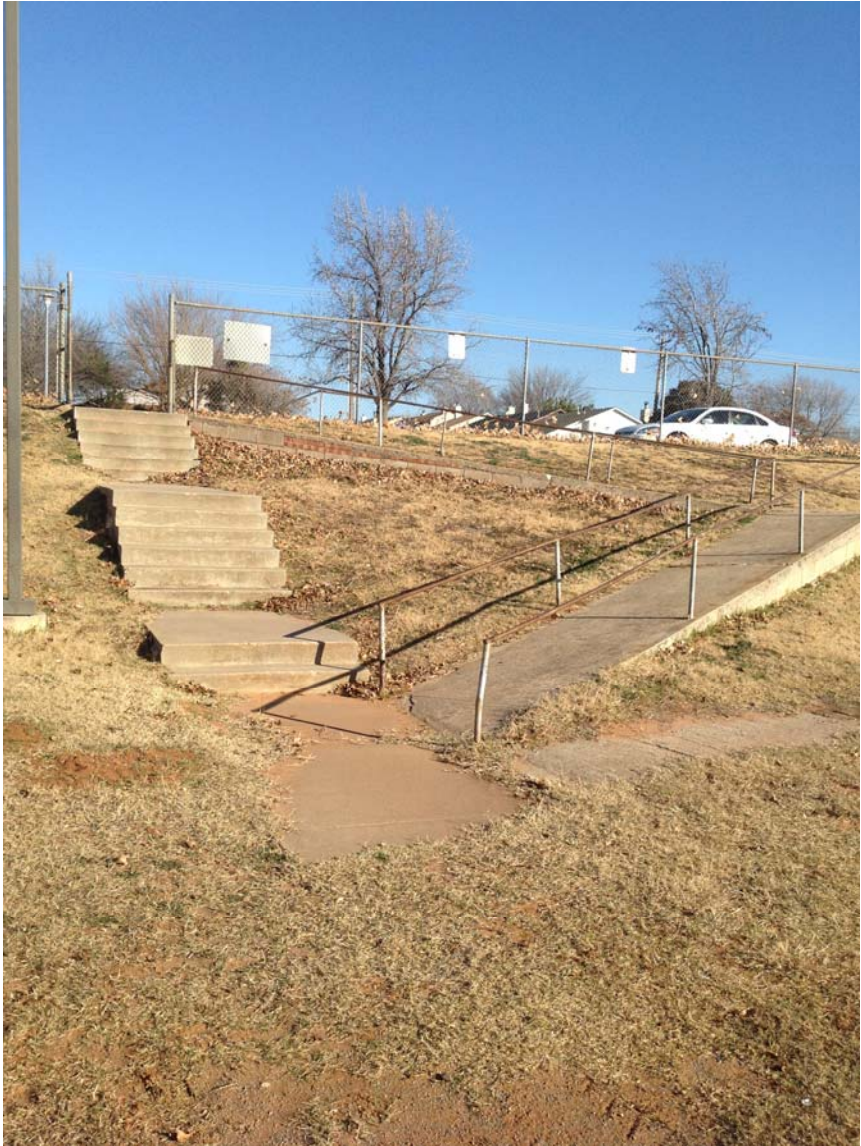
The stairs along the ramp are also dangerous. There are no handrails and the steps are uneven and sloped. The steps are not required to comply if the ramp does, but for liability purposes we recommend both are altered for compliance.

HIGH PRIORITY

We also recommend rebuilding the stairs provided. As long as the ramp complies the stairs are not required to, but because of their dangerous condition, we recommend altering them.

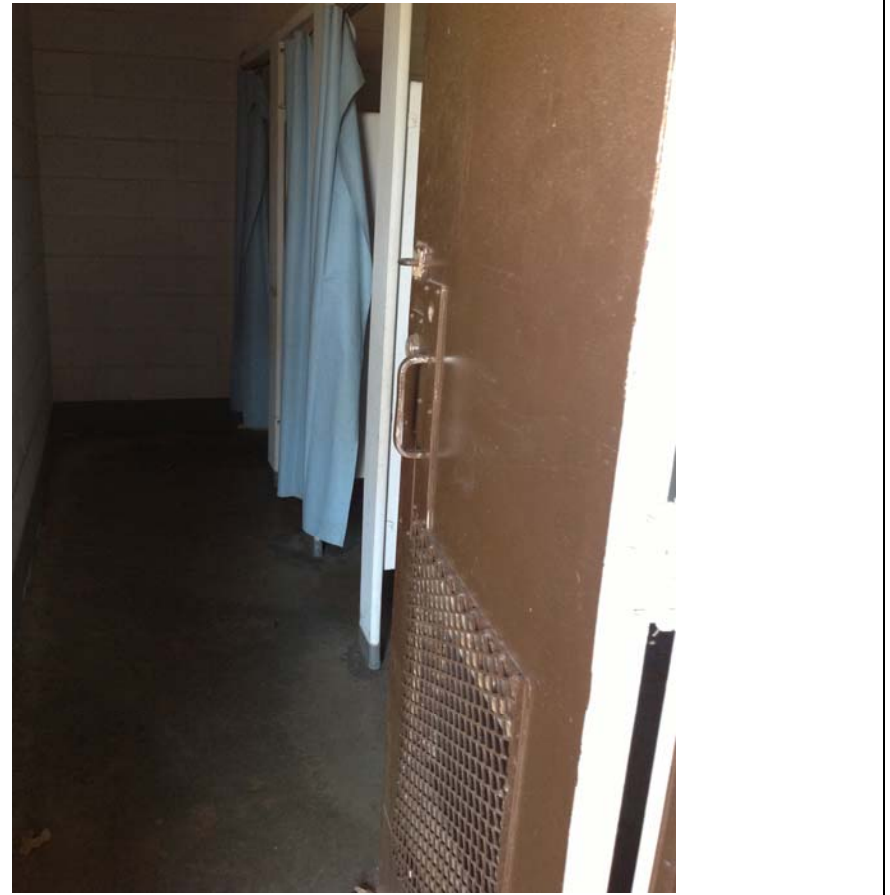
The restroom/concession at the main ball field has non accessible restrooms that need modifications for compliance.

MEDIUM PRIORITY

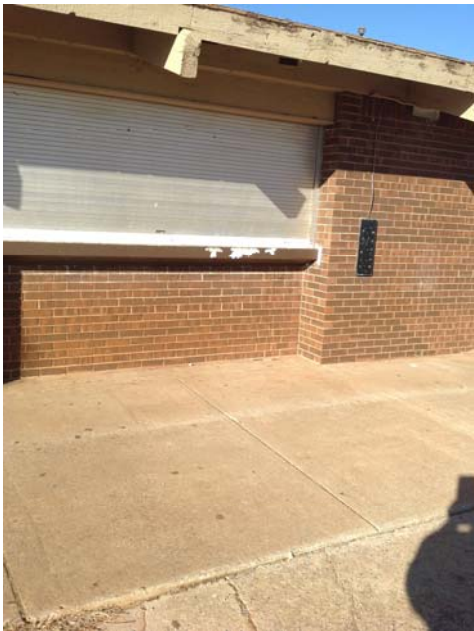
The concession stand does not have any compliant windows. At least one window needs to be provided at a maximum of 36” above the finished ground.

MEDIUM PRIORITY

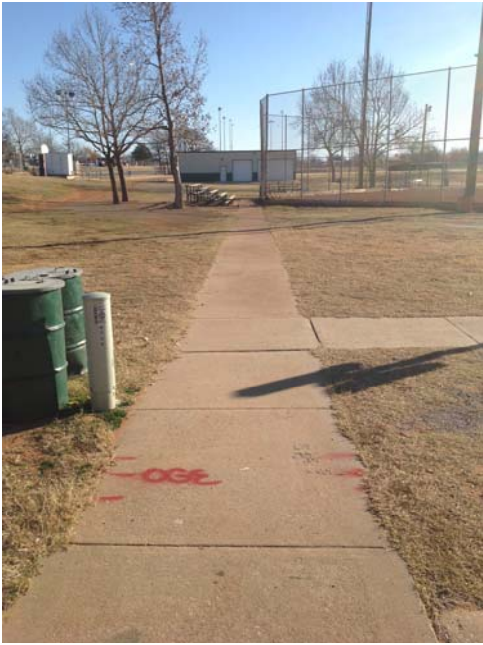
The exterior routes are required to be maintained in an accessible condition. These are in pretty good condition, for the most part.

HIGH PRIORITY

Ensure the maintenance team is trained to look for non-complying conditions and get them onto a schedule for repair when necessary.

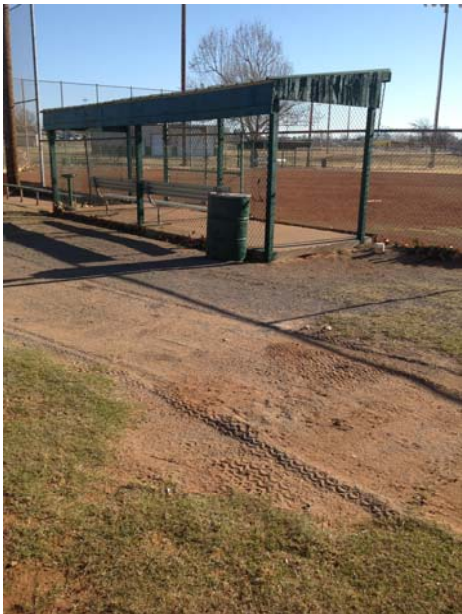
The dugout areas are not accessible because of the pad they sit on. These need to be altered for compliance so that all citizens, disabled or not, are able to access them.

MEDIUM PRIORITY

Provide a ramp or sloped sidewalk that gets all citizens onto the dugouts. We recommend this is done for all dugouts to prevent scheduling issues on game days.

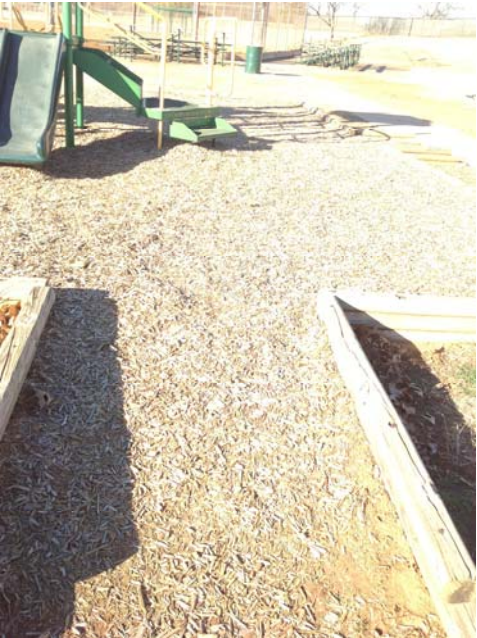
Although an accessible route is provided into the playground, the playground surface is not compliant. There is a list of accessible surfaces that include manufactured wood chips, which is the closest surface type to this.

MEDIUM PRIORITY

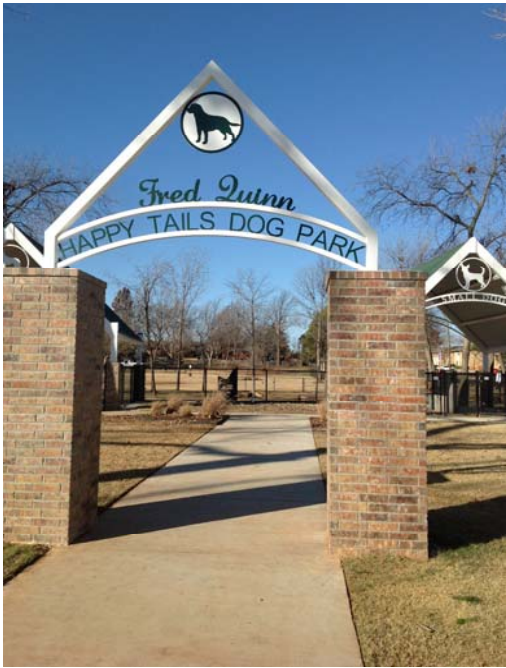
With the exception of the notes on the parking, the dog park is substantially compliant.

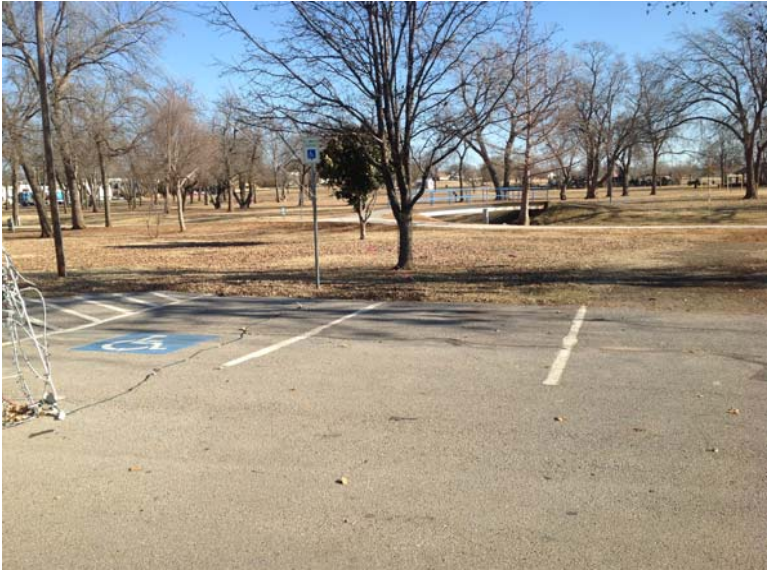
This parking space doesn't serve an accessible route. A route should be provided to the bridge and the areas served by the bridge.

MEDIUM PRIORITY
COST: \$9,600

One of the "projects" that needs to be scheduled is improving passage through the park to all amenities, which includes installing new routes that connect existing features. This can be done as one big project or on a park by park basis.

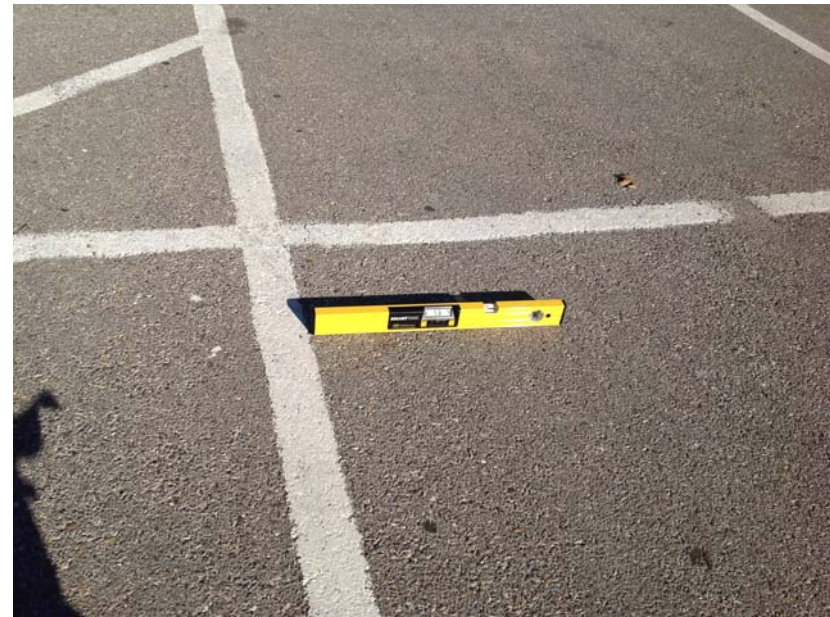
This is another view of the parking spaces noted above to show the slope issue.

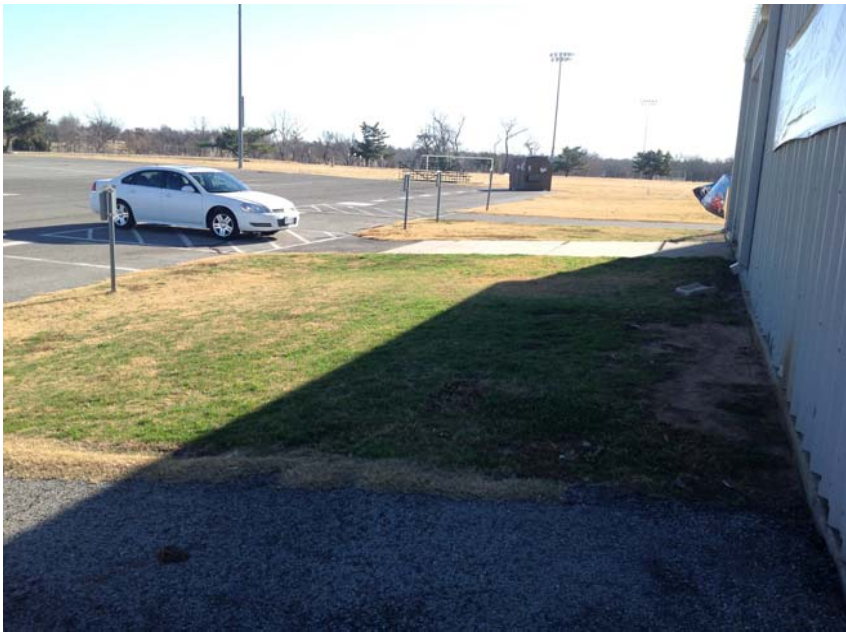
An alternate route to the concession area could be provided along this side of the building.

MEDIUM PRIORITY

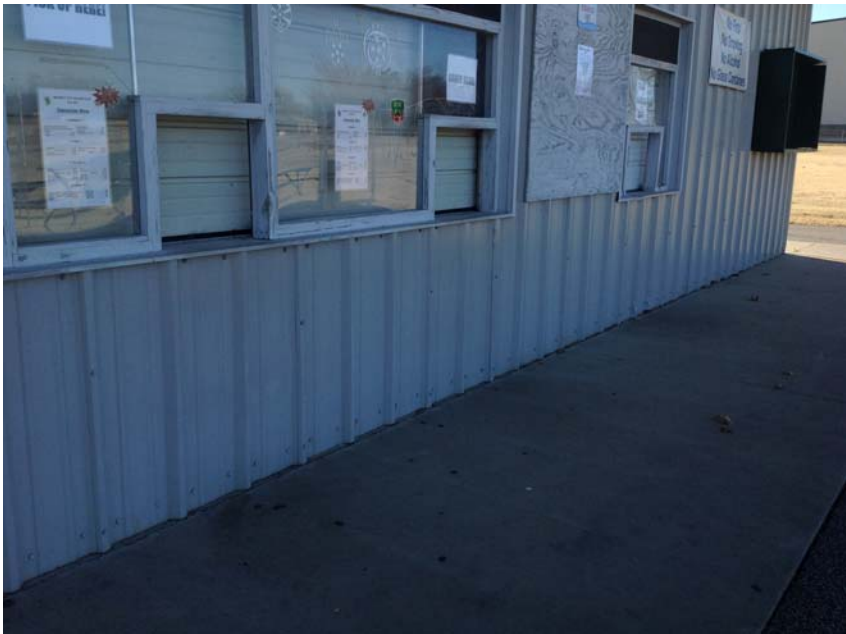
The concession stand does not have any compliant windows. At least one window needs to be provided at a maximum of 36” above the finished ground.

MEDIUM PRIORITY

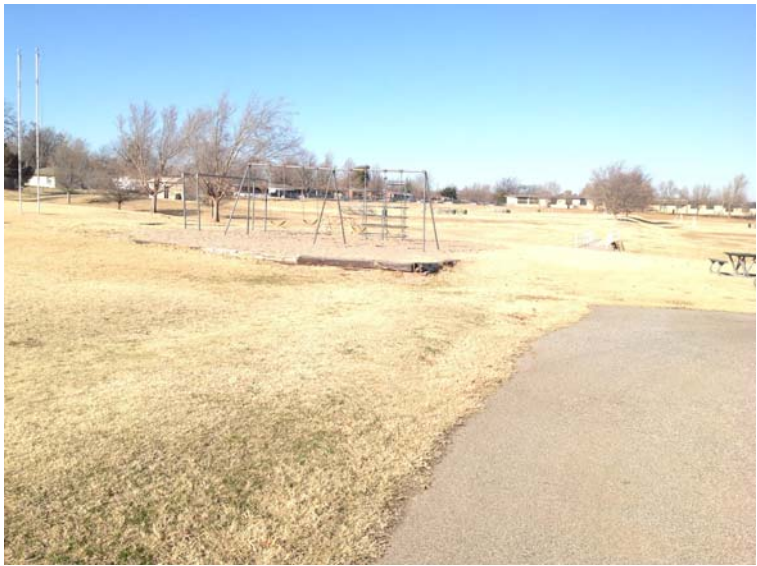
This playground, over by the soccer fields, has no accessible features. No accessible route is provided to the playground and none of the elements of the playground are compliant.

MEDIUM PRIORITY
COST: \$4,500

One of the “projects” that needs to be scheduled is ensuring each of the playgrounds has a compliant path of travel and the equipment is fully compliant. This could be done system wide or on a park by park basis.

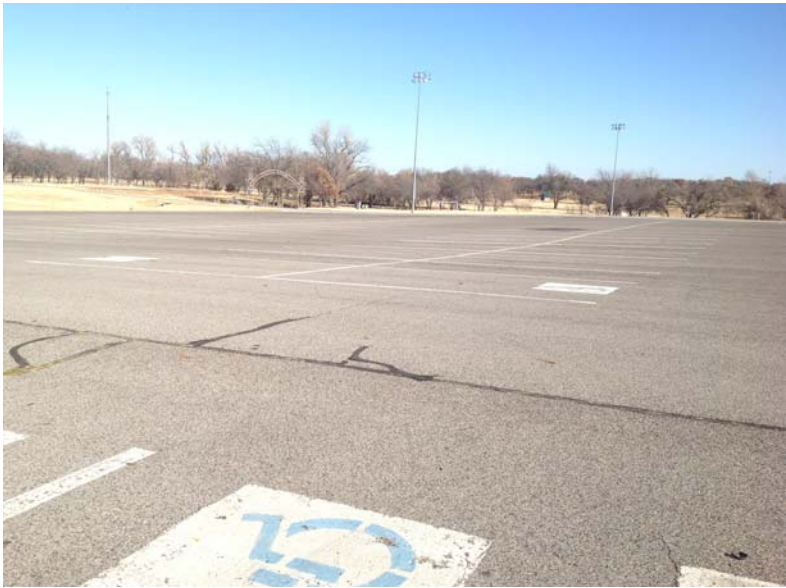
As noted in the parking section above, these parking spaces do not have any access aisles serving the amenities intended to be served by the lot. They also do not have proper signage.

HIGH PRIORITY
COST: Already accounted for in parking

Recommendations were made in the parking section.

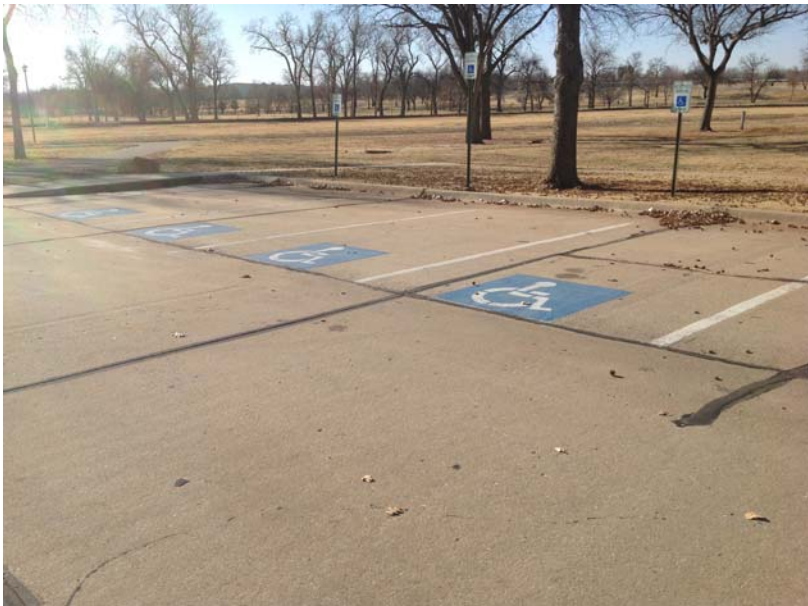
As noted in the parking section above, these parking spaces do not have any access aisles serving the amenities intended to be served by the lot.

HIGH PRIORITY

Recommendations were made in the parking section.

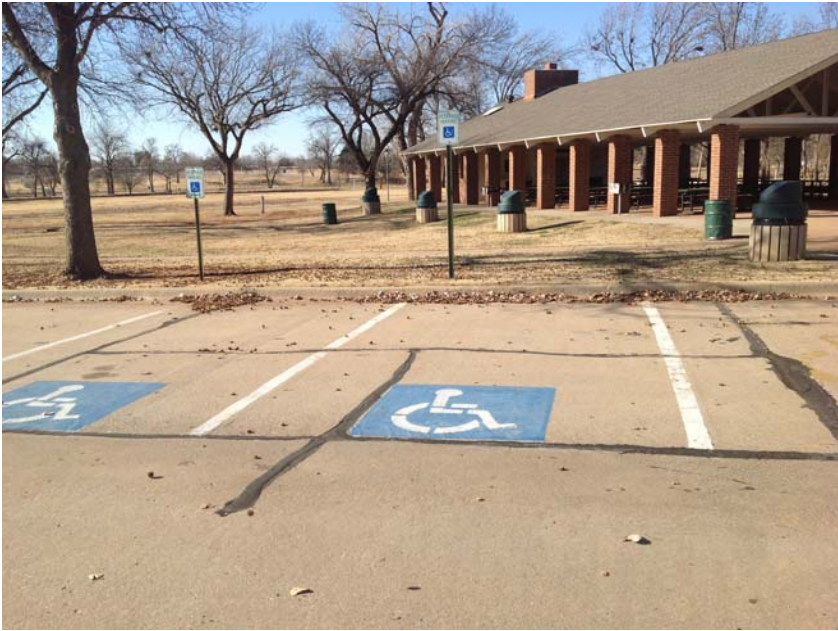
Although the parking itself has been addressed, there is also no accessible route to the pavilion.

MEDIUM PRIORITY
COST: \$7,300

Ensure there is an accessible route leading from the accessible parking spaces to the amenities they are intended to serve.

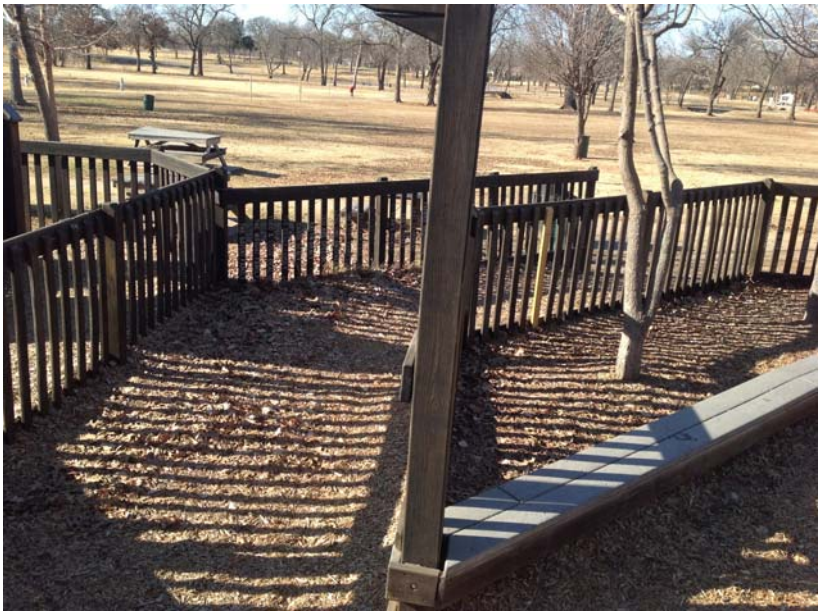
The exterior routes are required to be maintained in an accessible condition. These are in pretty good condition, for the most part.

RECOMMENDATION:

Ensure the maintenance team is trained to look for non-complying conditions and get them onto a schedule for repair when necessary.

MEDIUM PRIORITY

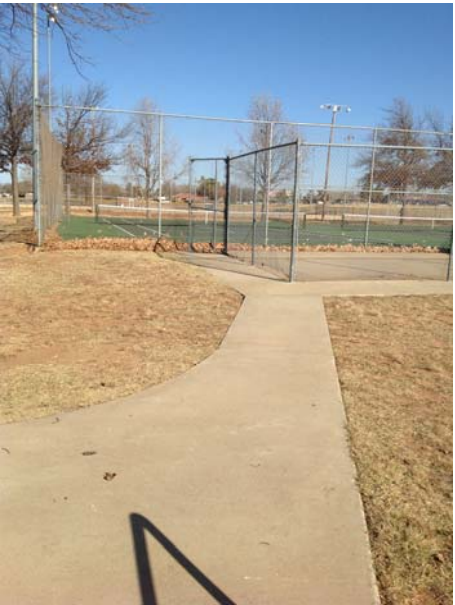
The path of travel to the tennis courts has some slope issues, but more importantly it leads to a noncompliant door into the courts. The entry makes the courts noncompliant. As illustrated below, the door orientation and location make it difficult for someone in a wheelchair to get in.

MEDIUM PRIORITY
COST: \$6,300

RECOMMENDATION:

Install a compliant path of travel and door leading into the tennis courts.

MEDIUM PRIORITY
COST: Included in above cost

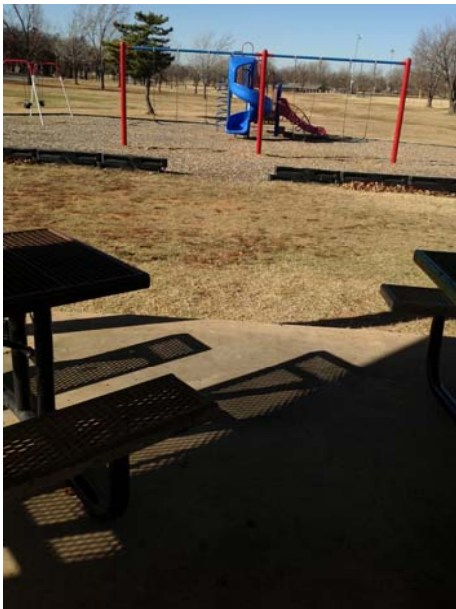
Although an accessible route is provided into the playground, the playground surface is not compliant. There is a list of accessible surfaces that include manufactured wood chips, which is the closest surface type to this.

RECOMMENDATION:

One of the “projects” that needs to be scheduled is replacing the surfacing for all playgrounds. This can be done as one big project or on a park by park basis.

MEDIUM PRIORITY
COST: \$7,400

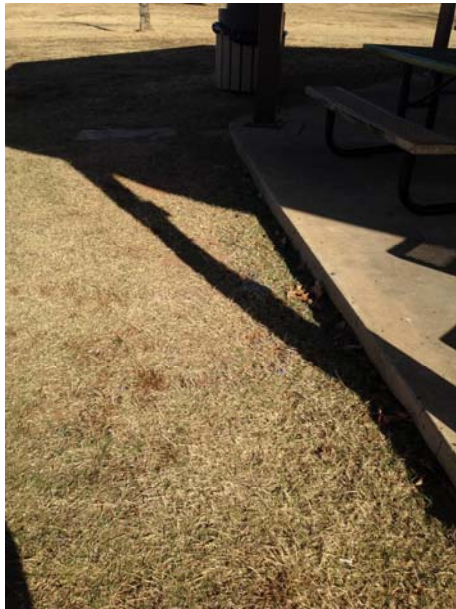
These picnic tables are mounted on a concrete slab with a level change that makes them inaccessible. Even with an accessible route, this level change is a liability to the City.

RECOMMENDATION:

One of the “projects” that needs to be scheduled is ensuring the picnic areas are compliant. This can be done as one big project or on a park by park basis.

MEDIUM PRIORITY
COST: \$1,200

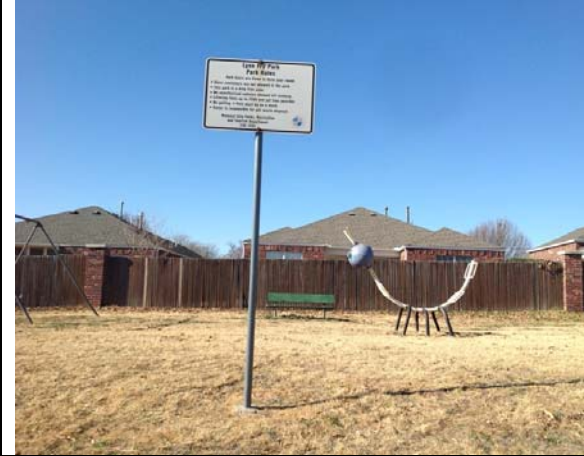
1. Comment: Violation Amn_I1

Violation #1: The play equipment is older and does not comply with playground standards.

Recommendation: Install Compliant playground equipment - Cost will depend on equipment purchased

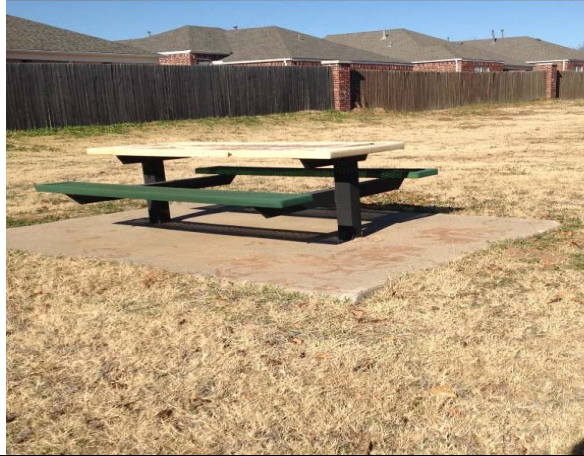
2. Comment: Violation Amn_I2

Violation #2: The picnic bench is on a cement slab with a level change on all sides. An accessible picnic table must be provided

Recommendation: Provide an access path to an accessible picnic table
