City of Midwest City ADA Self-Evaluation and Transition Plan

Project: ADA Self-Evaluation and Transition Plan

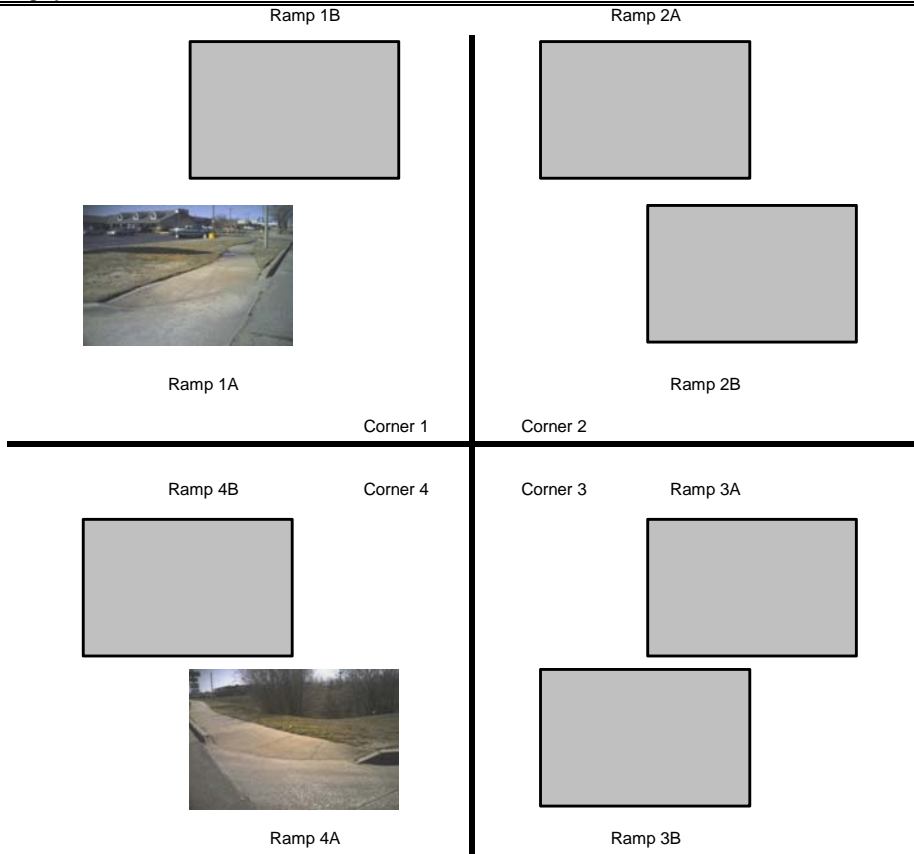
Ramp Issues	Ramp ID								Recommendations
	1A	1B	2A	2B	3A	3B	4A	4B	
Ramp does not land in crosswalk									
No 48" extension into crosswalk									
Ramp does not exist and is needed									
Flare cross slope is greater than 10%	X						X		
Ramp running slope is greater than 8.33%	X						X		Remove and replace ramp
Ramp cross slope is greater than 2%	X						X		
Ramp width is less than 48"	X						X		
Obstruction present in ramp or landing area									
No textured surface at base of ramp	X						X		Install colored truncated domes
No color contrast at base of ramp	X						X		
Landing area is less than 5' x 5', has a cross slope greater than 2% or does not exist	X						X		Install landing area
No pedestrian push buttons									
Pedestrian pushbutton diameter is not 2"									
Pedestrian pushbutton height is greater than 42"									
Pedestrian head offset is greater than 10' from the nearest crosswalk edge

Clear floor space for pedestrian pushbutton is less than 30" x 48", has a cross slope greater than 2% or does not exist									
Ramp transition onto roadway is greater than 0.25"									
Ponding occurs at base of ramp	X								Fix ramp transition
No existing curb in path of travel			X		X				Do not install ramp
Ramp Priority:	H		-		-		H

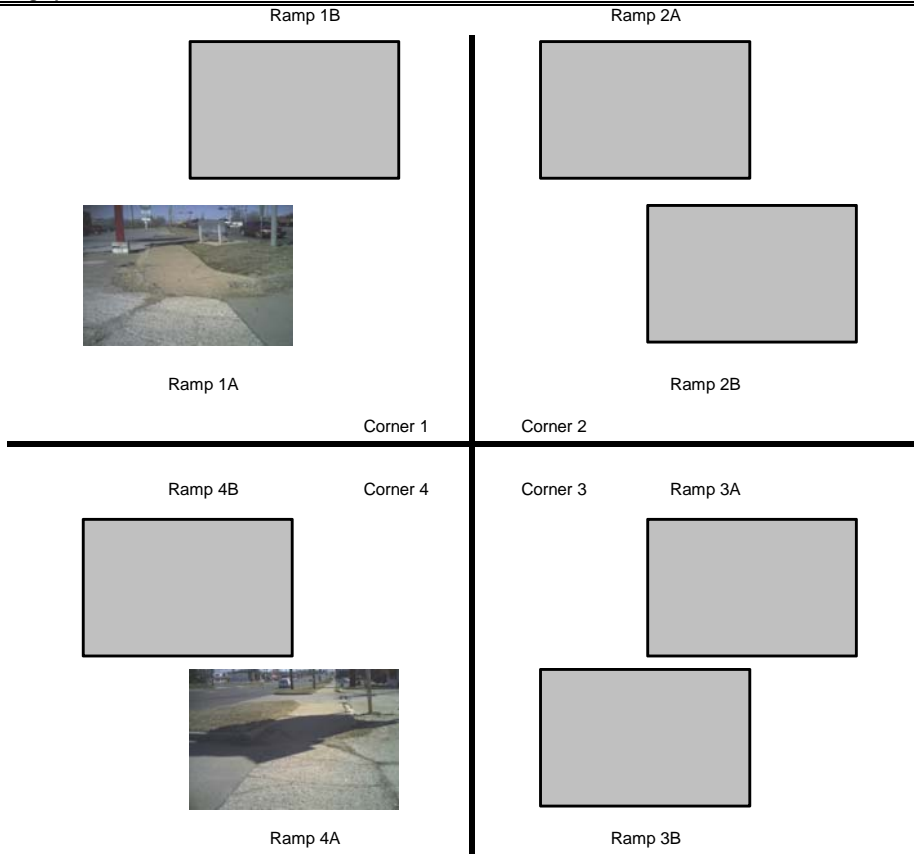
Ramp Issues	Ramp ID								Recommendations
	1A	1B	2A	2B	3A	3B	4A	4B	
Ramp does not land in crosswalk									
No 48" extension into crosswalk									
Ramp does not exist and is needed									
Flare cross slope is greater than 10%									
Ramp running slope is greater than 8.33%	X						X		Remove and replace ramp
Ramp cross slope is greater than 2%							X		
Ramp width is less than 48"							X		
Obstruction present in ramp or landing area									
No textured surface at base of ramp	X						X		Install colored truncated domes
No color contrast at base of ramp	X						X		
Landing area is less than 5' x 5', has a cross slope greater than 2% or does not exist	X						X		Install landing area
No pedestrian push buttons									
Pedestrian pushbutton diameter is not 2"									
Pedestrian pushbutton height is greater than 42"									
Pedestrian head offset is greater than 10' from the nearest crosswalk edge

Clear floor space for pedestrian pushbutton is less than 30" x 48", has a cross slope greater than 2% or does not exist									
Ramp transition onto roadway is greater than 0.25"	X						X		Fix ramp transition
Ponding occurs at base of ramp	X						X		
No existing curb in path of travel			X		X				Do not install ramp
Ramp Priority:	H		-		-		H

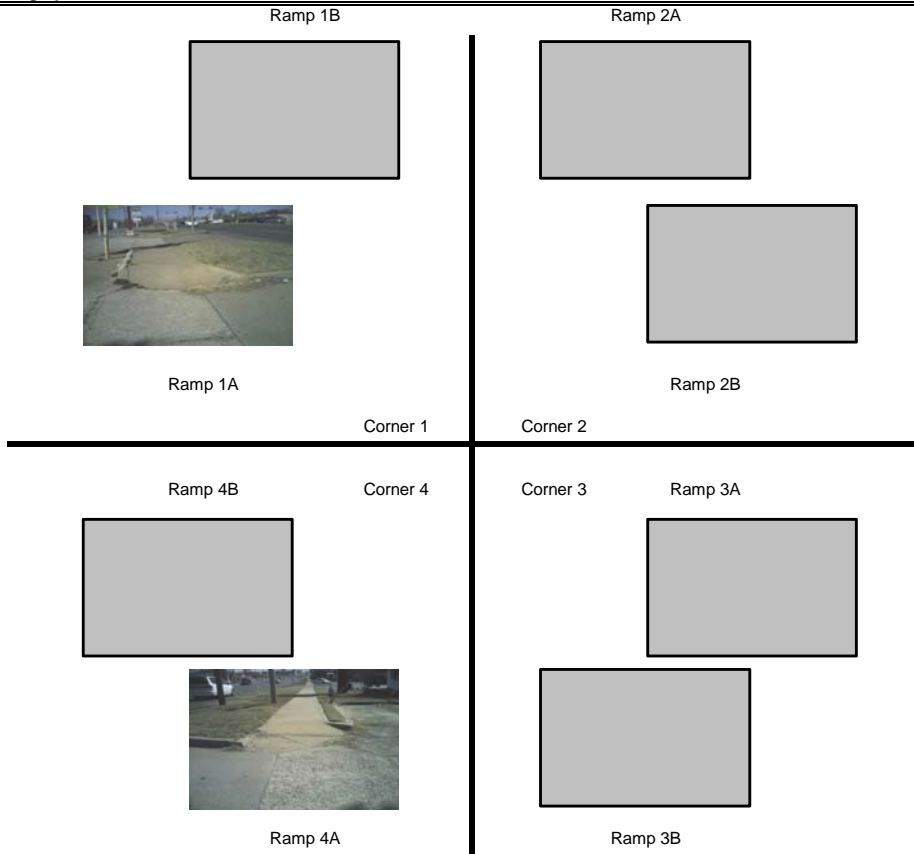
Ramp Issues	Ramp ID								Recommendations
	1A	1B	2A	2B	3A	3B	4A	4B	
Ramp does not land in crosswalk									
No 48" extension into crosswalk									
Ramp does not exist and is needed			X		X				Install handicap ramp
Flare cross slope is greater than 10%									
Ramp running slope is greater than 8.33%	X								Remove and replace ramp
Ramp cross slope is greater than 2%	X								
Ramp width is less than 48"									
Obstruction present in ramp or landing area									
No textured surface at base of ramp	X						X		Install colored truncated domes
No color contrast at base of ramp	X						X		
Landing area is less than 5' x 5', has a cross slope greater than 2% or does not exist	X						X		Install landing area
No pedestrian push buttons									
Pedestrian pushbutton diameter is not 2"									
Pedestrian pushbutton height is greater than 42"									
Pedestrian head offset is greater than 10' from the nearest crosswalk edge

Clear floor space for pedestrian pushbutton is less than 30" x 48", has a cross slope greater than 2% or does not exist									
Ramp transition onto roadway is greater than 0.25"	X								Fix ramp transition
Ponding occurs at base of ramp	X						X		
No existing curb in path of travel									
Ramp Priority:	H		H		H		M

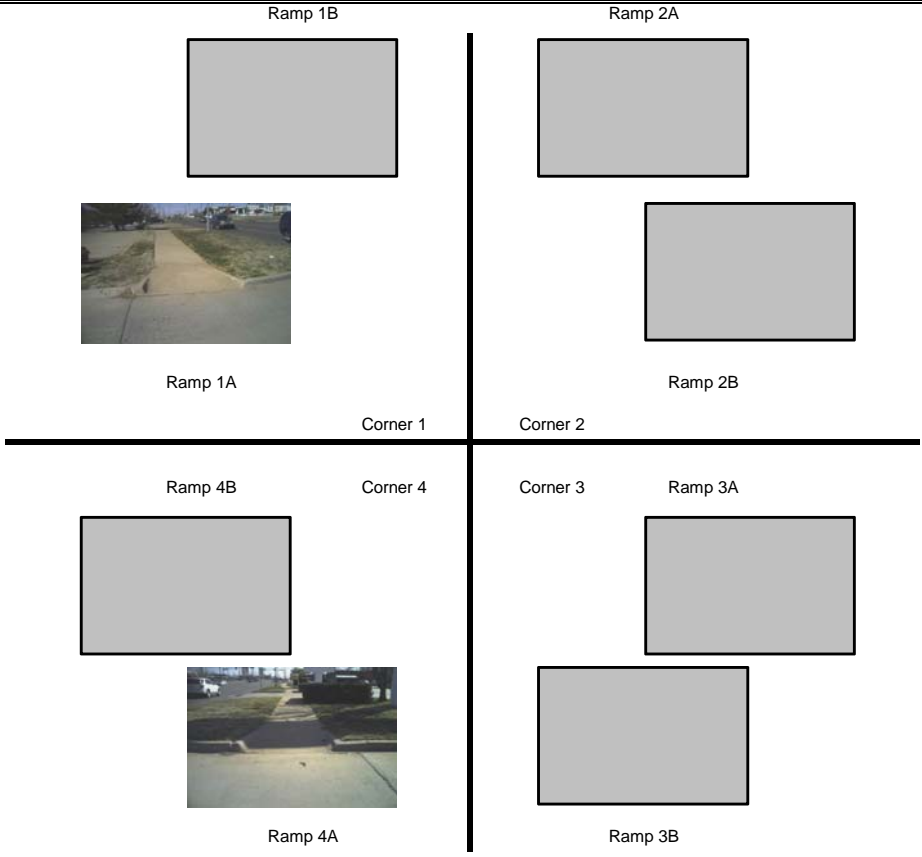
Ramp Issues	Ramp ID								Recommendations
	1A	1B	2A	2B	3A	3B	4A	4B	
Ramp does not land in crosswalk									
No 48" extension into crosswalk									
Ramp does not exist and is needed			X		X				Install handicap ramp
Flare cross slope is greater than 10%									
Ramp running slope is greater than 8.33%	X								
Ramp cross slope is greater than 2%	X						X		Remove and replace ramp
Ramp width is less than 48"									
Obstruction present in ramp or landing area									
No textured surface at base of ramp	X						X		Install colored truncated domes
No color contrast at base of ramp	X						X		
Landing area is less than 5' x 5', has a cross slope greater than 2% or does not exist	X								Install landing area
No pedestrian push buttons									
Pedestrian pushbutton diameter is not 2"									
Pedestrian pushbutton height is greater than 42"									
Pedestrian head offset is greater than 10' from the nearest crosswalk edge

Clear floor space for pedestrian pushbutton is less than 30" x 48", has a cross slope greater than 2% or does not exist									
Ramp transition onto roadway is greater than 0.25"	X						X		Fix ramp transition
Ponding occurs at base of ramp	X						X		
No existing curb in path of travel									
Ramp Priority:	H		H		H		H

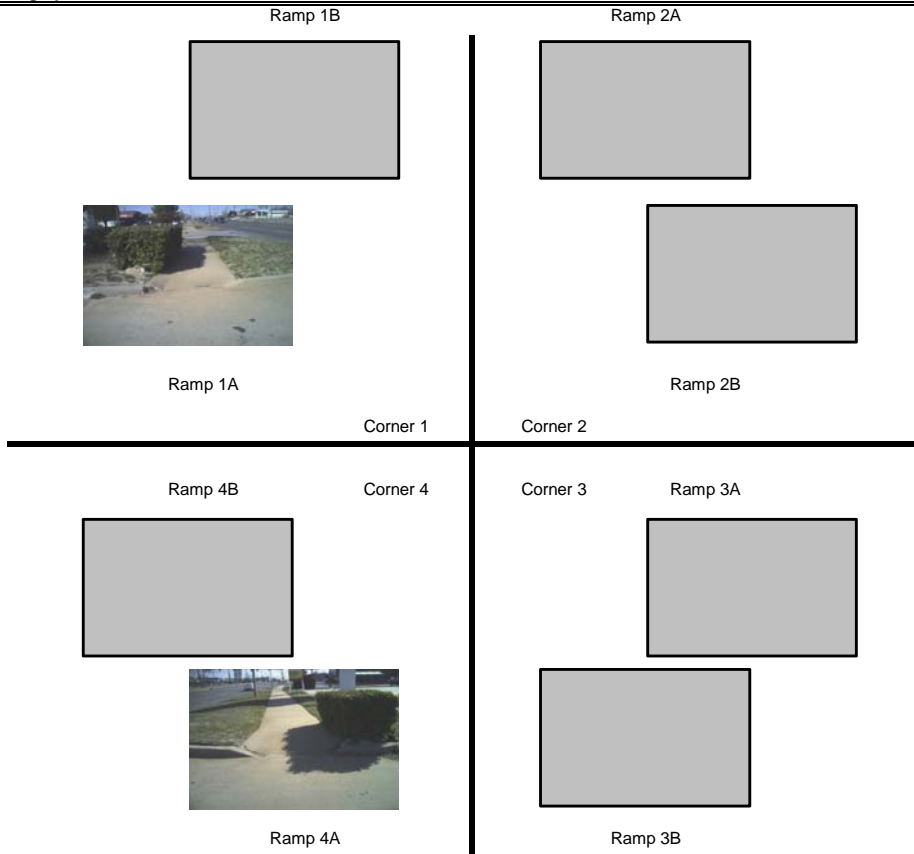
Ramp Issues	Ramp ID								Recommendations
	1A	1B	2A	2B	3A	3B	4A	4B	
Ramp does not land in crosswalk									
No 48" extension into crosswalk									
Ramp does not exist and is needed			X		X				Install handicap ramp
Flare cross slope is greater than 10%	X						X		
Ramp running slope is greater than 8.33%							X		
Ramp cross slope is greater than 2%									
Ramp width is less than 48"	X								Remove and replace ramp
Obstruction present in ramp or landing area									
No textured surface at base of ramp	X						X		
No color contrast at base of ramp	X						X		Install colored truncated domes
Landing area is less than 5' x 5', has a cross slope greater than 2% or does not exist									
No pedestrian push buttons									
Pedestrian pushbutton diameter is not 2"									
Pedestrian pushbutton height is greater than 42"									
Pedestrian head offset is greater than 10' from the nearest crosswalk edge

Clear floor space for pedestrian pushbutton is less than 30" x 48", has a cross slope greater than 2% or does not exist									
Ramp transition onto roadway is greater than 0.25"	X						X		Fix ramp transition
Ponding occurs at base of ramp									
No existing curb in path of travel									
Ramp Priority:	H		H		H		H

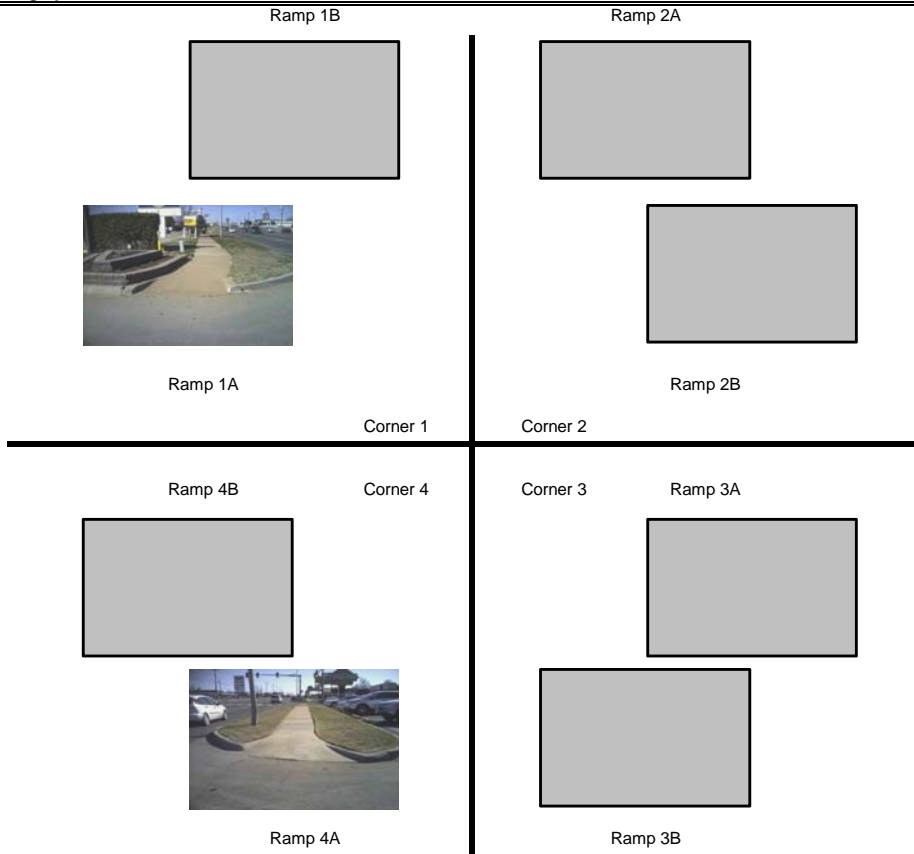
Ramp Issues	Ramp ID								Recommendations
	1A	1B	2A	2B	3A	3B	4A	4B	
Ramp does not land in crosswalk									
No 48" extension into crosswalk									
Ramp does not exist and is needed			X		X				Install handicap ramp
Flare cross slope is greater than 10%									
Ramp running slope is greater than 8.33%								X	
Ramp cross slope is greater than 2%	X								Remove and replace ramp
Ramp width is less than 48"									
Obstruction present in ramp or landing area									
No textured surface at base of ramp	X							X	Install colored truncated domes
No color contrast at base of ramp	X							X	
Landing area is less than 5' x 5', has a cross slope greater than 2% or does not exist								X	Install landing area
No pedestrian push buttons									
Pedestrian pushbutton diameter is not 2"									
Pedestrian pushbutton height is greater than 42"									
Pedestrian head offset is greater than 10' from the nearest crosswalk edge

Clear floor space for pedestrian pushbutton is less than 30" x 48", has a cross slope greater than 2% or does not exist									
Ramp transition onto roadway is greater than 0.25"								X	Fix ramp transition
Ponding occurs at base of ramp									
No existing curb in path of travel									
Ramp Priority:	H	H	H	H	H	H	H	H

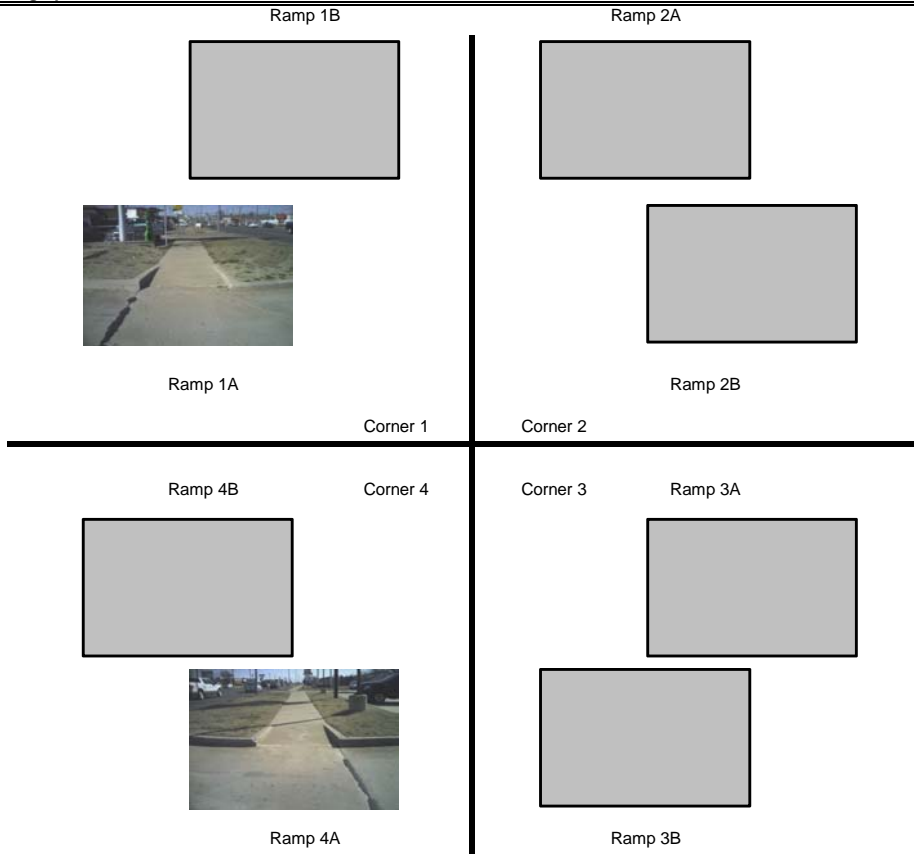
Ramp Issues	Ramp ID								Recommendations
	1A	1B	2A	2B	3A	3B	4A	4B	
Ramp does not land in crosswalk									
No 48" extension into crosswalk									
Ramp does not exist and is needed									
Flare cross slope is greater than 10%									
Ramp running slope is greater than 8.33%							X		
Ramp cross slope is greater than 2%	X						X		Remove and replace ramp
Ramp width is less than 48"									
Obstruction present in ramp or landing area									
No textured surface at base of ramp	X						X		Install colored truncated domes
No color contrast at base of ramp	X						X		
Landing area is less than 5' x 5', has a cross slope greater than 2% or does not exist	X								Install landing area
No pedestrian push buttons									
Pedestrian pushbutton diameter is not 2"									
Pedestrian pushbutton height is greater than 42"									
Pedestrian head offset is greater than 10' from the nearest crosswalk edge

Clear floor space for pedestrian pushbutton is less than 30" x 48", has a cross slope greater than 2% or does not exist									
Ramp transition onto roadway is greater than 0.25"									
Ponding occurs at base of ramp									
No existing curb in path of travel			X		X				Do not install ramp
Ramp Priority:	H		-		-		H

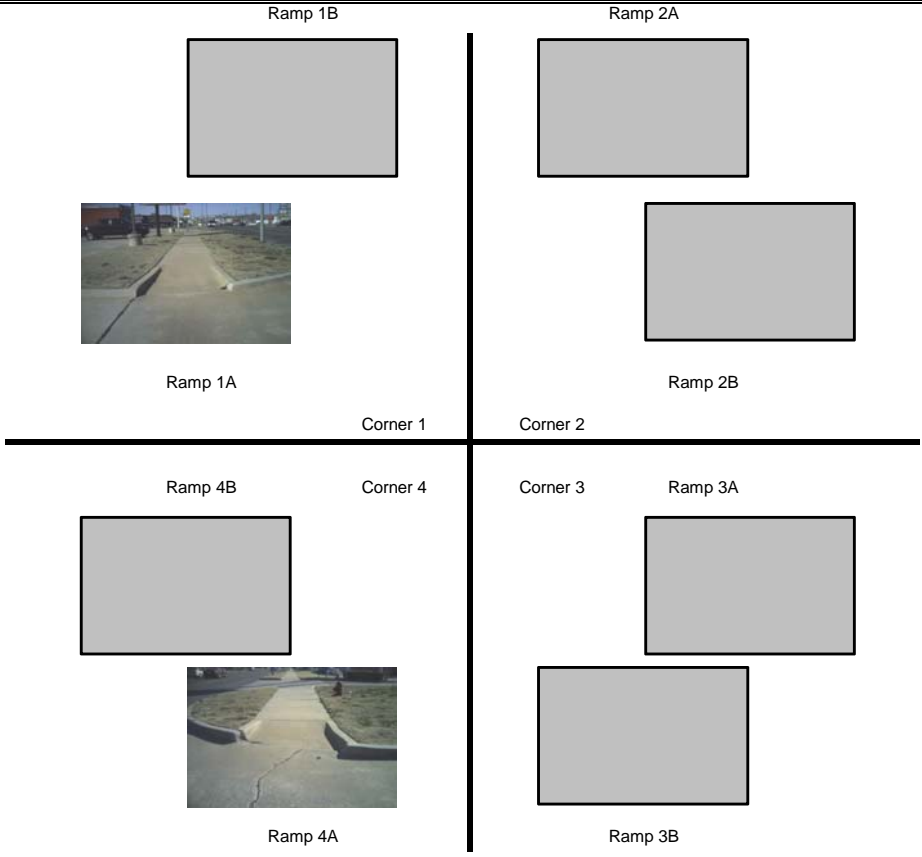
Ramp Issues	Ramp ID								Recommendations
	1A	1B	2A	2B	3A	3B	4A	4B	
Ramp does not land in crosswalk									
No 48" extension into crosswalk									
Ramp does not exist and is needed			X		X				Install handicap ramp
Flare cross slope is greater than 10%									
Ramp running slope is greater than 8.33%							X		Remove and replace ramp
Ramp cross slope is greater than 2%									
Ramp width is less than 48"									
Obstruction present in ramp or landing area									
No textured surface at base of ramp	X						X		Install colored truncated domes
No color contrast at base of ramp	X						X		
Landing area is less than 5' x 5', has a cross slope greater than 2% or does not exist							X		Install landing area
No pedestrian push buttons									
Pedestrian pushbutton diameter is not 2"									
Pedestrian pushbutton height is greater than 42"									
Pedestrian head offset is greater than 10' from the nearest crosswalk edge

Clear floor space for pedestrian pushbutton is less than 30" x 48", has a cross slope greater than 2% or does not exist									
Ramp transition onto roadway is greater than 0.25"	X						X		Fix ramp transition
Ponding occurs at base of ramp									
No existing curb in path of travel									
Ramp Priority:	H		H		H		H

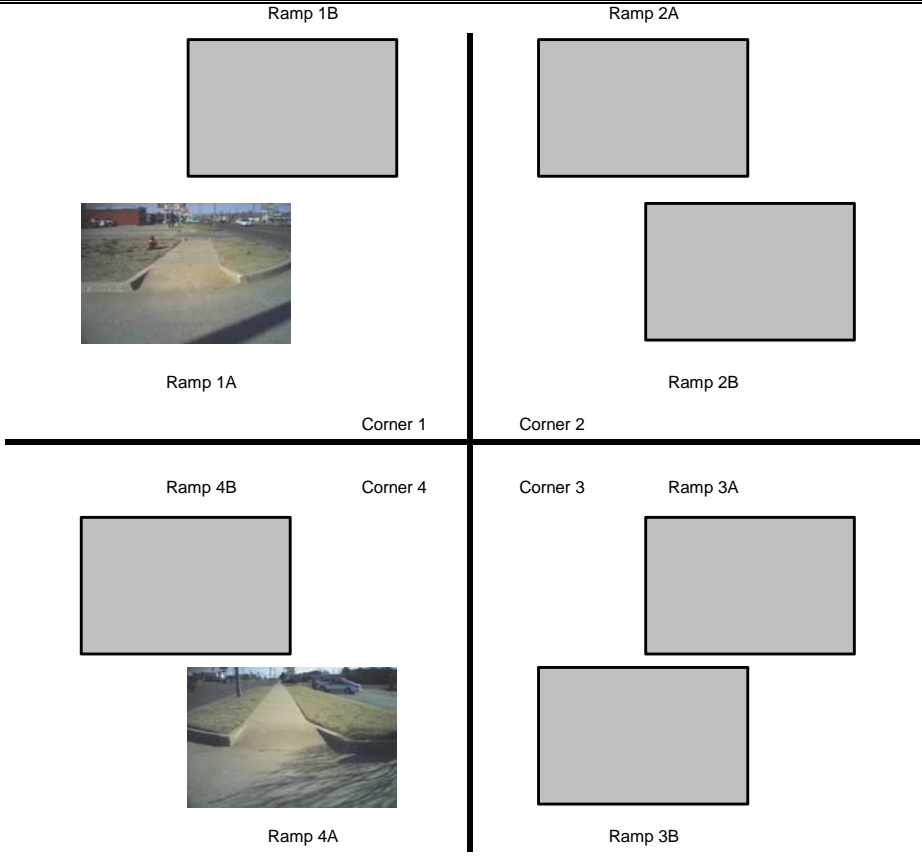
Ramp Issues	Ramp ID								Recommendations
	1A	1B	2A	2B	3A	3B	4A	4B	
Ramp does not land in crosswalk									
No 48" extension into crosswalk									
Ramp does not exist and is needed									
Flare cross slope is greater than 10%									
Ramp running slope is greater than 8.33%								X	
Ramp cross slope is greater than 2%	X								Remove and replace ramp
Ramp width is less than 48"									
Obstruction present in ramp or landing area									
No textured surface at base of ramp	X							X	Install colored truncated domes
No color contrast at base of ramp	X							X	
Landing area is less than 5' x 5', has a cross slope greater than 2% or does not exist	X								Install landing area
No pedestrian push buttons									
Pedestrian pushbutton diameter is not 2"									
Pedestrian pushbutton height is greater than 42"									
Pedestrian head offset is greater than 10' from the nearest crosswalk edge

Clear floor space for pedestrian pushbutton is less than 30" x 48", has a cross slope greater than 2% or does not exist									
Ramp transition onto roadway is greater than 0.25"								X	Fix ramp transition
Ponding occurs at base of ramp	X							X	
No existing curb in path of travel			X		X				Do not install ramp
Ramp Priority:	H		-		-			H

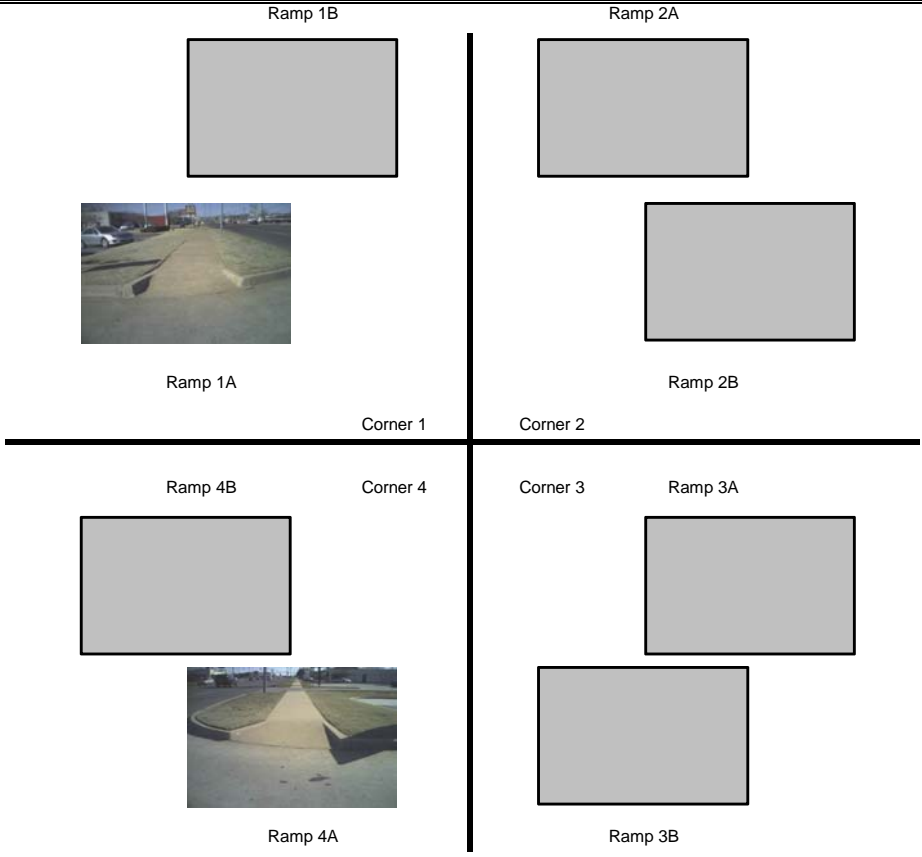
Intersection Issues	Crosswalk				Recommendations
	N	E	S	W	
Pavement condition at the crosswalk	N/A	N/A	N/A	N/A	
Crosswalk cross slope is greater than 2%	-	-	-	-	
Crosswalk striping	N/A	N/A	N/A	N/A

Ramp Issues	Ramp ID								Recommendations
	1A	1B	2A	2B	3A	3B	4A	4B	
Ramp does not land in crosswalk									
No 48" extension into crosswalk									
Ramp does not exist and is needed									
Flare cross slope is greater than 10%									
Ramp running slope is greater than 8.33%	X							X	Remove and replace ramp
Ramp cross slope is greater than 2%	X							X	
Ramp width is less than 48"									
Obstruction present in ramp or landing area									
No textured surface at base of ramp	X							X	Install colored truncated domes
No color contrast at base of ramp	X							X	
Landing area is less than 5' x 5', has a cross slope greater than 2% or does not exist								X	Install landing area
No pedestrian push buttons									
Pedestrian pushbutton diameter is not 2"									
Pedestrian pushbutton height is greater than 42"									
Pedestrian head offset is greater than 10' from the nearest crosswalk edge

Clear floor space for pedestrian pushbutton is less than 30" x 48", has a cross slope greater than 2% or does not exist									
Ramp transition onto roadway is greater than 0.25"									
Ponding occurs at base of ramp								X	Fix ramp transition
No existing curb in path of travel			X		X				Do not install ramp
Ramp Priority:	H		-		-			H

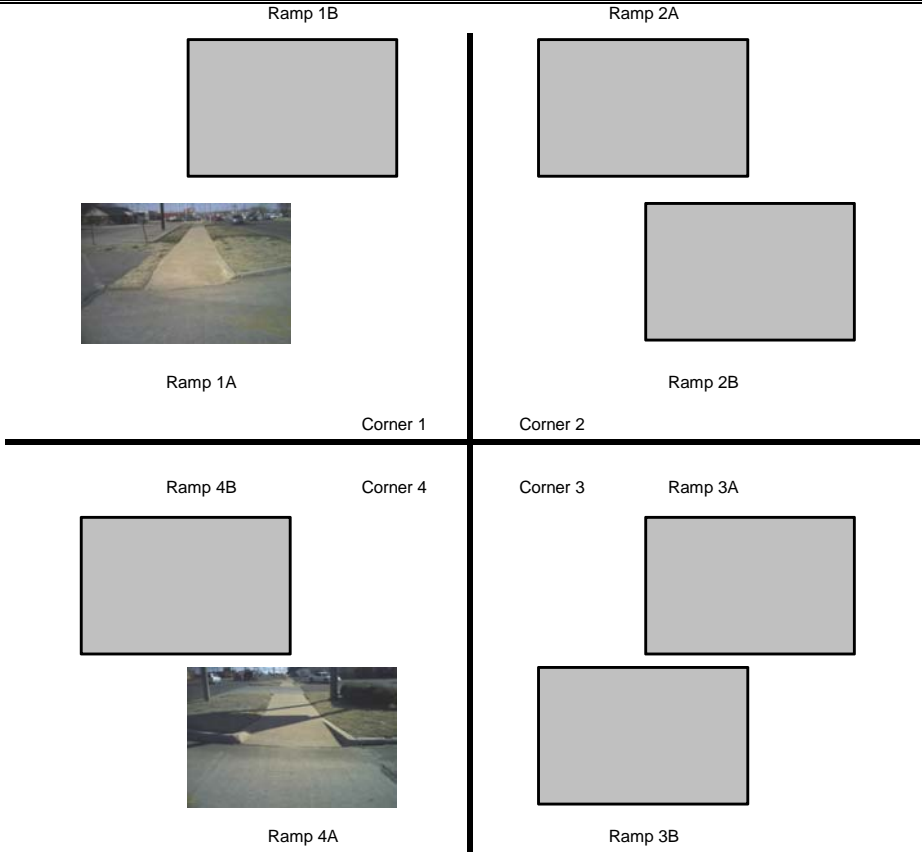
Intersection Issues	Crosswalk				Recommendations
	N	E	S	W	
Pavement condition at the crosswalk	N/A	N/A	N/A	N/A	
Crosswalk cross slope is greater than 2%	-	-	-	-	
Crosswalk striping	N/A	N/A	N/A	N/A

Ramp Issues	Ramp ID								Recommendations
	1A	1B	2A	2B	3A	3B	4A	4B	
Ramp does not land in crosswalk									
No 48" extension into crosswalk									
Ramp does not exist and is needed									
Flare cross slope is greater than 10%									
Ramp running slope is greater than 8.33%							X		
Ramp cross slope is greater than 2%	X						X		Remove and replace ramp
Ramp width is less than 48"									
Obstruction present in ramp or landing area									
No textured surface at base of ramp	X						X		Install colored truncated domes
No color contrast at base of ramp	X						X		
Landing area is less than 5' x 5', has a cross slope greater than 2% or does not exist	X								Install landing area
No pedestrian push buttons									
Pedestrian pushbutton diameter is not 2"									
Pedestrian pushbutton height is greater than 42"									
Pedestrian head offset is greater than 10' from the nearest crosswalk edge

Clear floor space for pedestrian pushbutton is less than 30" x 48", has a cross slope greater than 2% or does not exist									
Ramp transition onto roadway is greater than 0.25"									
Ponding occurs at base of ramp							X		Fix ramp transition
No existing curb in path of travel			X		X				Do not install ramp
Ramp Priority:	H		-		-		H

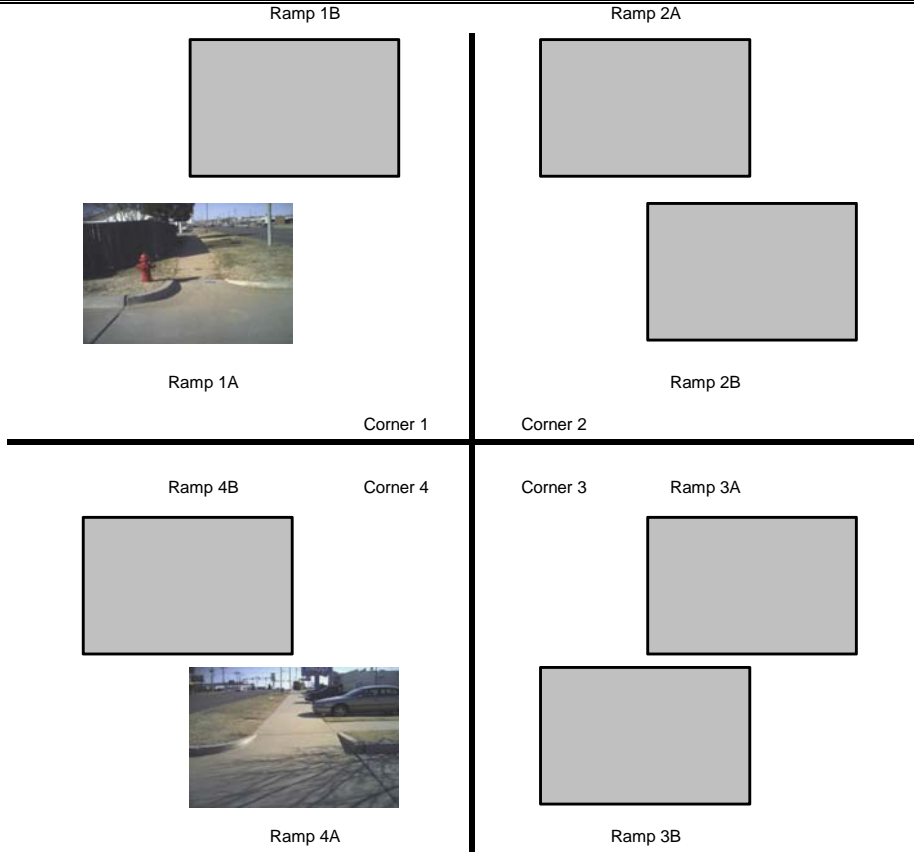
Intersection Issues	Crosswalk				Recommendations
	N	E	S	W	
Pavement condition at the crosswalk	N/A	N/A	N/A	N/A	
Crosswalk cross slope is greater than 2%	-	-	-	-	
Crosswalk striping	N/A	N/A	N/A	N/A

Ramp Issues	Ramp ID								Recommendations
	1A	1B	2A	2B	3A	3B	4A	4B	
Ramp does not land in crosswalk									
No 48" extension into crosswalk									
Ramp does not exist and is needed									
Flare cross slope is greater than 10%									
Ramp running slope is greater than 8.33%									
Ramp cross slope is greater than 2%									Remove and replace ramp
Ramp width is less than 48"	X								
Obstruction present in ramp or landing area	X								Install colored truncated domes
No textured surface at base of ramp	X					X			
No color contrast at base of ramp	X					X			
Landing area is less than 5' x 5', has a cross slope greater than 2% or does not exist	X								Install landing area
No pedestrian push buttons									
Pedestrian pushbutton diameter is not 2"									
Pedestrian pushbutton height is greater than 42"									
Pedestrian head offset is greater than 10' from the nearest crosswalk edge

Clear floor space for pedestrian pushbutton is less than 30" x 48", has a cross slope greater than 2% or does not exist									
Ramp transition onto roadway is greater than 0.25"	X								Fix ramp transition
Ponding occurs at base of ramp									
No existing curb in path of travel			X		X				Do not install ramp
Ramp Priority:	H		-		-			H

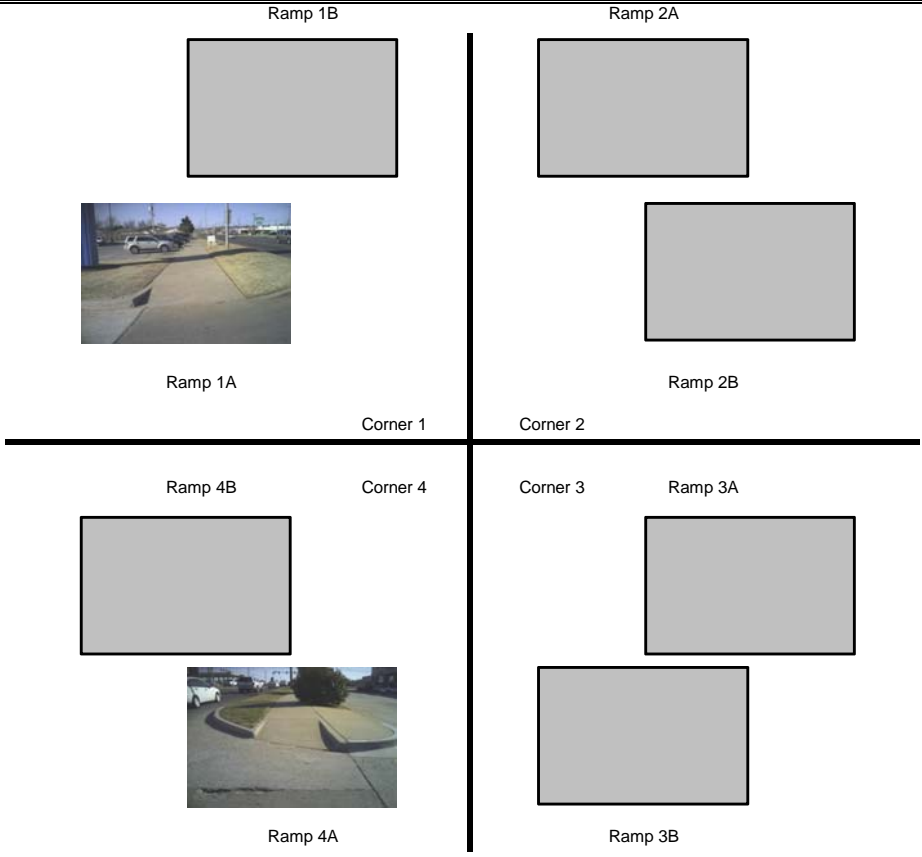
Intersection Issues	Crosswalk				Recommendations
	N	E	S	W	
Pavement condition at the crosswalk	N/A	N/A	N/A	N/A	
Crosswalk cross slope is greater than 2%	-	-	-	-	
Crosswalk striping	N/A	N/A	N/A	N/A

Ramp Issues	Ramp ID								Recommendations
	1A	1B	2A	2B	3A	3B	4A	4B	
Ramp does not land in crosswalk									
No 48" extension into crosswalk									
Ramp does not exist and is needed			X		X				Install handicap ramp
Flare cross slope is greater than 10%									
Ramp running slope is greater than 8.33%							X		Remove and replace ramp
Ramp cross slope is greater than 2%									
Ramp width is less than 48"									
Obstruction present in ramp or landing area									
No textured surface at base of ramp	X						X		Install colored truncated domes
No color contrast at base of ramp	X						X		
Landing area is less than 5' x 5', has a cross slope greater than 2% or does not exist	X						X		Install landing area
No pedestrian push buttons									
Pedestrian pushbutton diameter is not 2"									
Pedestrian pushbutton height is greater than 42"									
Pedestrian head offset is greater than 10' from the nearest crosswalk edge

Clear floor space for pedestrian pushbutton is less than 30" x 48", has a cross slope greater than 2% or does not exist									
Ramp transition onto roadway is greater than 0.25"									
Ponding occurs at base of ramp									
No existing curb in path of travel									
Ramp Priority:	M		H		H		H

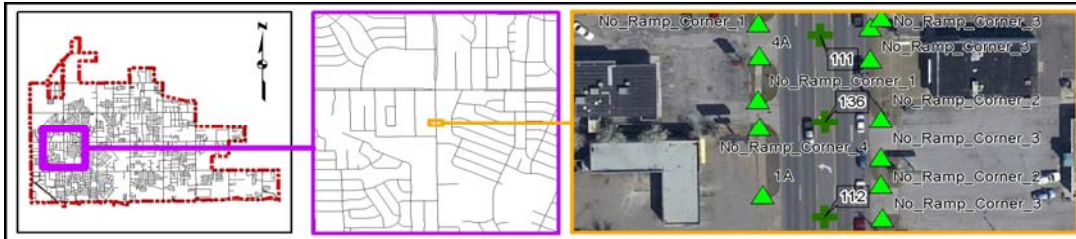
Project Location

Intersection Issues	Crosswalk				Recommendations
	N	E	S	W	
Pavement condition at the crosswalk	N/A	N/A	N/A	N/A	
Crosswalk cross slope is greater than 2%	X	X	X	X	Repave roadway and install crosswalk pavement markings
Crosswalk striping	N/A	N/A	N/A	N/A

Ramp Issues	Ramp ID								Recommendations
	1A	1B	2A	2B	3A	3B	4A	4B	
Ramp does not land in crosswalk									
No 48" extension into crosswalk									
Ramp does not exist and is needed									
Flare cross slope is greater than 10%									
Ramp running slope is greater than 8.33%									
Ramp cross slope is greater than 2%									
Ramp width is less than 48"									
Obstruction present in ramp or landing area									
No textured surface at base of ramp									
No color contrast at base of ramp									
Landing area is less than 5' x 5', has a cross slope greater than 2% or does not exist									
No pedestrian push buttons									
Pedestrian pushbutton diameter is not 2'									
Pedestrian pushbutton height is greater than 42"									
Pedestrian head offset is greater than 10' from the nearest crosswalk edge									
Clear floor space for pedestrian pushbutton is less than 30" x 48", has a cross slope greater than 2% or does not exist

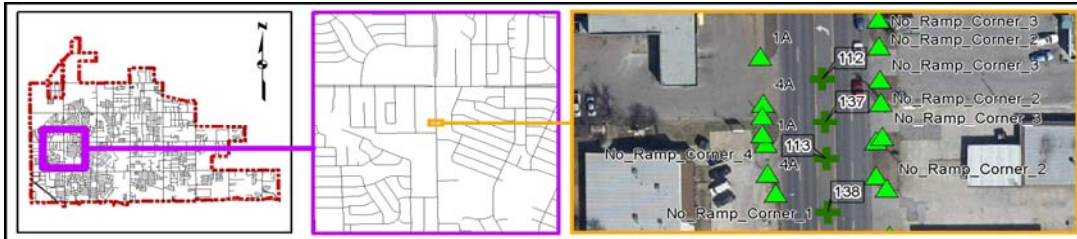
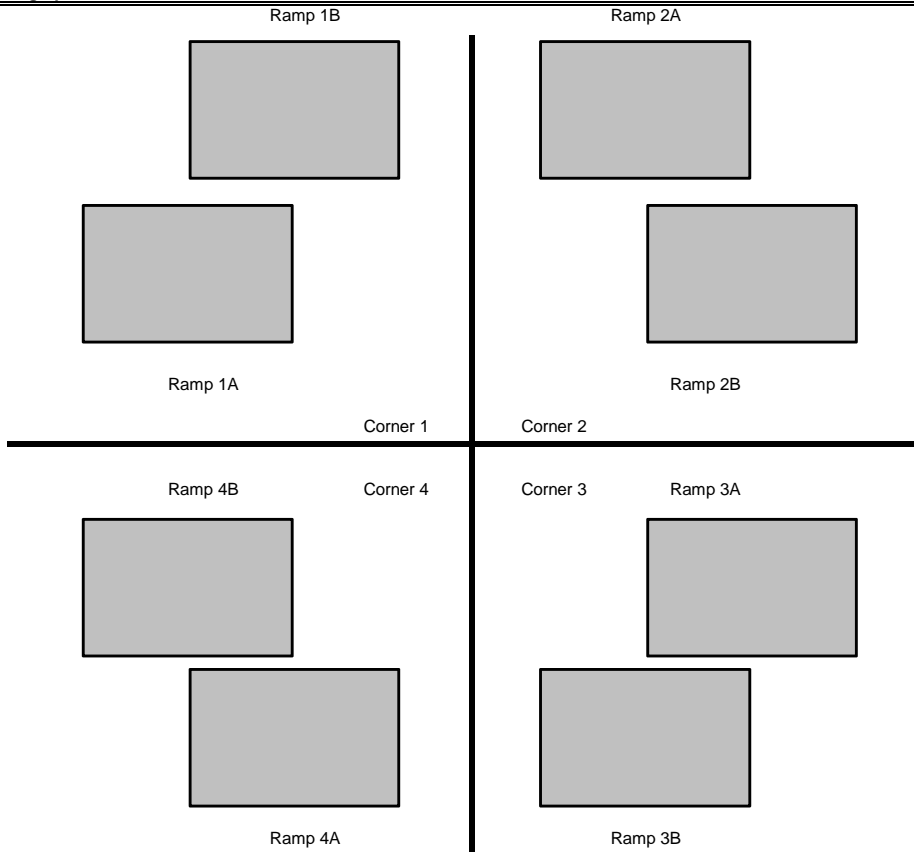
Project Location

Intersection Issues	Crosswalk				Recommendations
	N	E	S	W	
Pavement condition at the crosswalk	N/A	N/A	N/A	N/A	
Crosswalk cross slope is greater than 2%	X	X	X	X	Repave roadway and install crosswalk pavement markings
Crosswalk striping	N/A	N/A	N/A	N/A

Ramp Issues	Ramp ID								Recommendations
	1A	1B	2A	2B	3A	3B	4A	4B	
Ramp does not land in crosswalk									
No 48" extension into crosswalk									
Ramp does not exist and is needed									
Flare cross slope is greater than 10%									
Ramp running slope is greater than 8.33%									
Ramp cross slope is greater than 2%									
Ramp width is less than 48"									
Obstruction present in ramp or landing area									
No textured surface at base of ramp									
No color contrast at base of ramp									
Landing area is less than 5' x 5', has a cross slope greater than 2% or does not exist									
No pedestrian push buttons									
Pedestrian pushbutton diameter is not 2"									
Pedestrian pushbutton height is greater than 42"									
Pedestrian head offset is greater than 10' from the nearest crosswalk edge									
Clear floor space for pedestrian pushbutton is less than 30" x 48", has a cross slope greater than 2% or does not exist

Ramp transition onto roadway is greater than 0.25"									
Ponding occurs at base of ramp									
No existing curb in path of travel	X		X		X		X		Do not install ramp
Ramp Priority:	-		-		-		-

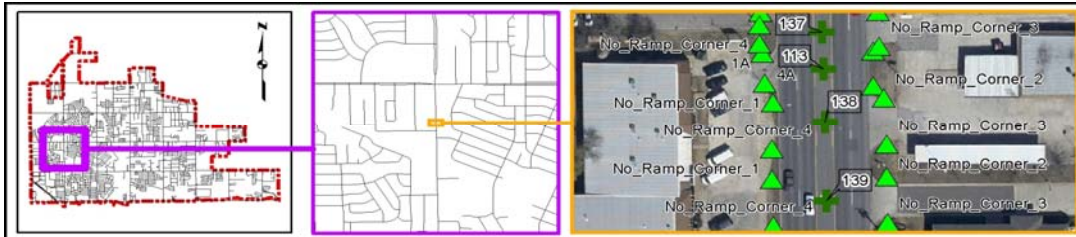
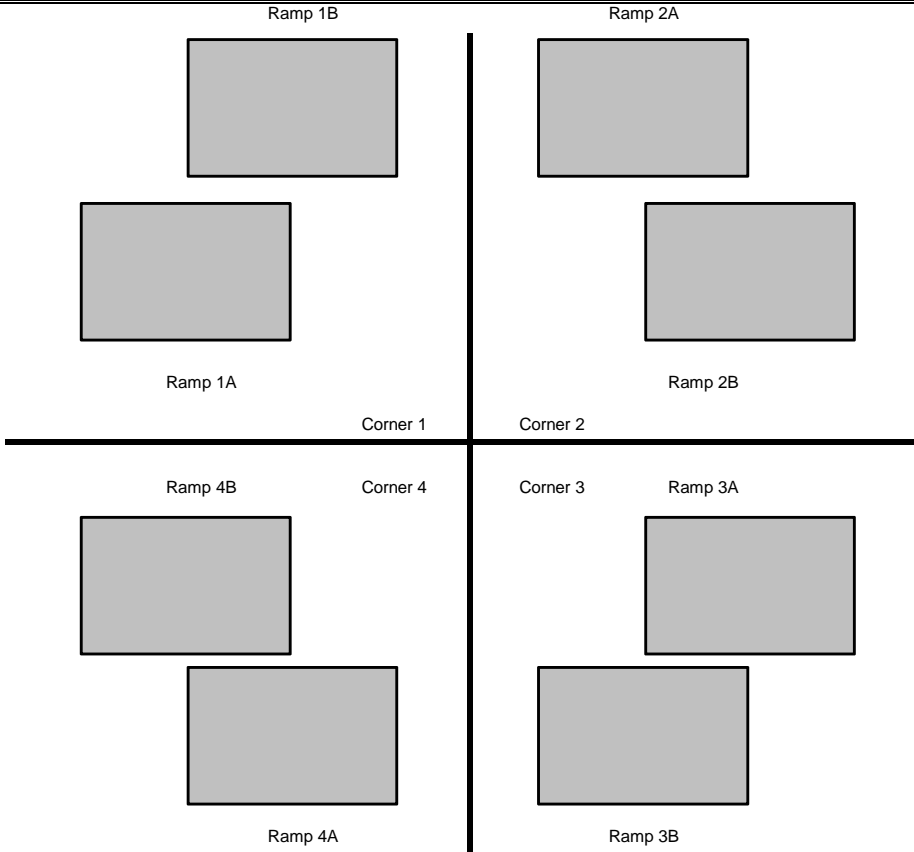
Project Location

Intersection Issues	Crosswalk				Recommendations
	N	E	S	W	
Pavement condition at the crosswalk	N/A	N/A	N/A	N/A	
Crosswalk cross slope is greater than 2%	X	X	X	X	Repave roadway and install crosswalk pavement markings
Crosswalk striping	N/A	N/A	N/A	N/A

Ramp Issues	Ramp ID								Recommendations
	1A	1B	2A	2B	3A	3B	4A	4B	
Ramp does not land in crosswalk									
No 48" extension into crosswalk									
Ramp does not exist and is needed									
Flare cross slope is greater than 10%									
Ramp running slope is greater than 8.33%									
Ramp cross slope is greater than 2%									
Ramp width is less than 48"									
Obstruction present in ramp or landing area									
No textured surface at base of ramp									
No color contrast at base of ramp									
Landing area is less than 5' x 5', has a cross slope greater than 2% or does not exist									
No pedestrian push buttons									
Pedestrian pushbutton diameter is not 2'									
Pedestrian pushbutton height is greater than 42"									
Pedestrian head offset is greater than 10' from the nearest crosswalk edge									
Clear floor space for pedestrian pushbutton is less than 30" x 48", has a cross slope greater than 2% or does not exist

Ramp transition onto roadway is greater than 0.25"									
Ponding occurs at base of ramp									
No existing curb in path of travel	X		X		X		X		Do not install ramp
Ramp Priority:	-		-		-		-

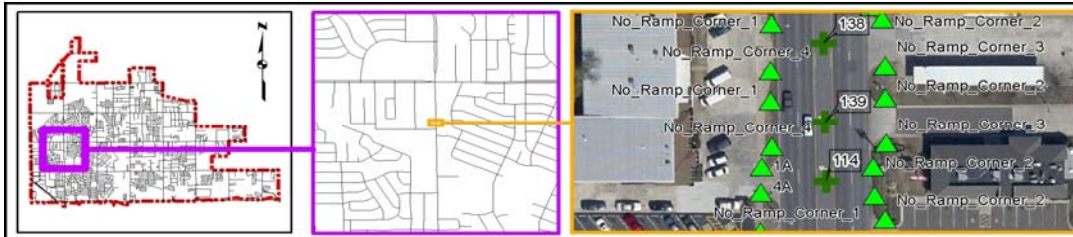
Project Location

Intersection Issues	Crosswalk				Recommendations
	N	E	S	W	
Pavement condition at the crosswalk	N/A	N/A	N/A	N/A	
Crosswalk cross slope is greater than 2%	X	X	X	X	Repave roadway and install crosswalk pavement markings
Crosswalk striping	N/A	N/A	N/A	N/A

Ramp Issues	Ramp ID								Recommendations
	1A	1B	2A	2B	3A	3B	4A	4B	
Ramp does not land in crosswalk									
No 48" extension into crosswalk									
Ramp does not exist and is needed			X		X				Install handicap ramp
Flare cross slope is greater than 10%									
Ramp running slope is greater than 8.33%									
Ramp cross slope is greater than 2%									
Ramp width is less than 48"									
Obstruction present in ramp or landing area									
No textured surface at base of ramp									
No color contrast at base of ramp									
Landing area is less than 5' x 5', has a cross slope greater than 2% or does not exist									
No pedestrian push buttons									
Pedestrian pushbutton diameter is not 2"									
Pedestrian pushbutton height is greater than 42"									
Pedestrian head offset is greater than 10' from the nearest crosswalk edge									
Clear floor space for pedestrian pushbutton is less than 30" x 48", has a cross slope greater than 2% or does not exist

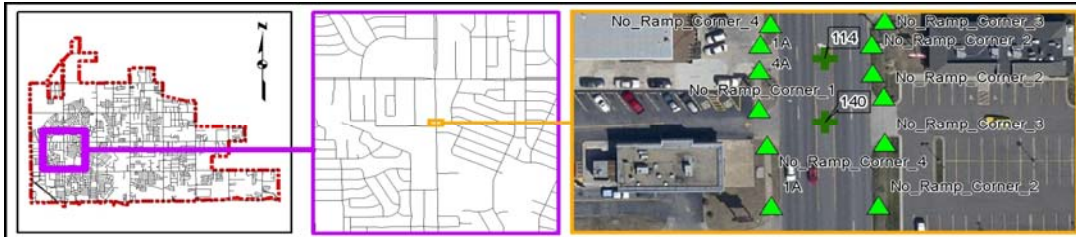
Project Location

Intersection Issues	Crosswalk				Recommendations
	N	E	S	W	
Pavement condition at the crosswalk	N/A	N/A	N/A	N/A	
Crosswalk cross slope is greater than 2%	X	X	X	X	Repave roadway and install crosswalk pavement markings
Crosswalk striping	N/A	N/A	N/A	N/A

Ramp Issues	Ramp ID								Recommendations
	1A	1B	2A	2B	3A	3B	4A	4B	
Ramp does not land in crosswalk									
No 48" extension into crosswalk									
Ramp does not exist and is needed			X		X				Install handicap ramp
Flare cross slope is greater than 10%									
Ramp running slope is greater than 8.33%									
Ramp cross slope is greater than 2%									
Ramp width is less than 48"									
Obstruction present in ramp or landing area									
No textured surface at base of ramp									
No color contrast at base of ramp									
Landing area is less than 5' x 5', has a cross slope greater than 2% or does not exist									
No pedestrian push buttons									
Pedestrian pushbutton diameter is not 2"									
Pedestrian pushbutton height is greater than 42"									
Pedestrian head offset is greater than 10' from the nearest crosswalk edge									
Clear floor space for pedestrian pushbutton is less than 30" x 48", has a cross slope greater than 2% or does not exist

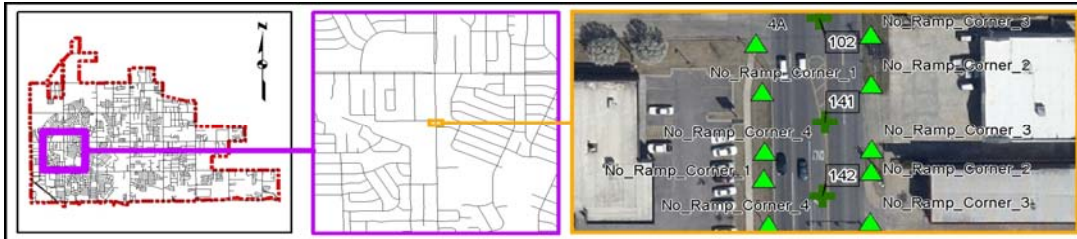
Project Location

Intersection Issues	Crosswalk				Recommendations
	N	E	S	W	
Pavement condition at the crosswalk	N/A	N/A	N/A	N/A	
Crosswalk cross slope is greater than 2%	X	X	X	X	Repave roadway and install crosswalk pavement markings
Crosswalk striping	N/A	N/A	N/A	N/A

Ramp Issues	Ramp ID								Recommendations
	1A	1B	2A	2B	3A	3B	4A	4B	
Ramp does not land in crosswalk									
No 48" extension into crosswalk									
Ramp does not exist and is needed									
Flare cross slope is greater than 10%									
Ramp running slope is greater than 8.33%									
Ramp cross slope is greater than 2%									
Ramp width is less than 48"									
Obstruction present in ramp or landing area									
No textured surface at base of ramp									
No color contrast at base of ramp									
Landing area is less than 5' x 5', has a cross slope greater than 2% or does not exist									
No pedestrian push buttons									
Pedestrian pushbutton diameter is not 2"									
Pedestrian pushbutton height is greater than 42"									
Pedestrian head offset is greater than 10' from the nearest crosswalk edge									
Clear floor space for pedestrian pushbutton is less than 30" x 48", has a cross slope greater than 2% or does not exist

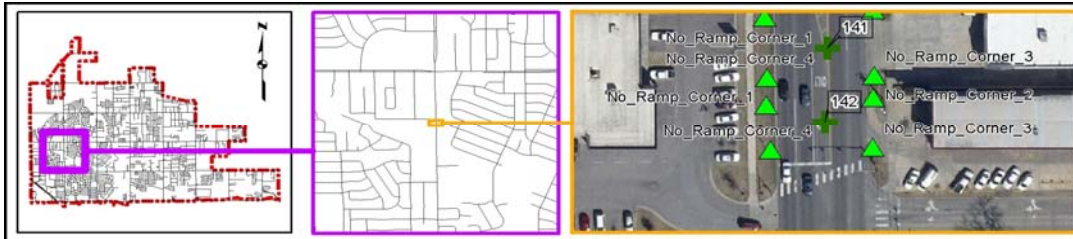
Project Location

Intersection Issues	Crosswalk				Recommendations
	N	E	S	W	
Pavement condition at the crosswalk	N/A	N/A	N/A	N/A	
Crosswalk cross slope is greater than 2%	X	X	X	X	Repave roadway and install crosswalk pavement markings
Crosswalk striping	N/A	N/A	N/A	N/A

Ramp Issues	Ramp ID								Recommendations
	1A	1B	2A	2B	3A	3B	4A	4B	
Ramp does not land in crosswalk									
No 48" extension into crosswalk									
Ramp does not exist and is needed									
Flare cross slope is greater than 10%									
Ramp running slope is greater than 8.33%									
Ramp cross slope is greater than 2%									
Ramp width is less than 48"									
Obstruction present in ramp or landing area									
No textured surface at base of ramp									
No color contrast at base of ramp									
Landing area is less than 5' x 5', has a cross slope greater than 2% or does not exist									
No pedestrian push buttons									
Pedestrian pushbutton diameter is not 2"									
Pedestrian pushbutton height is greater than 42"									
Pedestrian head offset is greater than 10' from the nearest crosswalk edge									
Clear floor space for pedestrian pushbutton is less than 30" x 48", has a cross slope greater than 2% or does not exist

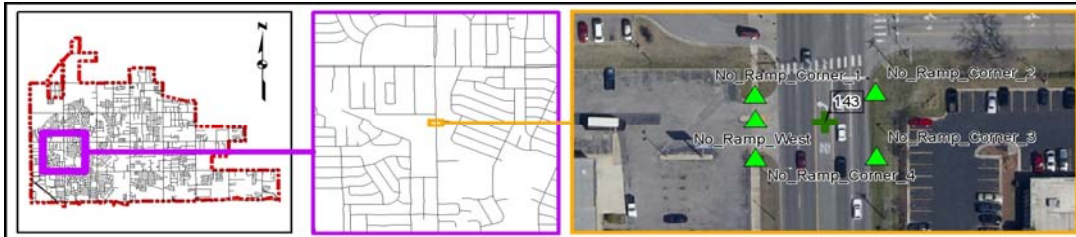
Project Location

Intersection Issues	Crosswalk				Recommendations
	N	E	S	W	
Pavement condition at the crosswalk	N/A	N/A	N/A	N/A	
Crosswalk cross slope is greater than 2%	X	X	X	X	Repave roadway and install crosswalk pavement markings
Crosswalk striping	N/A	N/A	N/A	N/A

Ramp Issues	Ramp ID							Recommendations	
	1A	1B	2A	2B	3A	3B	4A		W
Ramp does not land in crosswalk									
No 48" extension into crosswalk									
Ramp does not exist and is needed								X	Median nose modification
Flare cross slope is greater than 10%									
Ramp running slope is greater than 8.33%									
Ramp cross slope is greater than 2%									
Ramp width is less than 48"									
Obstruction present in ramp or landing area									
No textured surface at base of ramp									
No color contrast at base of ramp									
Landing area is less than 5' x 5', has a cross slope greater than 2% or does not exist									
No pedestrian push buttons									
Pedestrian pushbutton diameter is not 2'									
Pedestrian pushbutton height is greater than 42"									
Pedestrian head offset is greater than 10' from the nearest crosswalk edge									
Clear floor space for pedestrian pushbutton is less than 30" x 48", has a cross slope greater than 2% or does not exist

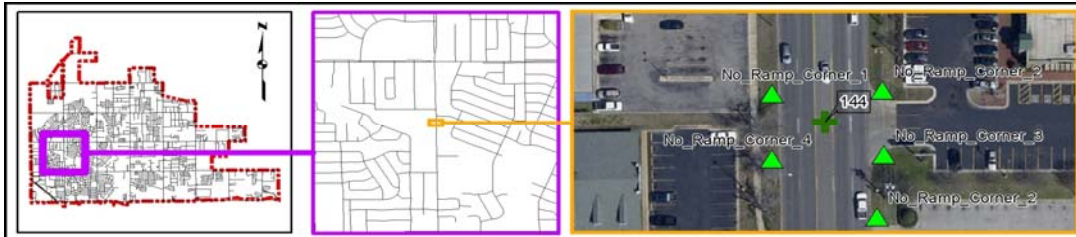
Project Location

Intersection Issues	Crosswalk				Recommendations
	N	E	S	W	
Pavement condition at the crosswalk	N/A	N/A	N/A	N/A	
Crosswalk cross slope is greater than 2%	X	X	X	X	Repave roadway and install crosswalk pavement markings
Crosswalk striping	N/A	N/A	N/A	N/A

Ramp Issues	Ramp ID								Recommendations
	1A	1B	2A	2B	3A	3B	4A	4B	
Ramp does not land in crosswalk									
No 48" extension into crosswalk									
Ramp does not exist and is needed			X		X				Install handicap ramp
Flare cross slope is greater than 10%									
Ramp running slope is greater than 8.33%									
Ramp cross slope is greater than 2%									
Ramp width is less than 48"									
Obstruction present in ramp or landing area									
No textured surface at base of ramp									
No color contrast at base of ramp									
Landing area is less than 5' x 5', has a cross slope greater than 2% or does not exist									
No pedestrian push buttons									
Pedestrian pushbutton diameter is not 2"									
Pedestrian pushbutton height is greater than 42"									
Pedestrian head offset is greater than 10' from the nearest crosswalk edge									
Clear floor space for pedestrian pushbutton is less than 30" x 48", has a cross slope greater than 2% or does not exist
