City of Midwest City ADA Self-Evaluation and Transition Plan

Project: ADA Self-Evaluation and Transition Plan

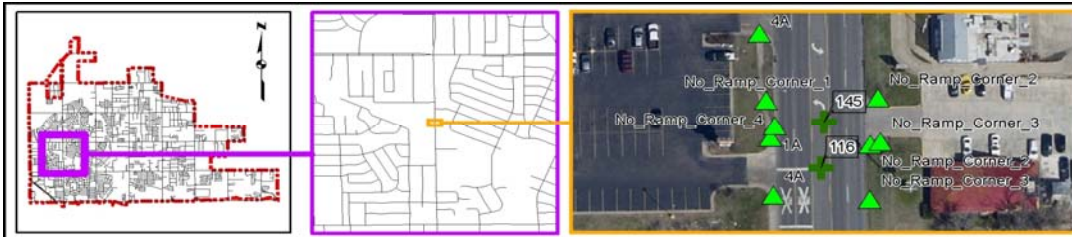
Project Location

Intersection Issues	Crosswalk				Recommendations
	N	E	S	W	
Pavement condition at the crosswalk	N/A	N/A	N/A	N/A	
Crosswalk cross slope is greater than 2%	X	X	X	X	Repave roadway and install crosswalk pavement markings
Crosswalk striping	N/A	N/A	N/A	N/A

Ramp Issues	Ramp ID								Recommendations
	1A	1B	2A	2B	3A	3B	4A	4B	
Ramp does not land in crosswalk									
No 48" extension into crosswalk									
Ramp does not exist and is needed			X		X				Install handicap ramp
Flare cross slope is greater than 10%									
Ramp running slope is greater than 8.33%									
Ramp cross slope is greater than 2%									
Ramp width is less than 48"									
Obstruction present in ramp or landing area									
No textured surface at base of ramp									
No color contrast at base of ramp									
Landing area is less than 5' x 5', has a cross slope greater than 2% or does not exist									
No pedestrian push buttons									
Pedestrian pushbutton diameter is not 2"									
Pedestrian pushbutton height is greater than 42"									
Pedestrian head offset is greater than 10' from the nearest crosswalk edge									
Clear floor space for pedestrian pushbutton is less than 30" x 48", has a cross slope greater than 2% or does not exist

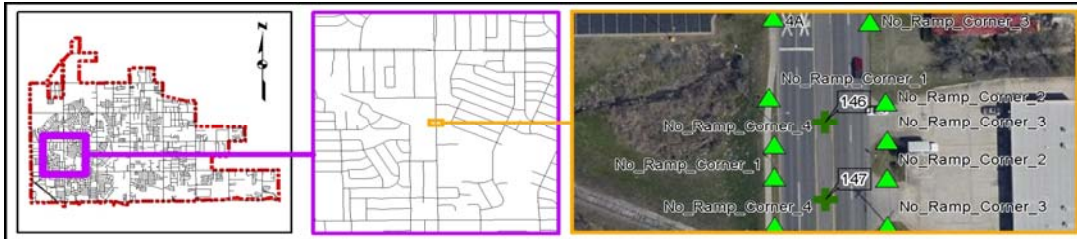
Project Location

Intersection Issues	Crosswalk				Recommendations
	N	E	S	W	
Pavement condition at the crosswalk	N/A	N/A	N/A	N/A	
Crosswalk cross slope is greater than 2%	X	X	X	X	Repave roadway and install crosswalk pavement markings
Crosswalk striping	N/A	N/A	N/A	N/A

Ramp Issues	Ramp ID								Recommendations
	1A	1B	2A	2B	3A	3B	4A	4B	
Ramp does not land in crosswalk									
No 48" extension into crosswalk									
Ramp does not exist and is needed									
Flare cross slope is greater than 10%									
Ramp running slope is greater than 8.33%									
Ramp cross slope is greater than 2%									
Ramp width is less than 48"									
Obstruction present in ramp or landing area									
No textured surface at base of ramp									
No color contrast at base of ramp									
Landing area is less than 5' x 5', has a cross slope greater than 2% or does not exist									
No pedestrian push buttons									
Pedestrian pushbutton diameter is not 2"									
Pedestrian pushbutton height is greater than 42"									
Pedestrian head offset is greater than 10' from the nearest crosswalk edge									
Clear floor space for pedestrian pushbutton is less than 30" x 48", has a cross slope greater than 2% or does not exist

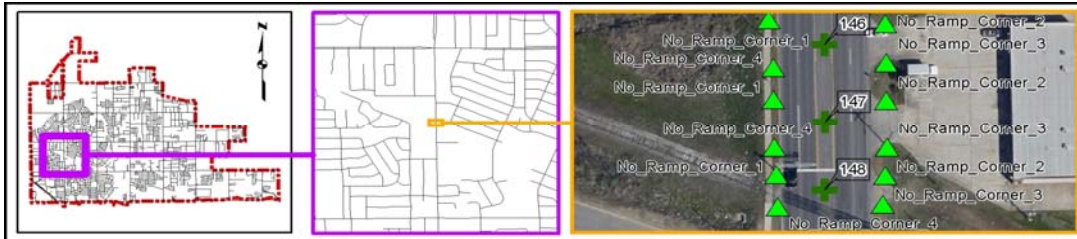
Project Location

Intersection Issues	Crosswalk				Recommendations
	N	E	S	W	
Pavement condition at the crosswalk	N/A	N/A	N/A	N/A	
Crosswalk cross slope is greater than 2%	X	X	X	X	Repave roadway and install crosswalk pavement markings
Crosswalk striping	N/A	N/A	N/A	N/A

Ramp Issues	Ramp ID								Recommendations
	1A	1B	2A	2B	3A	3B	4A	4B	
Ramp does not land in crosswalk									
No 48" extension into crosswalk									
Ramp does not exist and is needed									
Flare cross slope is greater than 10%									
Ramp running slope is greater than 8.33%									
Ramp cross slope is greater than 2%									
Ramp width is less than 48"									
Obstruction present in ramp or landing area									
No textured surface at base of ramp									
No color contrast at base of ramp									
Landing area is less than 5' x 5', has a cross slope greater than 2% or does not exist									
No pedestrian push buttons									
Pedestrian pushbutton diameter is not 2"									
Pedestrian pushbutton height is greater than 42"									
Pedestrian head offset is greater than 10' from the nearest crosswalk edge									
Clear floor space for pedestrian pushbutton is less than 30" x 48", has a cross slope greater than 2% or does not exist

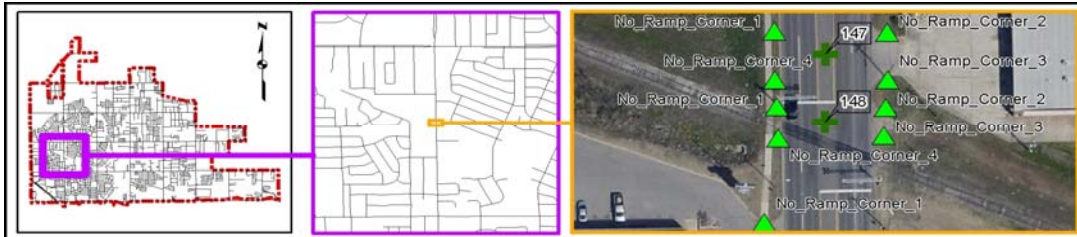
Project Location

Intersection Issues	Crosswalk				Recommendations
	N	E	S	W	
Pavement condition at the crosswalk	N/A	N/A	N/A	N/A	
Crosswalk cross slope is greater than 2%	X	X	X	X	Repave roadway and install crosswalk pavement markings
Crosswalk striping	N/A	N/A	N/A	N/A

Ramp Issues	Ramp ID								Recommendations
	1A	1B	2A	2B	3A	3B	4A	4B	
Ramp does not land in crosswalk									
No 48" extension into crosswalk									
Ramp does not exist and is needed									
Flare cross slope is greater than 10%									
Ramp running slope is greater than 8.33%									
Ramp cross slope is greater than 2%									
Ramp width is less than 48"									
Obstruction present in ramp or landing area									
No textured surface at base of ramp									
No color contrast at base of ramp									
Landing area is less than 5' x 5', has a cross slope greater than 2% or does not exist									
No pedestrian push buttons									
Pedestrian pushbutton diameter is not 2"									
Pedestrian pushbutton height is greater than 42"									
Pedestrian head offset is greater than 10' from the nearest crosswalk edge									
Clear floor space for pedestrian pushbutton is less than 30" x 48", has a cross slope greater than 2% or does not exist

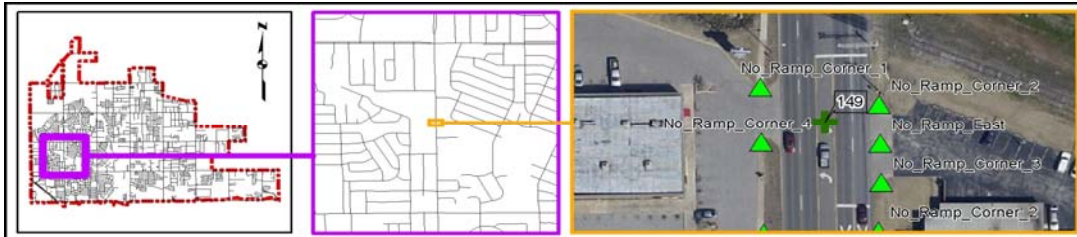
Project Location

Intersection Issues	Crosswalk				Recommendations
	N	E	S	W	
Pavement condition at the crosswalk	N/A	N/A	N/A	N/A	
Crosswalk cross slope is greater than 2%	X	X	X	X	Repave roadway and install crosswalk pavement markings
Crosswalk striping	N/A	N/A	N/A	N/A

Ramp Issues	Ramp ID							Recommendations	
	1A	1B	2A	2B	3A	3B	4A		E
Ramp does not land in crosswalk									
No 48" extension into crosswalk									
Ramp does not exist and is needed			X		X			X	Install handicap ramp / Median nose modification
Flare cross slope is greater than 10%									
Ramp running slope is greater than 8.33%									
Ramp cross slope is greater than 2%									
Ramp width is less than 48"									
Obstruction present in ramp or landing area									
No textured surface at base of ramp									
No color contrast at base of ramp									
Landing area is less than 5' x 5', has a cross slope greater than 2% or does not exist									
No pedestrian push buttons									
Pedestrian pushbutton diameter is not 2"									
Pedestrian pushbutton height is greater than 42"									
Pedestrian head offset is greater than 10' from the nearest crosswalk edge									
Clear floor space for pedestrian pushbutton is less than 30" x 48", has a cross slope greater than 2% or does not exist

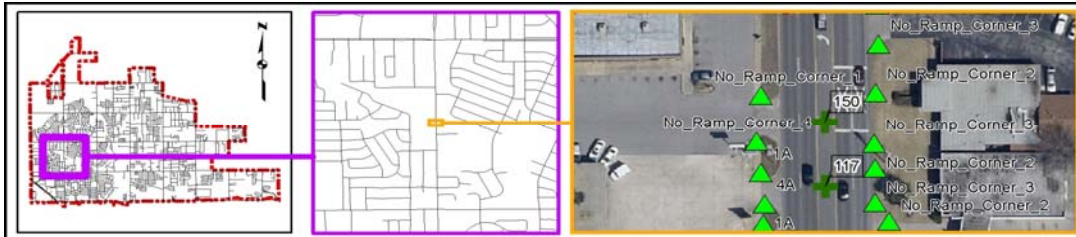
Project Location

Intersection Issues	Crosswalk				Recommendations
	N	E	S	W	
Pavement condition at the crosswalk	N/A	N/A	N/A	N/A	
Crosswalk cross slope is greater than 2%	X	X	X	X	Repave roadway and install crosswalk pavement markings
Crosswalk striping	N/A	N/A	N/A	N/A

Ramp Issues	Ramp ID								Recommendations
	1A	1B	2A	2B	3A	3B	4A	4B	
Ramp does not land in crosswalk									
No 48" extension into crosswalk									
Ramp does not exist and is needed									
Flare cross slope is greater than 10%									
Ramp running slope is greater than 8.33%									
Ramp cross slope is greater than 2%									
Ramp width is less than 48"									
Obstruction present in ramp or landing area									
No textured surface at base of ramp									
No color contrast at base of ramp									
Landing area is less than 5' x 5', has a cross slope greater than 2% or does not exist									
No pedestrian push buttons									
Pedestrian pushbutton diameter is not 2"									
Pedestrian pushbutton height is greater than 42"									
Pedestrian head offset is greater than 10' from the nearest crosswalk edge									
Clear floor space for pedestrian pushbutton is less than 30" x 48", has a cross slope greater than 2% or does not exist

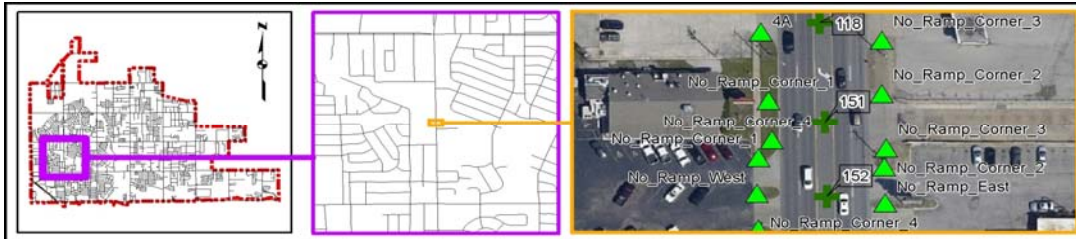
Project Location

Intersection Issues	Crosswalk				Recommendations
	N	E	S	W	
Pavement condition at the crosswalk	N/A	N/A	N/A	N/A	
Crosswalk cross slope is greater than 2%	X	X	X	X	Repave roadway and install crosswalk pavement markings
Crosswalk striping	N/A	N/A	N/A	N/A

Ramp Issues	Ramp ID								Recommendations
	1A	1B	2A	2B	3A	3B	4A	4B	
Ramp does not land in crosswalk									
No 48" extension into crosswalk									
Ramp does not exist and is needed			X		X				Install handicap ramp
Flare cross slope is greater than 10%									
Ramp running slope is greater than 8.33%									
Ramp cross slope is greater than 2%									
Ramp width is less than 48"									
Obstruction present in ramp or landing area									
No textured surface at base of ramp									
No color contrast at base of ramp									
Landing area is less than 5' x 5', has a cross slope greater than 2% or does not exist									
No pedestrian push buttons									
Pedestrian pushbutton diameter is not 2"									
Pedestrian pushbutton height is greater than 42"									
Pedestrian head offset is greater than 10' from the nearest crosswalk edge									
Clear floor space for pedestrian pushbutton is less than 30" x 48", has a cross slope greater than 2% or does not exist

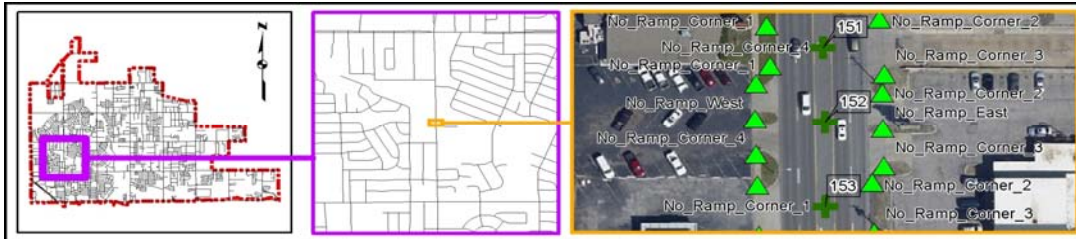
Project Location

Intersection Issues	Crosswalk				Recommendations
	N	E	S	W	
Pavement condition at the crosswalk	N/A	N/A	N/A	N/A	
Crosswalk cross slope is greater than 2%	X	X	X	X	Repave roadway and install crosswalk pavement markings
Crosswalk striping	N/A	N/A	N/A	N/A

Ramp Issues	Ramp ID							Recommendations	
	1A	1B	2A	2B	3A	3B	4A		E
Ramp does not land in crosswalk									
No 48" extension into crosswalk									
Ramp does not exist and is needed			X		X			X	Install handicap ramp / Cut-thru median ramp
Flare cross slope is greater than 10%									
Ramp running slope is greater than 8.33%									
Ramp cross slope is greater than 2%									
Ramp width is less than 48"									
Obstruction present in ramp or landing area									
No textured surface at base of ramp									
No color contrast at base of ramp									
Landing area is less than 5' x 5', has a cross slope greater than 2% or does not exist									
No pedestrian push buttons									
Pedestrian pushbutton diameter is not 2'									
Pedestrian pushbutton height is greater than 42"									
Pedestrian head offset is greater than 10' from the nearest crosswalk edge									
Clear floor space for pedestrian pushbutton is less than 30" x 48", has a cross slope greater than 2% or does not exist

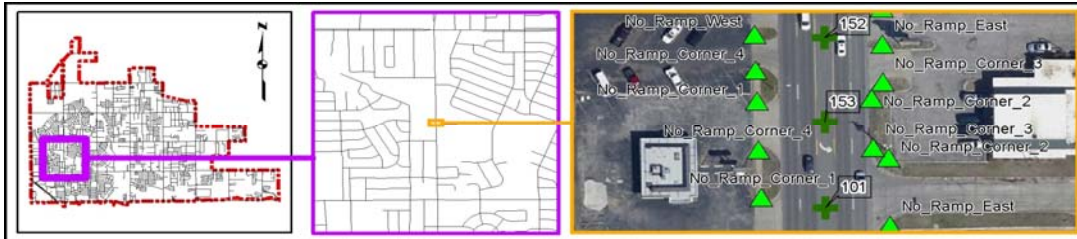
Intersection Issues	Crosswalk				Recommendations
	N	E	S	W	
Pavement condition at the crosswalk	N/A	N/A	N/A	N/A	
Crosswalk cross slope is greater than 2%	X	X	X	X	Repave roadway and install crosswalk pavement markings
Crosswalk striping	N/A	N/A	N/A	N/A

Ramp Issues	Ramp ID								Recommendations
	1A	1B	2A	2B	3A	3B	4A	4B	
Ramp does not land in crosswalk									
No 48" extension into crosswalk									
Ramp does not exist and is needed									
Flare cross slope is greater than 10%									
Ramp running slope is greater than 8.33%									
Ramp cross slope is greater than 2%									
Ramp width is less than 48"									
Obstruction present in ramp or landing area									
No textured surface at base of ramp									
No color contrast at base of ramp									
Landing area is less than 5' x 5', has a cross slope greater than 2% or does not exist									
No pedestrian push buttons									
Pedestrian pushbutton diameter is not 2"									
Pedestrian pushbutton height is greater than 42"									
Pedestrian head offset is greater than 10' from the nearest crosswalk edge									
Clear floor space for pedestrian pushbutton is less than 30" x 48", has a cross slope greater than 2% or does not exist

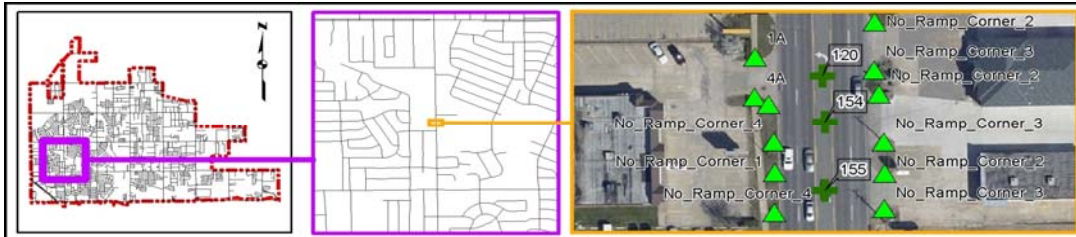
Intersection Issues	Crosswalk				Recommendations
	N	E	S	W	
Pavement condition at the crosswalk	N/A	N/A	N/A	N/A	
Crosswalk cross slope is greater than 2%	X	X	X	X	Repave roadway and install crosswalk pavement markings
Crosswalk striping	N/A	N/A	N/A	N/A

Ramp Issues	Ramp ID								Recommendations
	1A	1B	2A	2B	3A	3B	4A	4B	
Ramp does not land in crosswalk									
No 48" extension into crosswalk									
Ramp does not exist and is needed			X		X				Install handicap ramp
Flare cross slope is greater than 10%									
Ramp running slope is greater than 8.33%									
Ramp cross slope is greater than 2%									
Ramp width is less than 48"									
Obstruction present in ramp or landing area									
No textured surface at base of ramp									
No color contrast at base of ramp									
Landing area is less than 5' x 5', has a cross slope greater than 2% or does not exist									
No pedestrian push buttons									
Pedestrian pushbutton diameter is not 2"									
Pedestrian pushbutton height is greater than 42"									
Pedestrian head offset is greater than 10' from the nearest crosswalk edge									
Clear floor space for pedestrian pushbutton is less than 30" x 48", has a cross slope greater than 2% or does not exist

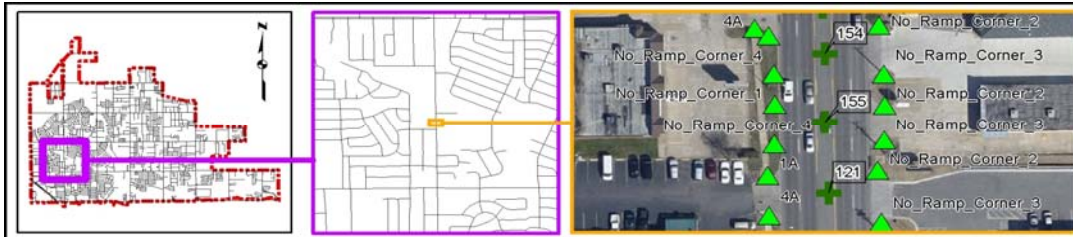
Intersection Issues	Crosswalk				Recommendations
	N	E	S	W	
Pavement condition at the crosswalk	N/A	N/A	N/A	N/A	
Crosswalk cross slope is greater than 2%	X	X	X	X	Repave roadway and install crosswalk pavement markings
Crosswalk striping	N/A	N/A	N/A	N/A

Ramp Issues	Ramp ID								Recommendations
	1A	1B	2A	2B	3A	3B	4A	4B	
Ramp does not land in crosswalk									
No 48" extension into crosswalk									
Ramp does not exist and is needed			X		X				Install handicap ramp
Flare cross slope is greater than 10%									
Ramp running slope is greater than 8.33%									
Ramp cross slope is greater than 2%									
Ramp width is less than 48"									
Obstruction present in ramp or landing area									
No textured surface at base of ramp									
No color contrast at base of ramp									
Landing area is less than 5' x 5', has a cross slope greater than 2% or does not exist									
No pedestrian push buttons									
Pedestrian pushbutton diameter is not 2"									
Pedestrian pushbutton height is greater than 42"									
Pedestrian head offset is greater than 10' from the nearest crosswalk edge									
Clear floor space for pedestrian pushbutton is less than 30" x 48", has a cross slope greater than 2% or does not exist

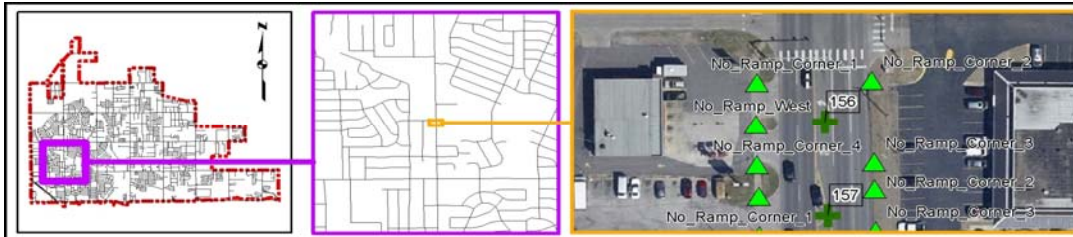
Intersection Issues	Crosswalk				Recommendations
	N	E	S	W	
Pavement condition at the crosswalk	N/A	N/A	N/A	N/A	
Crosswalk cross slope is greater than 2%	X	X	X	X	Repave roadway and install crosswalk pavement markings
Crosswalk striping	N/A	N/A	N/A	N/A

Ramp Issues	Ramp ID								Recommendations
	1A	1B	2A	2B	3A	3B	4A	4B	
Ramp does not land in crosswalk									
No 48" extension into crosswalk									
Ramp does not exist and is needed									
Flare cross slope is greater than 10%									
Ramp running slope is greater than 8.33%									
Ramp cross slope is greater than 2%									
Ramp width is less than 48"									
Obstruction present in ramp or landing area									
No textured surface at base of ramp									
No color contrast at base of ramp									
Landing area is less than 5' x 5', has a cross slope greater than 2% or does not exist									
No pedestrian push buttons									
Pedestrian pushbutton diameter is not 2"									
Pedestrian pushbutton height is greater than 42"									
Pedestrian head offset is greater than 10' from the nearest crosswalk edge									
Clear floor space for pedestrian pushbutton is less than 30" x 48", has a cross slope greater than 2% or does not exist

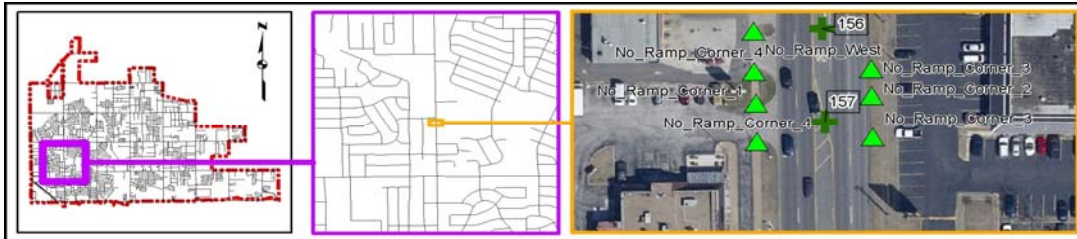
Intersection Issues	Crosswalk				Recommendations
	N	E	S	W	
Pavement condition at the crosswalk	N/A	N/A	N/A	N/A	
Crosswalk cross slope is greater than 2%	X	X	X	X	Repave roadway and install crosswalk pavement markings
Crosswalk striping	N/A	N/A	N/A	N/A

Ramp Issues	Ramp ID								Recommendations
	1A	1B	2A	2B	3A	3B	4A	4B	
Ramp does not land in crosswalk									
No 48" extension into crosswalk									
Ramp does not exist and is needed									
Flare cross slope is greater than 10%									
Ramp running slope is greater than 8.33%									
Ramp cross slope is greater than 2%									
Ramp width is less than 48"									
Obstruction present in ramp or landing area									
No textured surface at base of ramp									
No color contrast at base of ramp									
Landing area is less than 5' x 5', has a cross slope greater than 2% or does not exist									
No pedestrian push buttons									
Pedestrian pushbutton diameter is not 2"									
Pedestrian pushbutton height is greater than 42"									
Pedestrian head offset is greater than 10' from the nearest crosswalk edge									
Clear floor space for pedestrian pushbutton is less than 30" x 48", has a cross slope greater than 2% or does not exist

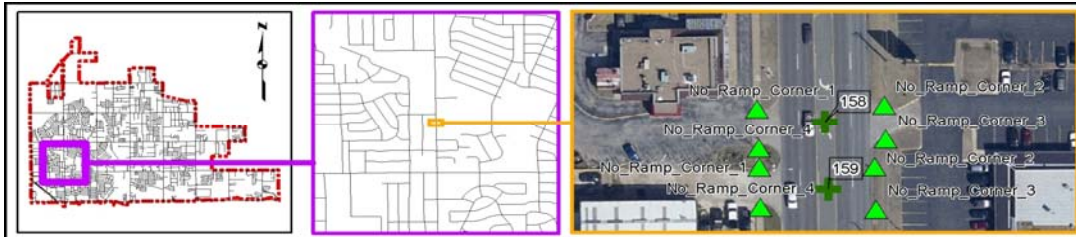
Intersection Issues	Crosswalk				Recommendations
	N	E	S	W	
Pavement condition at the crosswalk	N/A	N/A	N/A	N/A	
Crosswalk cross slope is greater than 2%	X	X	X	X	Repave roadway and install crosswalk pavement markings
Crosswalk striping	N/A	N/A	N/A	N/A

Ramp Issues	Ramp ID								Recommendations
	1A	1B	2A	2B	3A	3B	4A	4B	
Ramp does not land in crosswalk									
No 48" extension into crosswalk									
Ramp does not exist and is needed			X		X				Install handicap ramp
Flare cross slope is greater than 10%									
Ramp running slope is greater than 8.33%									
Ramp cross slope is greater than 2%									
Ramp width is less than 48"									
Obstruction present in ramp or landing area									
No textured surface at base of ramp									
No color contrast at base of ramp									
Landing area is less than 5' x 5', has a cross slope greater than 2% or does not exist									
No pedestrian push buttons									
Pedestrian pushbutton diameter is not 2"									
Pedestrian pushbutton height is greater than 42"									
Pedestrian head offset is greater than 10' from the nearest crosswalk edge									
Clear floor space for pedestrian pushbutton is less than 30" x 48", has a cross slope greater than 2% or does not exist

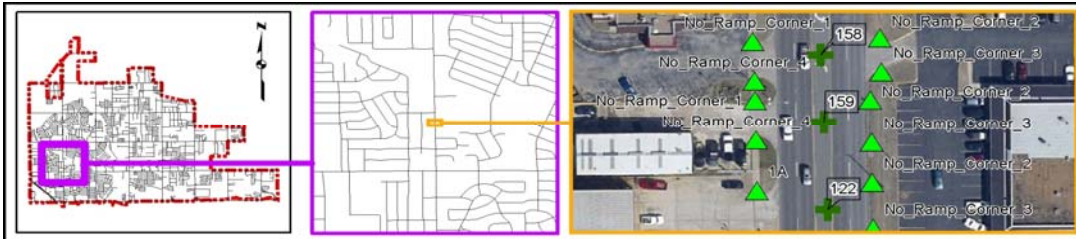
Intersection Issues	Crosswalk				Recommendations
	N	E	S	W	
Pavement condition at the crosswalk	N/A	N/A	N/A	N/A	
Crosswalk cross slope is greater than 2%	X	X	X	X	Repave roadway and install crosswalk pavement markings
Crosswalk striping	N/A	N/A	N/A	N/A

Ramp Issues	Ramp ID								Recommendations
	1A	1B	2A	2B	3A	3B	4A	4B	
Ramp does not land in crosswalk									
No 48" extension into crosswalk									
Ramp does not exist and is needed									
Flare cross slope is greater than 10%									
Ramp running slope is greater than 8.33%									
Ramp cross slope is greater than 2%									
Ramp width is less than 48"									
Obstruction present in ramp or landing area									
No textured surface at base of ramp									
No color contrast at base of ramp									
Landing area is less than 5' x 5', has a cross slope greater than 2% or does not exist									
No pedestrian push buttons									
Pedestrian pushbutton diameter is not 2'									
Pedestrian pushbutton height is greater than 42"									
Pedestrian head offset is greater than 10' from the nearest crosswalk edge									
Clear floor space for pedestrian pushbutton is less than 30" x 48", has a cross slope greater than 2% or does not exist

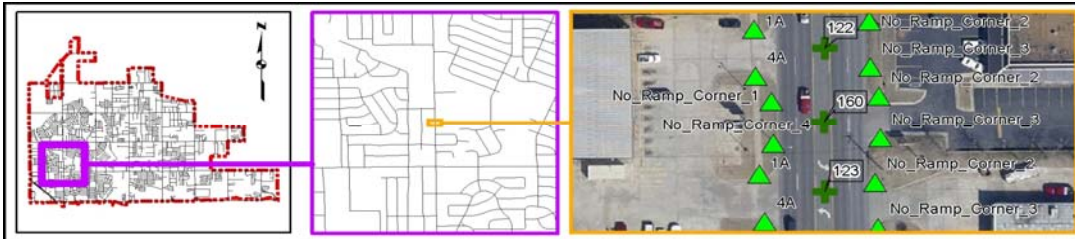
Intersection Issues	Crosswalk				Recommendations
	N	E	S	W	
Pavement condition at the crosswalk	N/A	N/A	N/A	N/A	
Crosswalk cross slope is greater than 2%	X	X	X	X	Repave roadway and install crosswalk pavement markings
Crosswalk striping	N/A	N/A	N/A	N/A

Ramp Issues	Ramp ID								Recommendations
	1A	1B	2A	2B	3A	3B	4A	4B	
Ramp does not land in crosswalk									
No 48" extension into crosswalk									
Ramp does not exist and is needed			X		X				Install handicap ramp
Flare cross slope is greater than 10%									
Ramp running slope is greater than 8.33%									
Ramp cross slope is greater than 2%									
Ramp width is less than 48"									
Obstruction present in ramp or landing area									
No textured surface at base of ramp									
No color contrast at base of ramp									
Landing area is less than 5' x 5', has a cross slope greater than 2% or does not exist									
No pedestrian push buttons									
Pedestrian pushbutton diameter is not 2"									
Pedestrian pushbutton height is greater than 42"									
Pedestrian head offset is greater than 10' from the nearest crosswalk edge									
Clear floor space for pedestrian pushbutton is less than 30" x 48", has a cross slope greater than 2% or does not exist

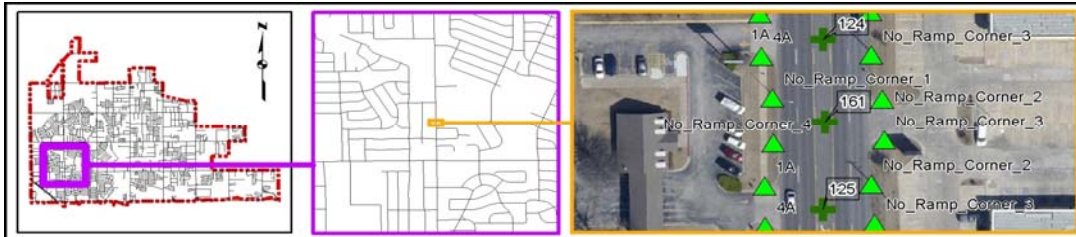
Intersection Issues	Crosswalk				Recommendations
	N	E	S	W	
Pavement condition at the crosswalk	N/A	N/A	N/A	N/A	
Crosswalk cross slope is greater than 2%	X	X	X	X	Repave roadway and install crosswalk pavement markings
Crosswalk striping	N/A	N/A	N/A	N/A

Ramp Issues	Ramp ID								Recommendations
	1A	1B	2A	2B	3A	3B	4A	4B	
Ramp does not land in crosswalk									
No 48" extension into crosswalk									
Ramp does not exist and is needed			X		X				Install handicap ramp
Flare cross slope is greater than 10%									
Ramp running slope is greater than 8.33%									
Ramp cross slope is greater than 2%									
Ramp width is less than 48"									
Obstruction present in ramp or landing area									
No textured surface at base of ramp									
No color contrast at base of ramp									
Landing area is less than 5' x 5', has a cross slope greater than 2% or does not exist									
No pedestrian push buttons									
Pedestrian pushbutton diameter is not 2"									
Pedestrian pushbutton height is greater than 42"									
Pedestrian head offset is greater than 10' from the nearest crosswalk edge									
Clear floor space for pedestrian pushbutton is less than 30" x 48", has a cross slope greater than 2% or does not exist

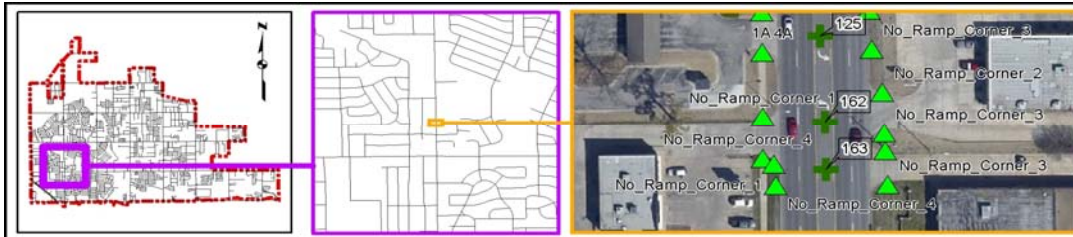
Intersection Issues	Crosswalk				Recommendations
	N	E	S	W	
Pavement condition at the crosswalk	N/A	N/A	N/A	N/A	
Crosswalk cross slope is greater than 2%	X	X	X	X	Repave roadway and install crosswalk pavement markings
Crosswalk striping	N/A	N/A	N/A	N/A

Ramp Issues	Ramp ID								Recommendations
	1A	1B	2A	2B	3A	3B	4A	4B	
Ramp does not land in crosswalk									
No 48" extension into crosswalk									
Ramp does not exist and is needed			X		X				Install handicap ramp
Flare cross slope is greater than 10%									
Ramp running slope is greater than 8.33%									
Ramp cross slope is greater than 2%									
Ramp width is less than 48"									
Obstruction present in ramp or landing area									
No textured surface at base of ramp									
No color contrast at base of ramp									
Landing area is less than 5' x 5', has a cross slope greater than 2% or does not exist									
No pedestrian push buttons									
Pedestrian pushbutton diameter is not 2"									
Pedestrian pushbutton height is greater than 42"									
Pedestrian head offset is greater than 10' from the nearest crosswalk edge									
Clear floor space for pedestrian pushbutton is less than 30" x 48", has a cross slope greater than 2% or does not exist

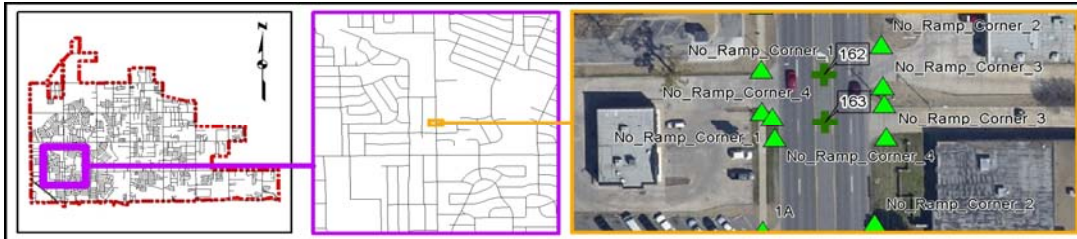
Intersection Issues	Crosswalk				Recommendations
	N	E	S	W	
Pavement condition at the crosswalk	N/A	N/A	N/A	N/A	
Crosswalk cross slope is greater than 2%	X	X	X	X	Repave roadway and install crosswalk pavement markings
Crosswalk striping	N/A	N/A	N/A	N/A

Ramp Issues	Ramp ID								Recommendations
	1A	1B	2A	2B	3A	3B	4A	4B	
Ramp does not land in crosswalk									
No 48" extension into crosswalk									
Ramp does not exist and is needed			X		X				Install handicap ramp
Flare cross slope is greater than 10%									
Ramp running slope is greater than 8.33%									
Ramp cross slope is greater than 2%									
Ramp width is less than 48"									
Obstruction present in ramp or landing area									
No textured surface at base of ramp									
No color contrast at base of ramp									
Landing area is less than 5' x 5', has a cross slope greater than 2% or does not exist									
No pedestrian push buttons									
Pedestrian pushbutton diameter is not 2"									
Pedestrian pushbutton height is greater than 42"									
Pedestrian head offset is greater than 10' from the nearest crosswalk edge									
Clear floor space for pedestrian pushbutton is less than 30" x 48", has a cross slope greater than 2% or does not exist

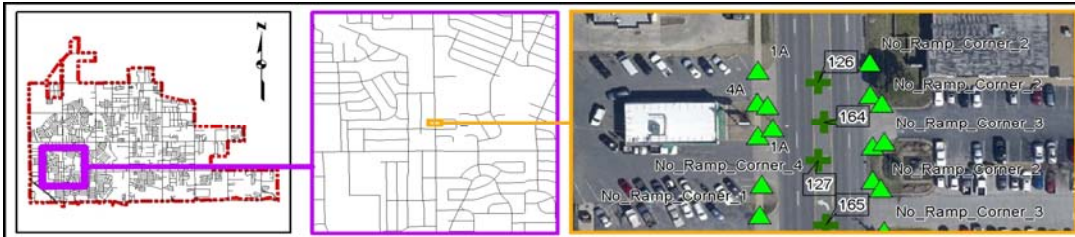
Intersection Issues	Crosswalk				Recommendations
	N	E	S	W	
Pavement condition at the crosswalk	N/A	N/A	N/A	N/A	
Crosswalk cross slope is greater than 2%	X	X	X	X	Repave roadway and install crosswalk pavement markings
Crosswalk striping	N/A	N/A	N/A	N/A

Ramp Issues	Ramp ID								Recommendations
	1A	1B	2A	2B	3A	3B	4A	4B	
Ramp does not land in crosswalk									
No 48" extension into crosswalk									
Ramp does not exist and is needed			X		X				Install handicap ramp
Flare cross slope is greater than 10%									
Ramp running slope is greater than 8.33%									
Ramp cross slope is greater than 2%									
Ramp width is less than 48"									
Obstruction present in ramp or landing area									
No textured surface at base of ramp									
No color contrast at base of ramp									
Landing area is less than 5' x 5', has a cross slope greater than 2% or does not exist									
No pedestrian push buttons									
Pedestrian pushbutton diameter is not 2"									
Pedestrian pushbutton height is greater than 42"									
Pedestrian head offset is greater than 10' from the nearest crosswalk edge									
Clear floor space for pedestrian pushbutton is less than 30" x 48", has a cross slope greater than 2% or does not exist

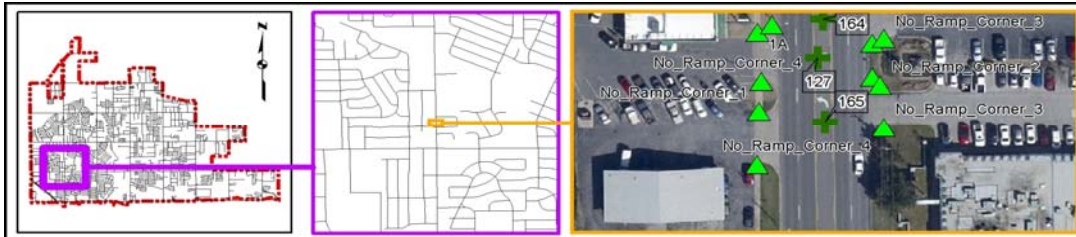
Intersection Issues	Crosswalk				Recommendations
	N	E	S	W	
Pavement condition at the crosswalk	N/A	N/A	N/A	N/A	
Crosswalk cross slope is greater than 2%	X	X	X	X	Repave roadway and install crosswalk pavement markings
Crosswalk striping	N/A	N/A	N/A	N/A

Ramp Issues	Ramp ID								Recommendations
	1A	1B	2A	2B	3A	3B	4A	4B	
Ramp does not land in crosswalk									
No 48" extension into crosswalk									
Ramp does not exist and is needed			X		X				Install handicap ramp
Flare cross slope is greater than 10%									
Ramp running slope is greater than 8.33%									
Ramp cross slope is greater than 2%									
Ramp width is less than 48"									
Obstruction present in ramp or landing area									
No textured surface at base of ramp									
No color contrast at base of ramp									
Landing area is less than 5' x 5', has a cross slope greater than 2% or does not exist									
No pedestrian push buttons									
Pedestrian pushbutton diameter is not 2"									
Pedestrian pushbutton height is greater than 42"									
Pedestrian head offset is greater than 10' from the nearest crosswalk edge									
Clear floor space for pedestrian pushbutton is less than 30" x 48", has a cross slope greater than 2% or does not exist

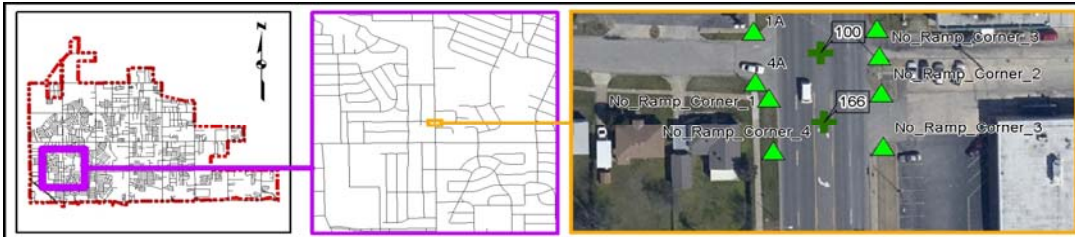
Intersection Issues	Crosswalk				Recommendations
	N	E	S	W	
Pavement condition at the crosswalk	N/A	N/A	N/A	N/A	
Crosswalk cross slope is greater than 2%	X	X	X	X	Repave roadway and install crosswalk pavement markings
Crosswalk striping	N/A	N/A	N/A	N/A

Ramp Issues	Ramp ID								Recommendations
	1A	1B	2A	2B	3A	3B	4A	4B	
Ramp does not land in crosswalk									
No 48" extension into crosswalk									
Ramp does not exist and is needed			X		X				Install handicap ramp
Flare cross slope is greater than 10%									
Ramp running slope is greater than 8.33%									
Ramp cross slope is greater than 2%									
Ramp width is less than 48"									
Obstruction present in ramp or landing area									
No textured surface at base of ramp									
No color contrast at base of ramp									
Landing area is less than 5' x 5', has a cross slope greater than 2% or does not exist									
No pedestrian push buttons									
Pedestrian pushbutton diameter is not 2"									
Pedestrian pushbutton height is greater than 42"									
Pedestrian head offset is greater than 10' from the nearest crosswalk edge									
Clear floor space for pedestrian pushbutton is less than 30" x 48", has a cross slope greater than 2% or does not exist

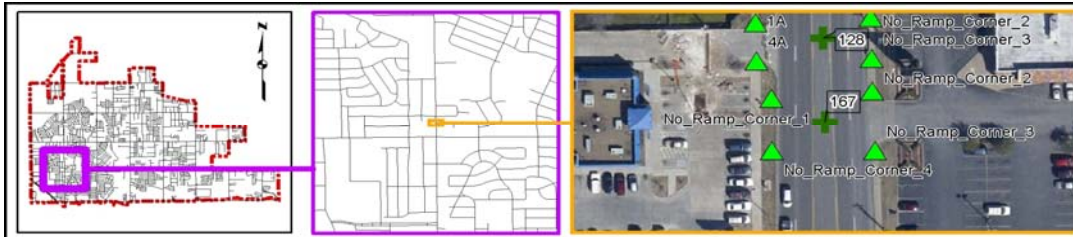
Intersection Issues	Crosswalk				Recommendations
	N	E	S	W	
Pavement condition at the crosswalk	N/A	N/A	N/A	N/A	
Crosswalk cross slope is greater than 2%	X	X	X	X	Repave roadway and install crosswalk pavement markings
Crosswalk striping	N/A	N/A	N/A	N/A

Ramp Issues	Ramp ID								Recommendations
	1A	1B	2A	2B	3A	3B	4A	4B	
Ramp does not land in crosswalk									
No 48" extension into crosswalk									
Ramp does not exist and is needed			X		X				Install handicap ramp
Flare cross slope is greater than 10%									
Ramp running slope is greater than 8.33%									
Ramp cross slope is greater than 2%									
Ramp width is less than 48"									
Obstruction present in ramp or landing area									
No textured surface at base of ramp									
No color contrast at base of ramp									
Landing area is less than 5' x 5', has a cross slope greater than 2% or does not exist									
No pedestrian push buttons									
Pedestrian pushbutton diameter is not 2"									
Pedestrian pushbutton height is greater than 42"									
Pedestrian head offset is greater than 10' from the nearest crosswalk edge									
Clear floor space for pedestrian pushbutton is less than 30" x 48", has a cross slope greater than 2% or does not exist

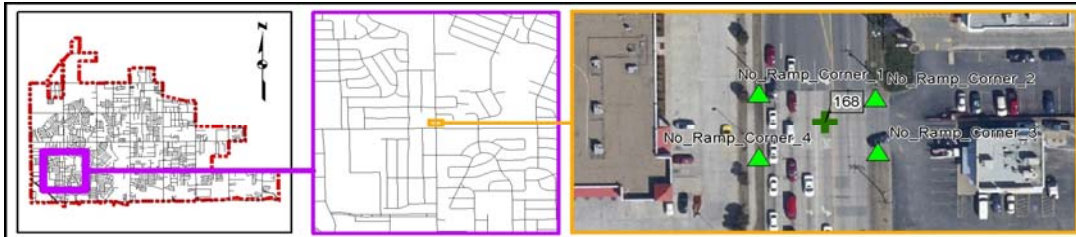
Intersection Issues	Crosswalk				Recommendations
	N	E	S	W	
Pavement condition at the crosswalk	N/A	N/A	N/A	N/A	
Crosswalk cross slope is greater than 2%	X	X	X	X	Repave roadway and install crosswalk pavement markings
Crosswalk striping	N/A	N/A	N/A	N/A

Ramp Issues	Ramp ID								Recommendations
	1A	1B	2A	2B	3A	3B	4A	4B	
Ramp does not land in crosswalk									
No 48" extension into crosswalk									
Ramp does not exist and is needed			X		X				Install handicap ramp
Flare cross slope is greater than 10%									
Ramp running slope is greater than 8.33%									
Ramp cross slope is greater than 2%									
Ramp width is less than 48"									
Obstruction present in ramp or landing area									
No textured surface at base of ramp									
No color contrast at base of ramp									
Landing area is less than 5' x 5', has a cross slope greater than 2% or does not exist									
No pedestrian push buttons									
Pedestrian pushbutton diameter is not 2"									
Pedestrian pushbutton height is greater than 42"									
Pedestrian head offset is greater than 10' from the nearest crosswalk edge									
Clear floor space for pedestrian pushbutton is less than 30" x 48", has a cross slope greater than 2% or does not exist
